ADDENDUM NO. 1

PROJECT: HBPED800Q, Pre-Scoping Services for the Porpoise Bridge in Flushing Meadows-Corona Park, Borough of Queens
PIN: 8502013HW0058P

Inspection Agency: 13 - Consultant Type of Inspection: 1 - BIENNIAL
 GTMS: --- -- Unknown - Unknown
 POSTINGS: See Gen Rec Page 1 for Postings at time of inspection.
 Further Investigation Needed: No
 State Highway Number: ----- Milepoint: ----- AADT/Yr: ----- / --
 Orientation: Political Unit: Year Built: ----
 Total Spans: 14 Ramp Bridge Attached To Span: --- BIN: -----
 General Recommendation: 4 Computed Condition Rating: 4.071

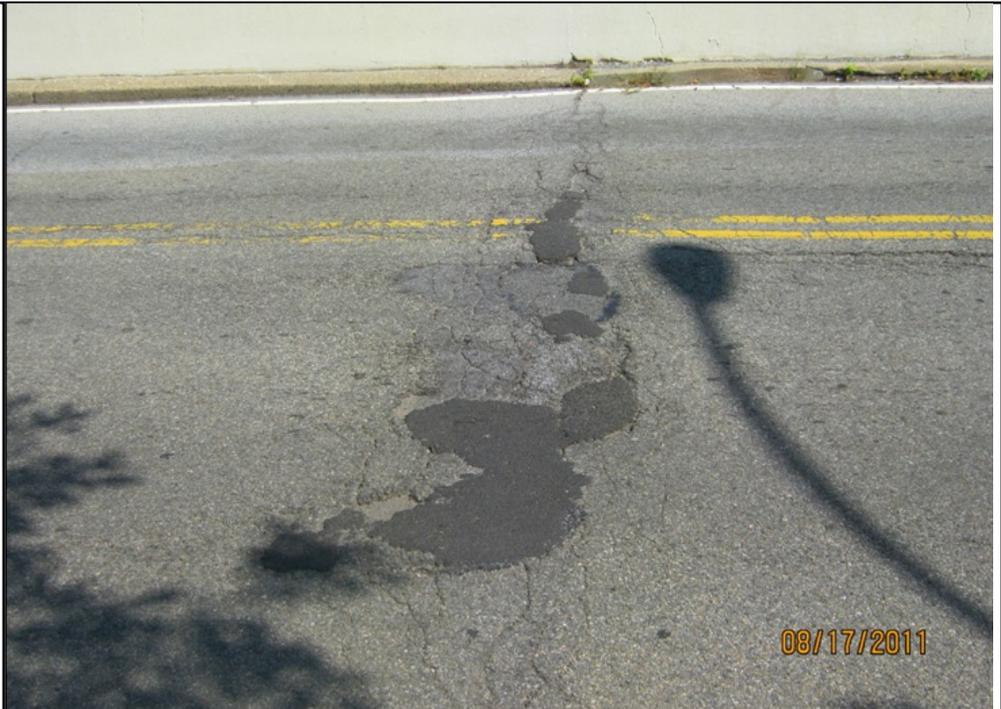
Photo Number: 3

The begin approach exhibits a large area of mapcracked asphalt pavement with uneven asphalt patches near the begin abutment line (see photo #3) and a 12" in diameter x 1 1/2" deep pothole at the utility manhole at the right side, approximately 20' from the begin abutment line (see photo #4). These conditions affect the riding quality.

Location: Begin approach pavement near begin abutment; looking left.

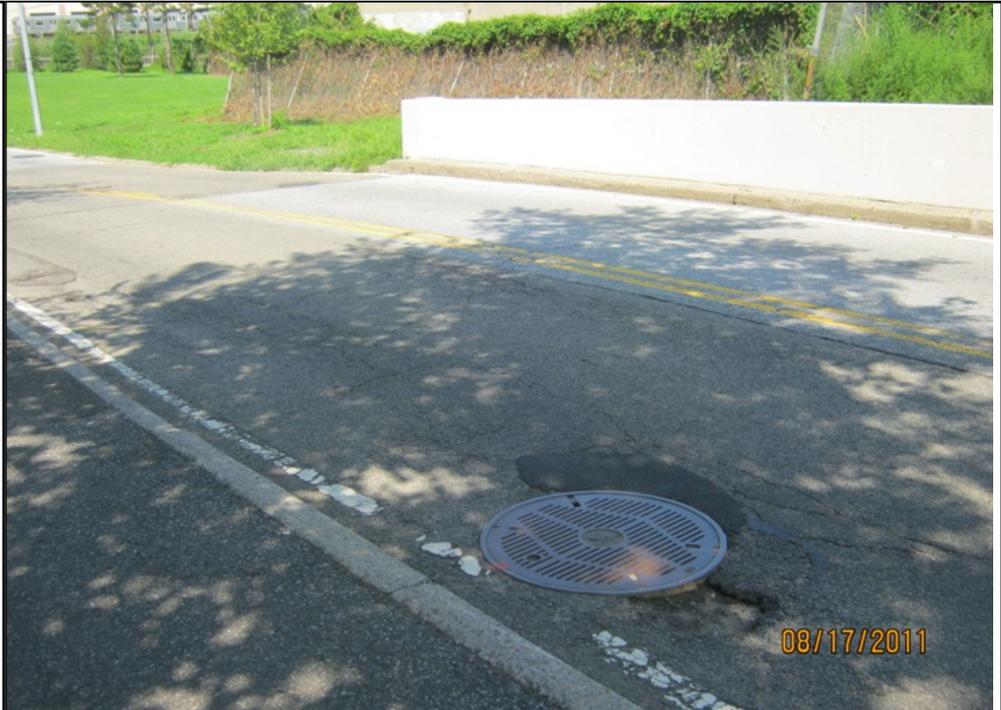
Photo Number: 4

Location: Begin approach pavement at utility manhole; looking back and left.

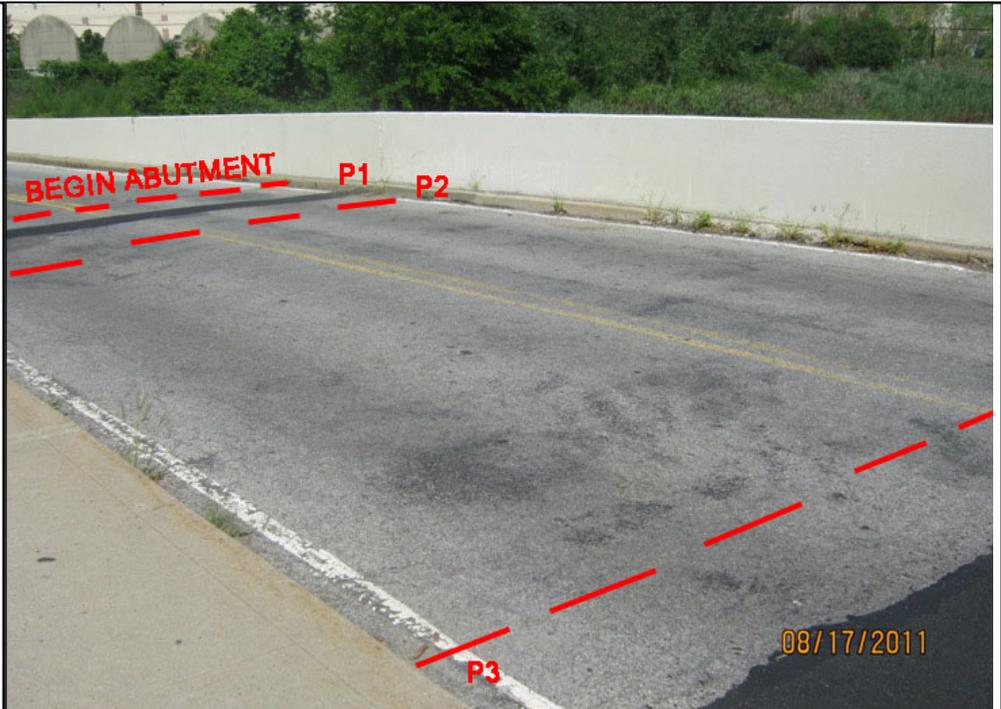
Photo Number: 7

At spans 1 to 4, the roadway exhibits moderate surface wear but it still has good riding quality. Rated '5'.

Location: Spans 1 to 4,
wearing surface; looking
back and left (Typ.).

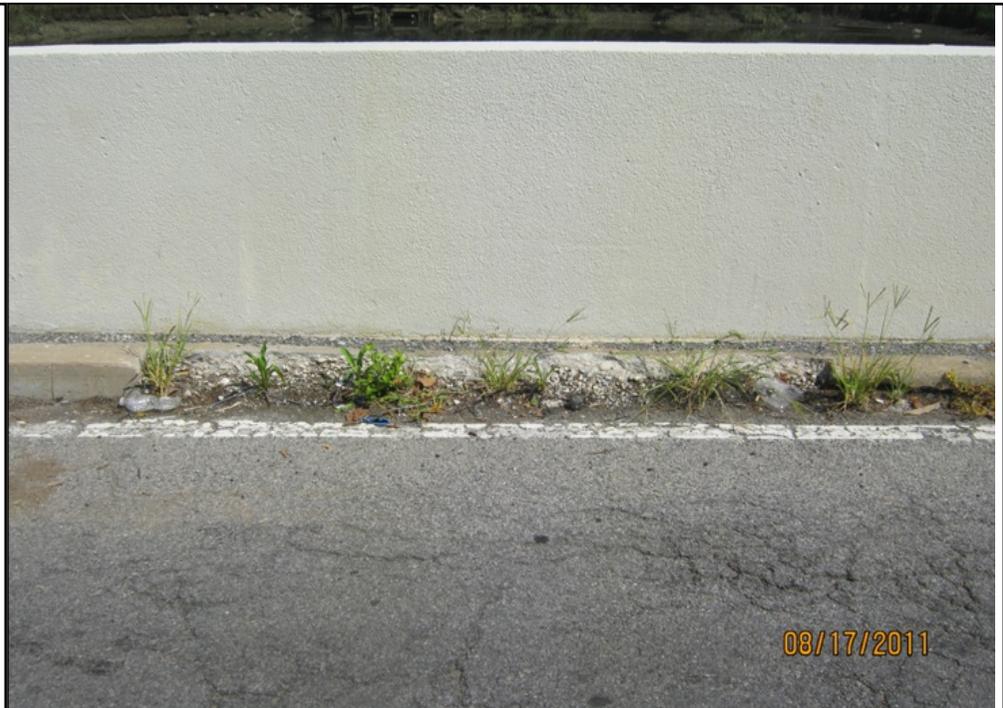
Photo Number: 10

At span 3, the left safety walk and curb exhibit a 8' long spalled area up to 2" deep with random vegetation growth.

Location: Span 3, left
safety walk at midspan;
looking left.

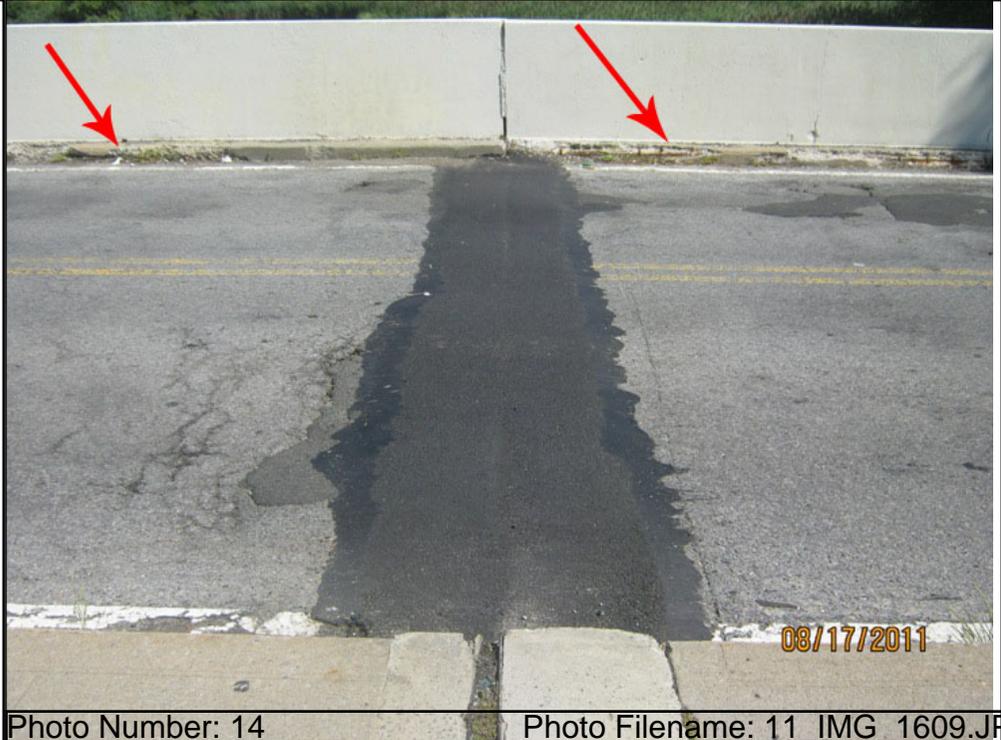
Photo Number: 14

At the top of deck, the expansion armor joint along the right sidewalk is filled with dirt between the armor plates. In addition, the end joint concrete header has cracked at the curb (see typical photo #26). The asphalt membrane over the joint in the roadway area is in good condition (see typical photo #14).

Location: Pier 13 joint, looking left (Typ.).

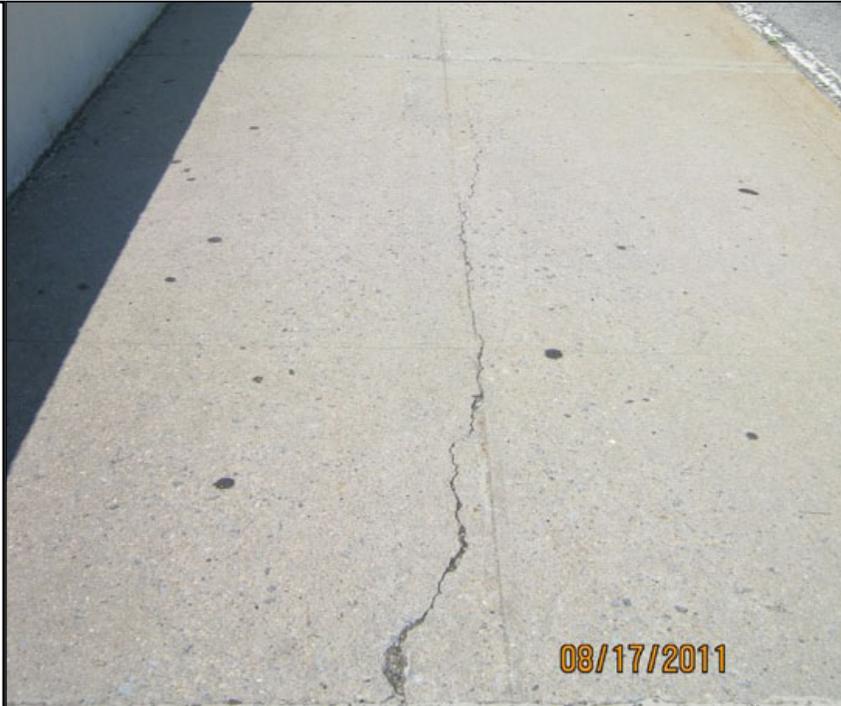
Photo Number: 16

At spans 2, 4, 8 and 10, the right sidewalk is in overall good condition with a fine longitudinal crack along the full span (see typical photo #16). The safety walk at the left side is in good condition.

Location: Span 3, right sidewalk; looking back (Typ.).

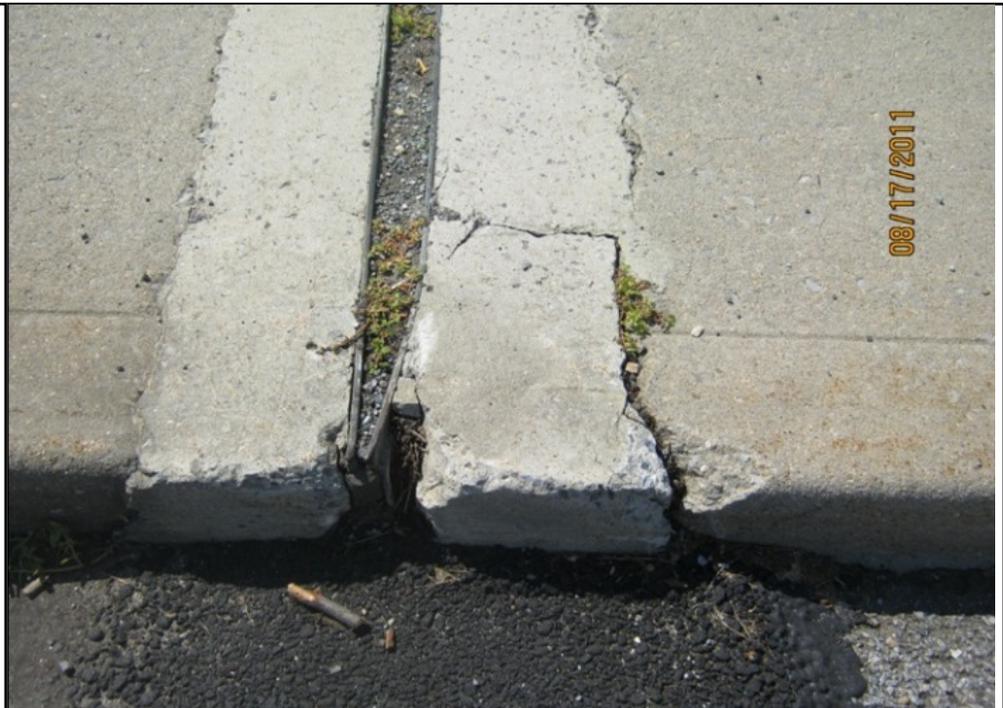
Photo Number: 26

Location: Pier 4 joint at
right sidewalk; looking
right
(Typ.).

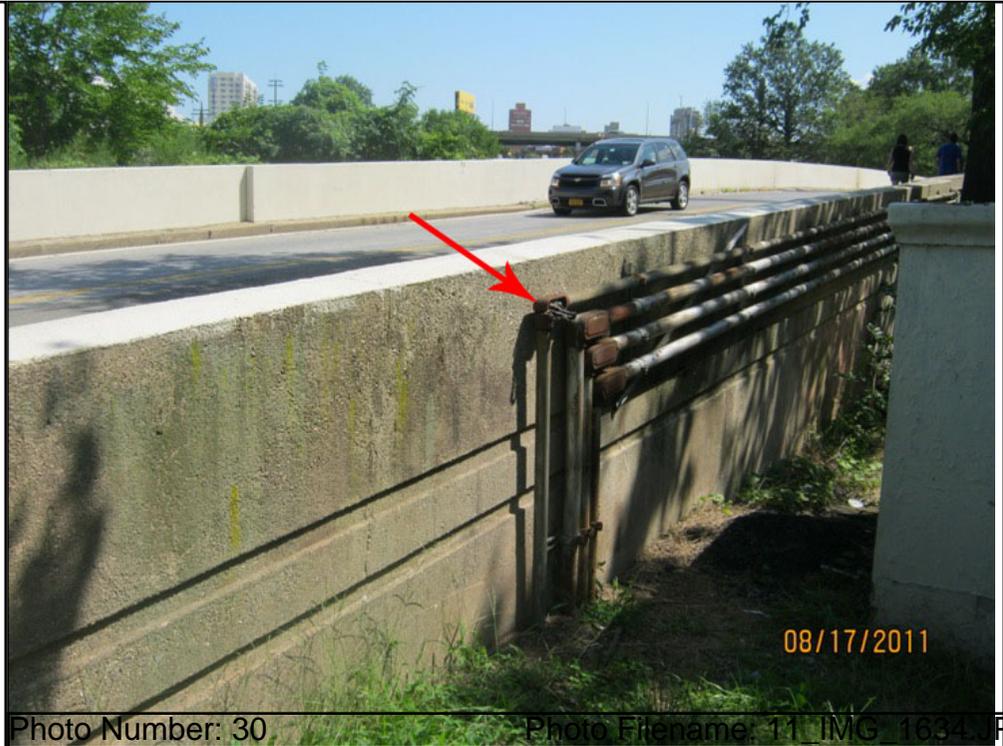
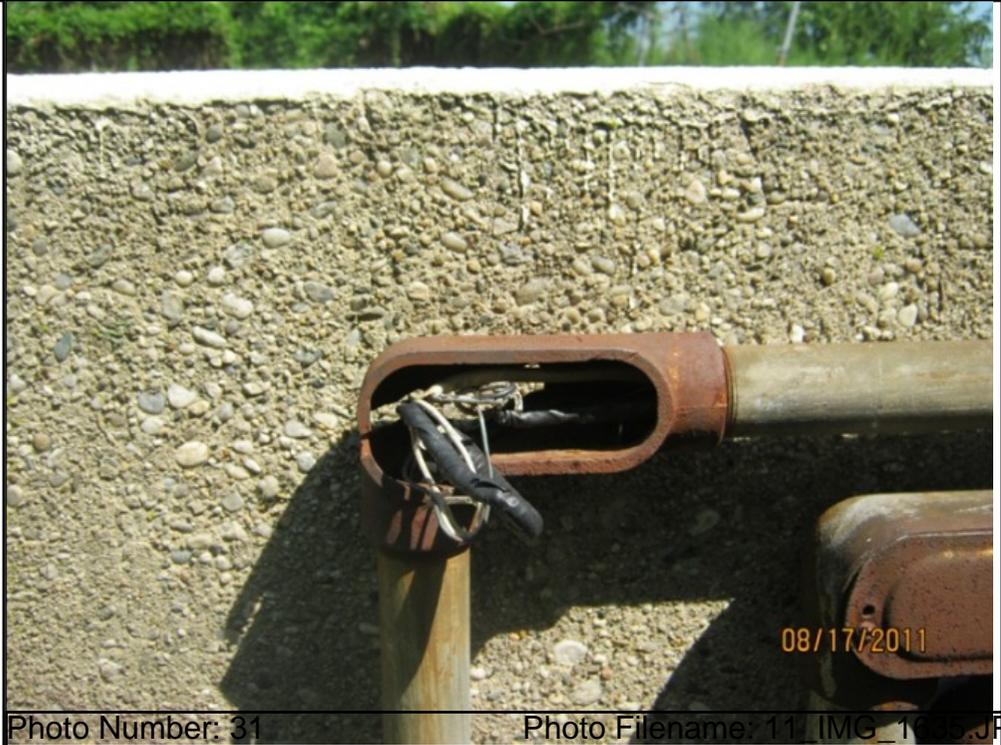
At the end of the begin approach right parapet, there is a broken conduit box with a missing cover and exposed electrical wires (see photos #30 and #31). This location is on the outside face of the parapet.

Location: Begin
approach, outside face of
right parapet; looking
ahead and left (Ref.:
CMR Report).

Location: Begin approach, outside face of right parapet; looking left (Ref.: CMR Report).

The above conditions have been reported as Corrective Maintenance Repairs (see attached CMR report).

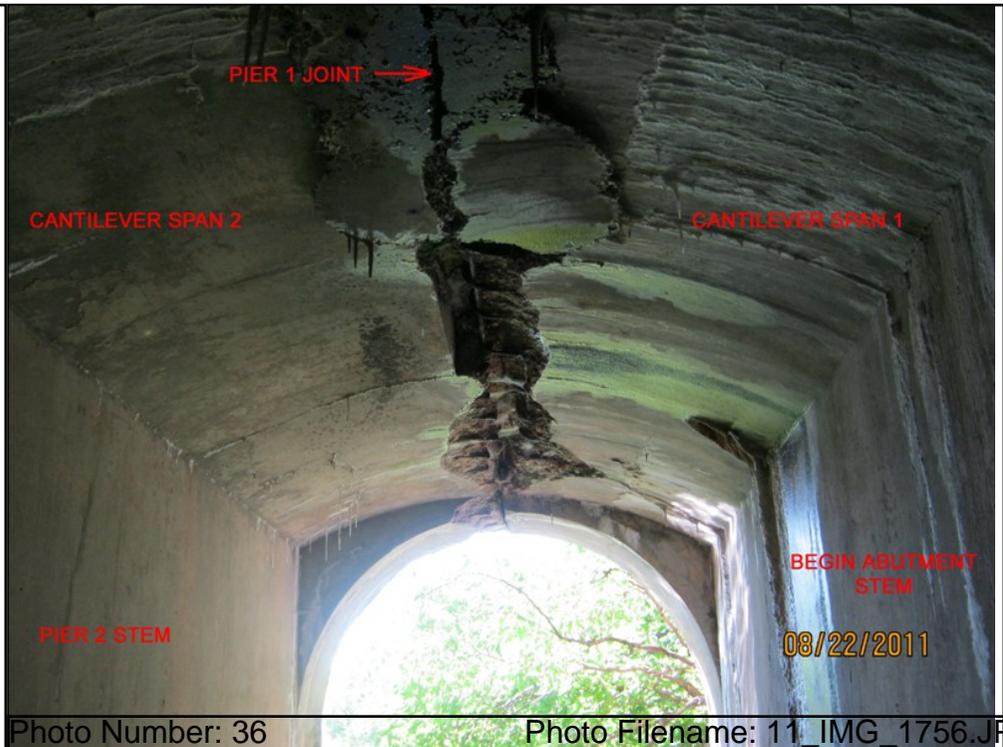
At cantilever spans 1 and 2, the frame underside exhibits a spall with exposed rusted rebar along the right side of the joint for approximately 15' long x up to 18" wide x up to 3" deep. In addition, approximately 30% of the underside surface area exhibits fine mapcracking and there are random longitudinal fine cracks with moderate to heavy efflorescence, predominantly at the left half side of the spans and wet stains due to active leakage of the right side of the joint (see attached sketch for details). The concrete patch under the left side of the joint is in good condition with no hollow sounding areas.

Location: Spans 1 and 2, frame underside; looking up and right.
