Fresh Kills Park

Phase 3A
Task 8.4.3
**Bridge Inspection
Report**

Final Report

August 2008

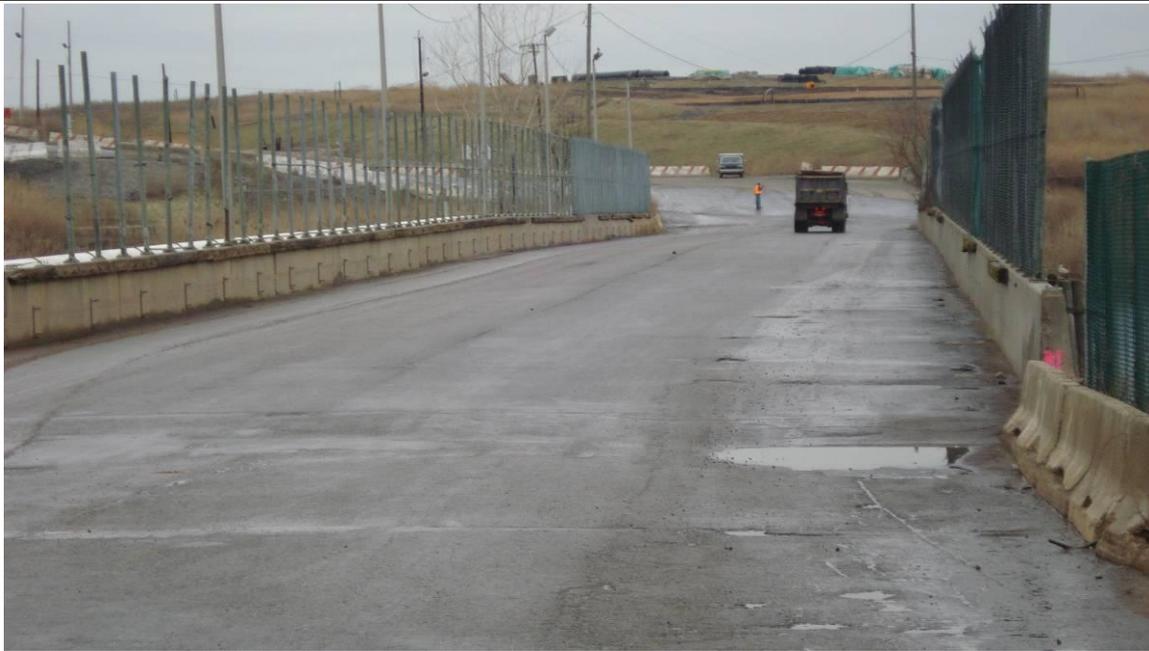
Photo No.: MC01

Location: Bridge roadway, looking east from the West Approach.

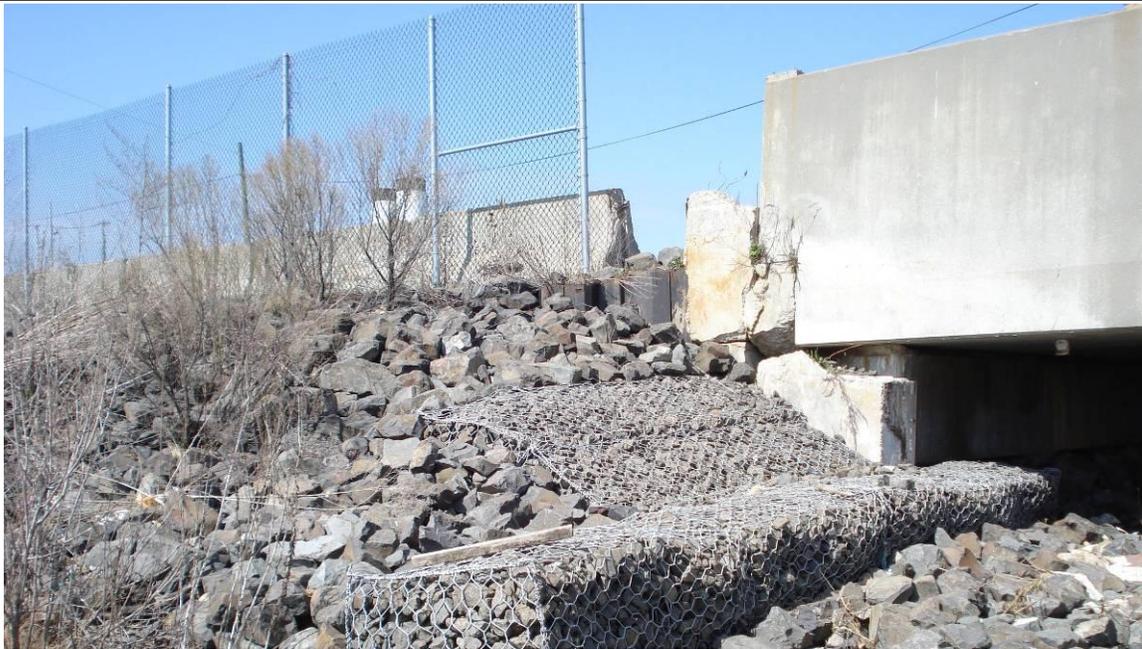
Photo No.: MC13

The small concrete wingwalls at the southwest and southeast corners of the bridge are in poor condition, with extensive breakup. The concrete wingwalls at the northwest and northeast corners of the bridge are in good condition with only normal minor cracking noted. Photos MC13 through MC15 illustrate these conditions.

Location: Southwest wingwall elevation, looking north.

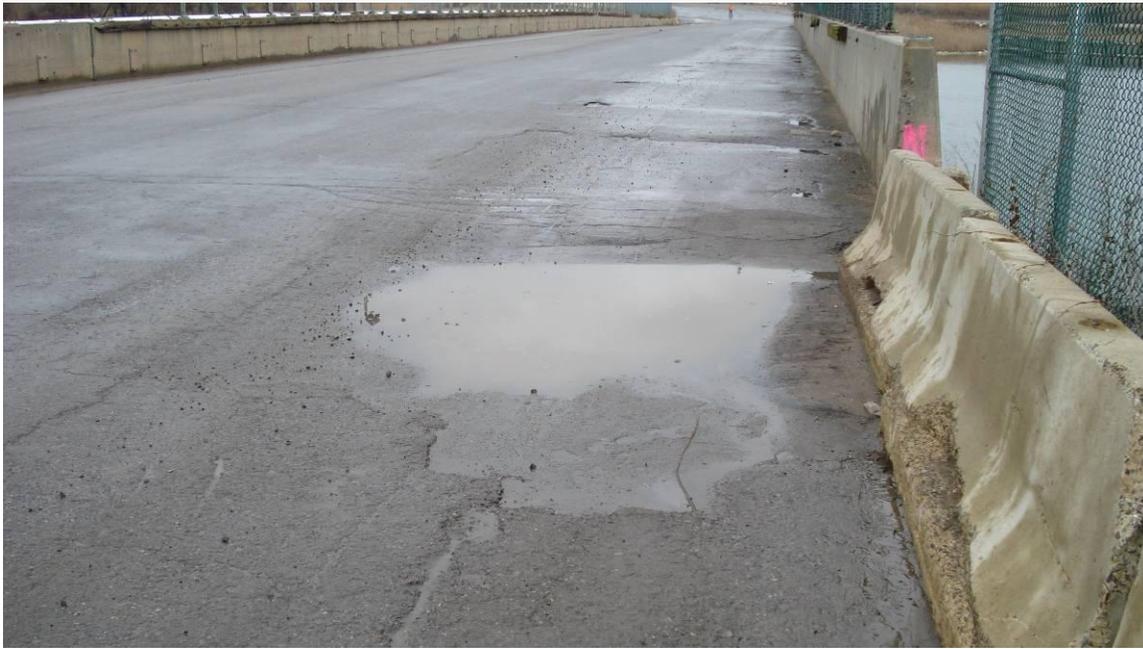
Photo No.: MC26

Location: West approach, south side, just behind west abutment, looking east.

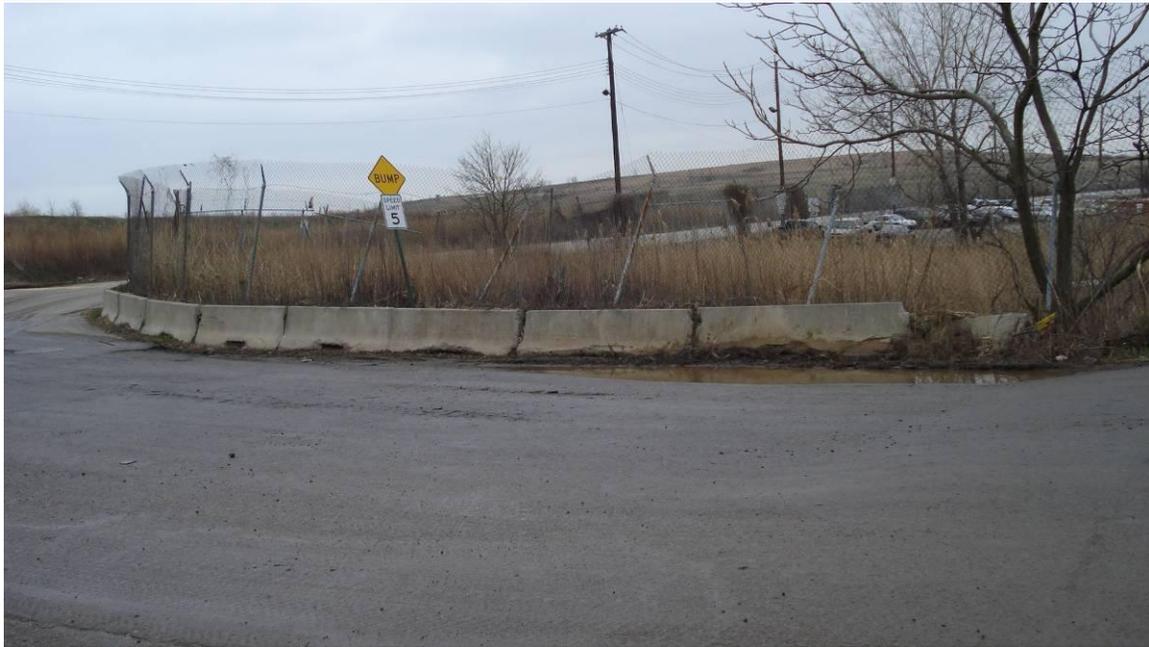
Photo No.: MC28

Description: Settlement of roadway behind east abutment causing ponding. Barrier just behind abutment damaged. Fence in poor condition.

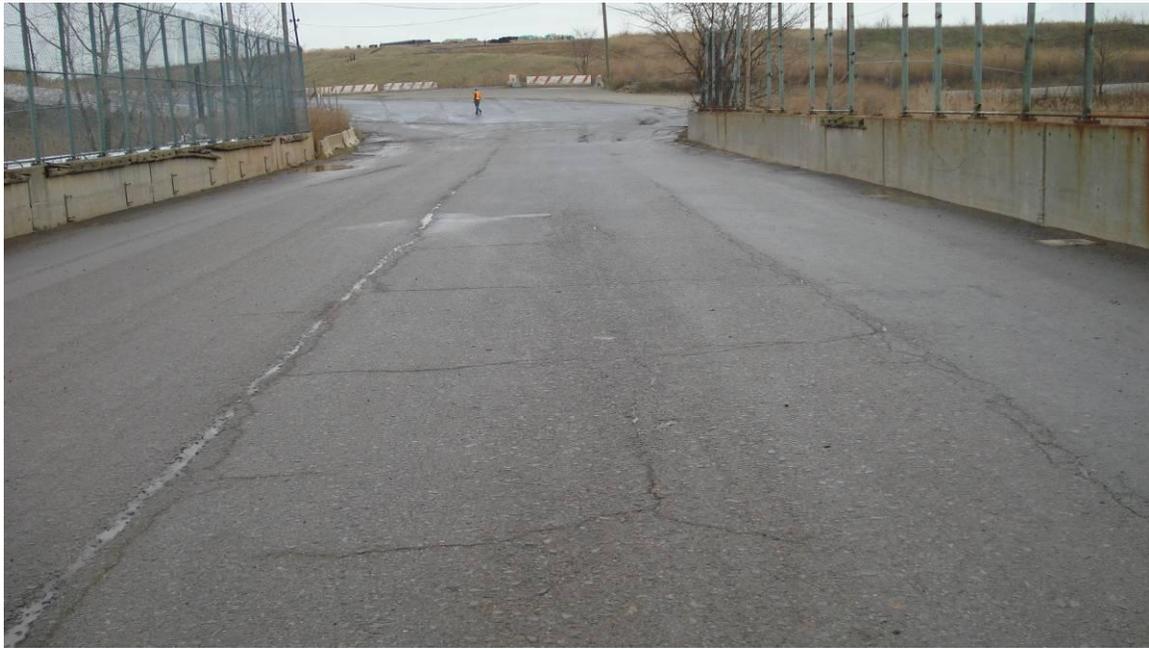
Photo No.: MC36

Location: Bridge deck looking east.

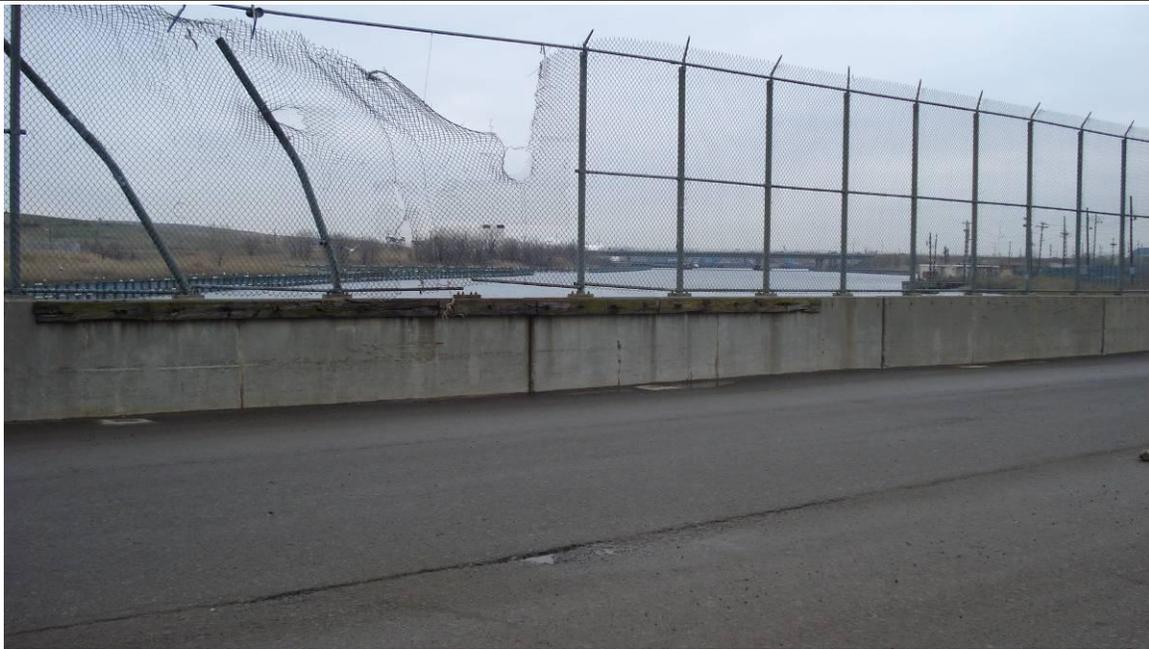
Photo No.: MC47

Description: Concrete is sound. Timber rub rail is missing in Span 7 and badly deteriorated in Spans 8 and 9. Fence badly damaged in Span 9.

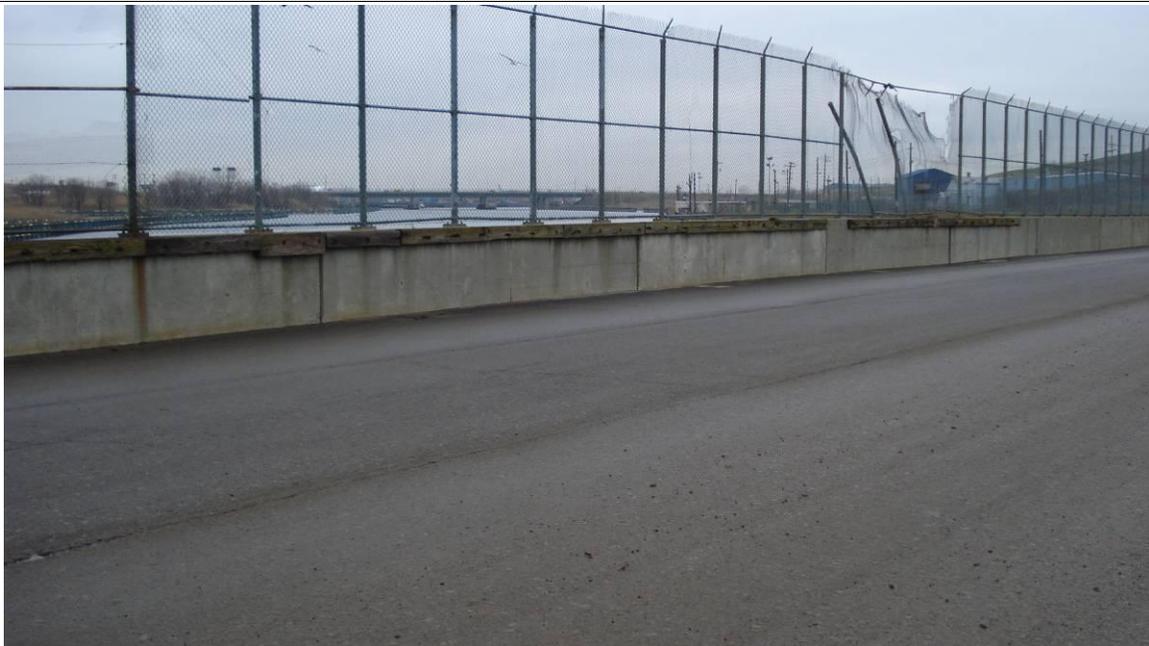
Photo No.: MC48

Description: Concrete is sound. Timber rub rail is intact but deteriorated. Fence in fair condition in Spans 10 and 11. Note that chain link mesh has been replaced with a light wire mesh in Span 12.

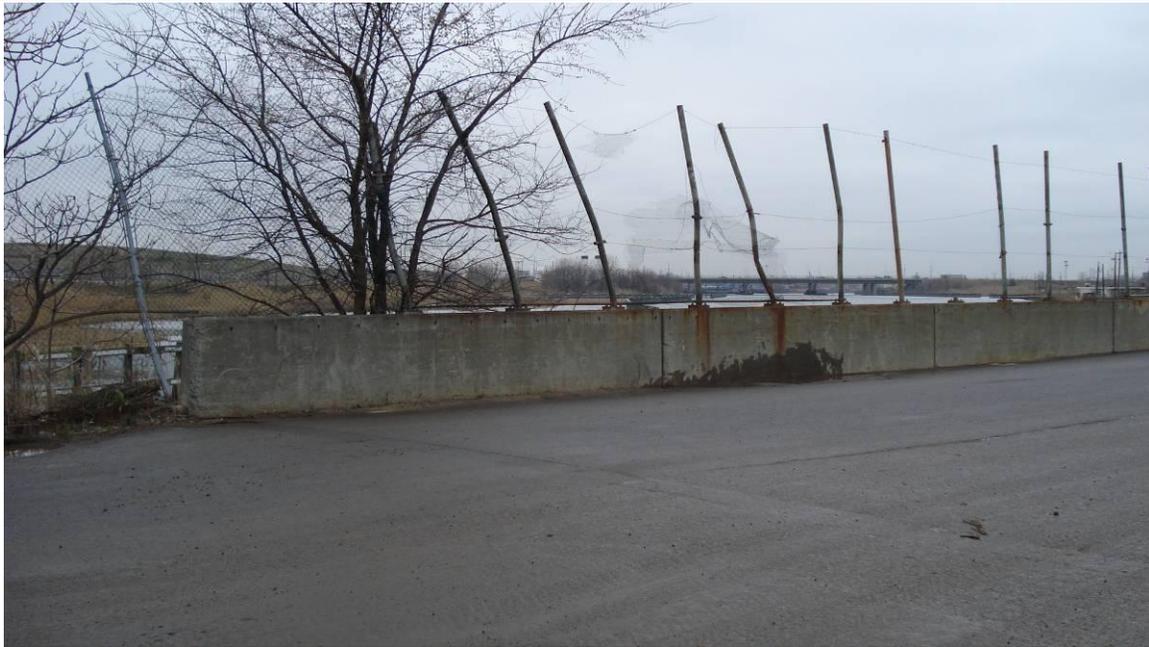
Photo No.: MC51

Description: Concrete is sound. Timber rub rail is missing. Fence in poor condition with bent and missing posts and missing horizontal rails.

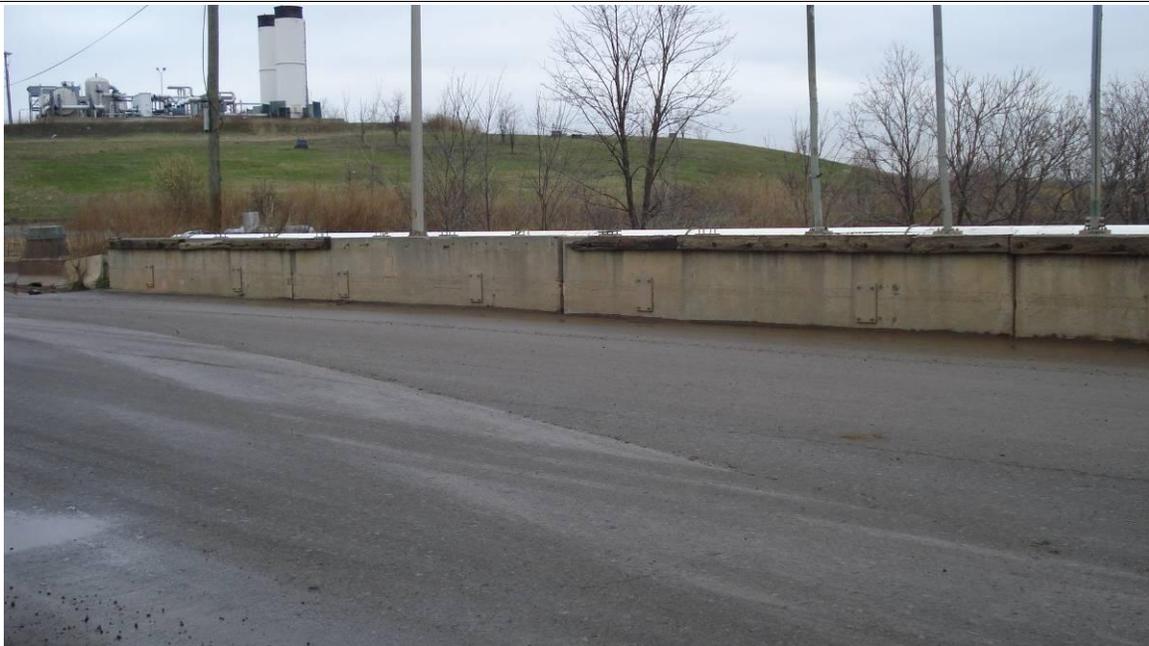
Photo No.: MC52

Description: Concrete is sound. Timber rub rail is missing in Span 2 and badly deteriorated in Spans 1 and 3. Fence is missing, with some posts still remaining.

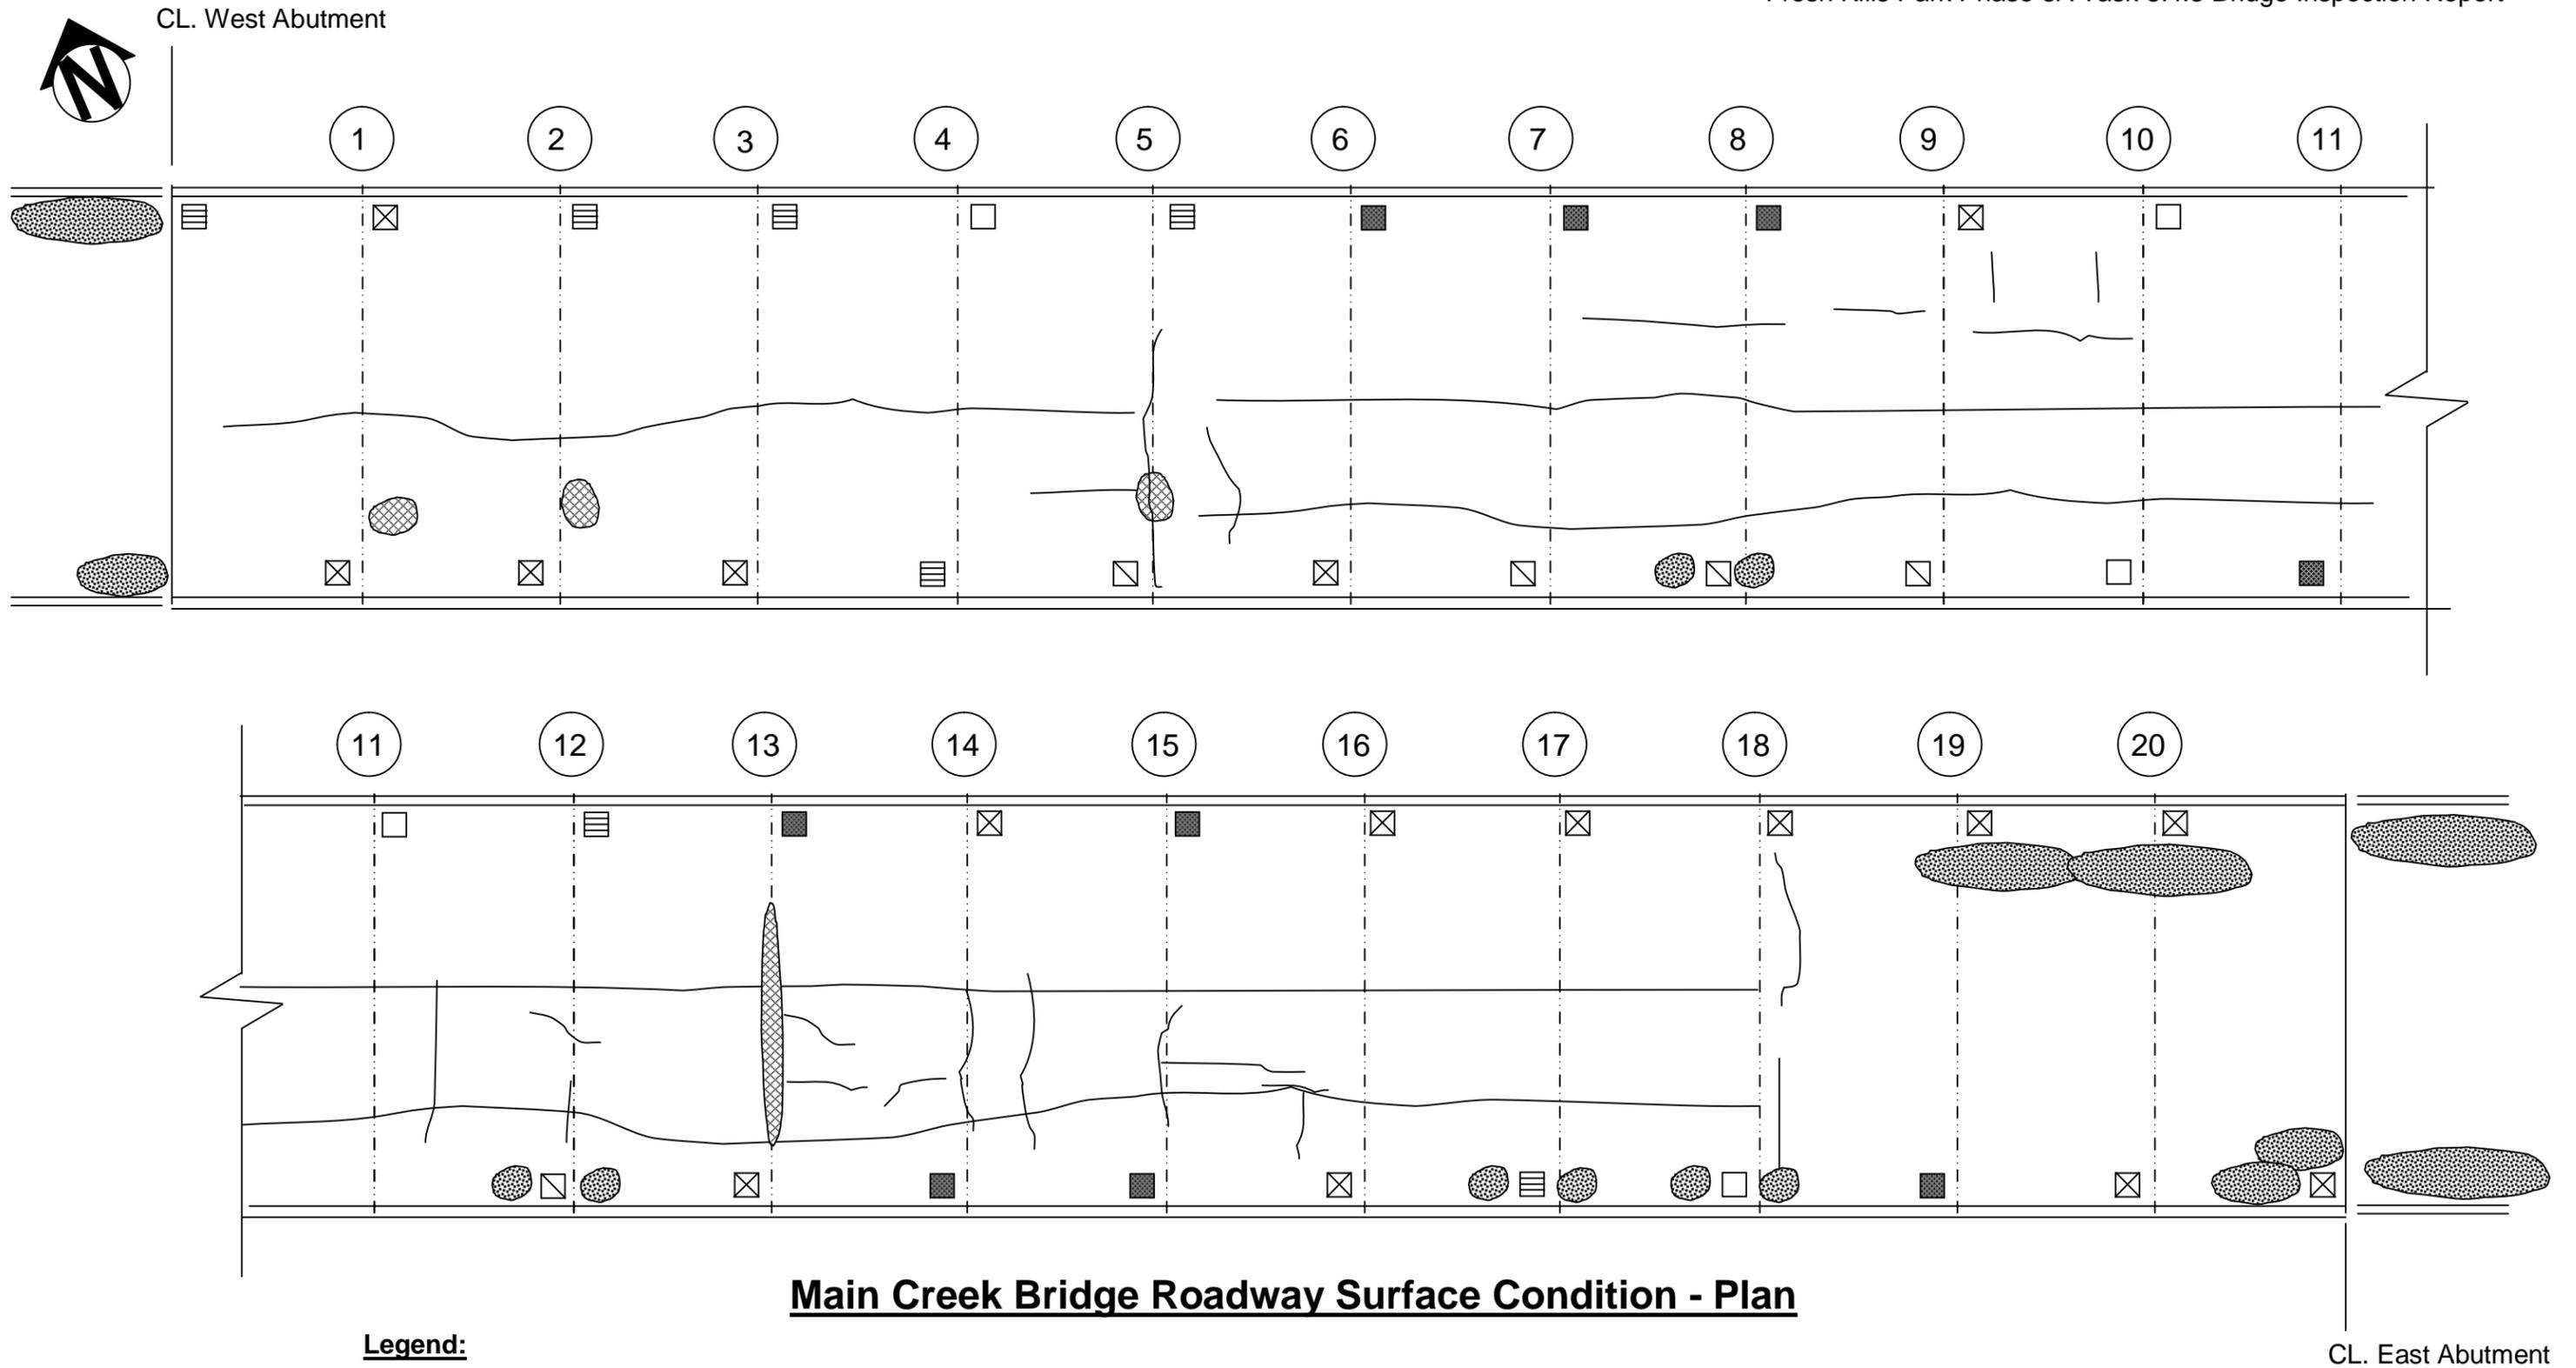
Main Creek Bridge Roadway Surface Condition - Plan

The 6 in. thick riding surface is in fair to poor condition, providing an uneven ride quality. Figure 7 in Appendix D presents the condition of the bridge pavement.

There are numerous longitudinal and transverse cracks, and some potholes. The pavement surface undulates, with many depressions where water ponds. It appears that the granular earth fill is slowly washing out through the underdrain system and between the adjacent parapet panels at the piers. See also Sections 2.7.3 and 2.7.4 below. Photos MC32 thru MC40 illustrate typical conditions.

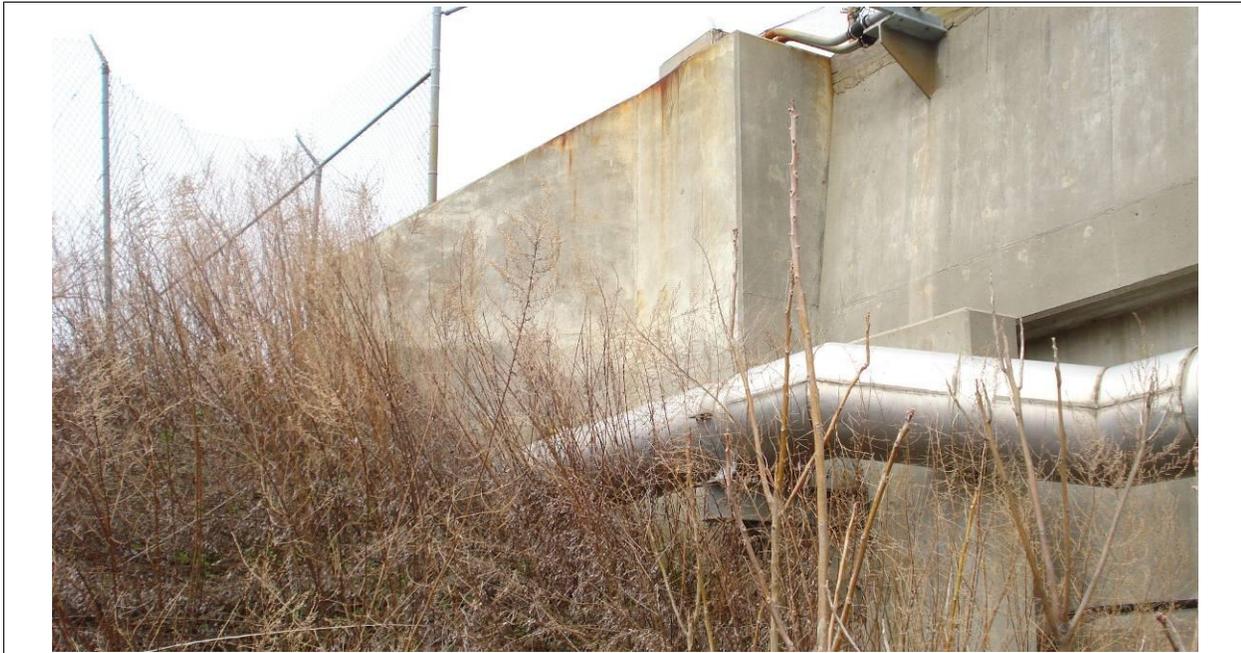
Photo No.: RC15
Location: West Abutment, south wingwall.
Description: Wingwall in good condition.

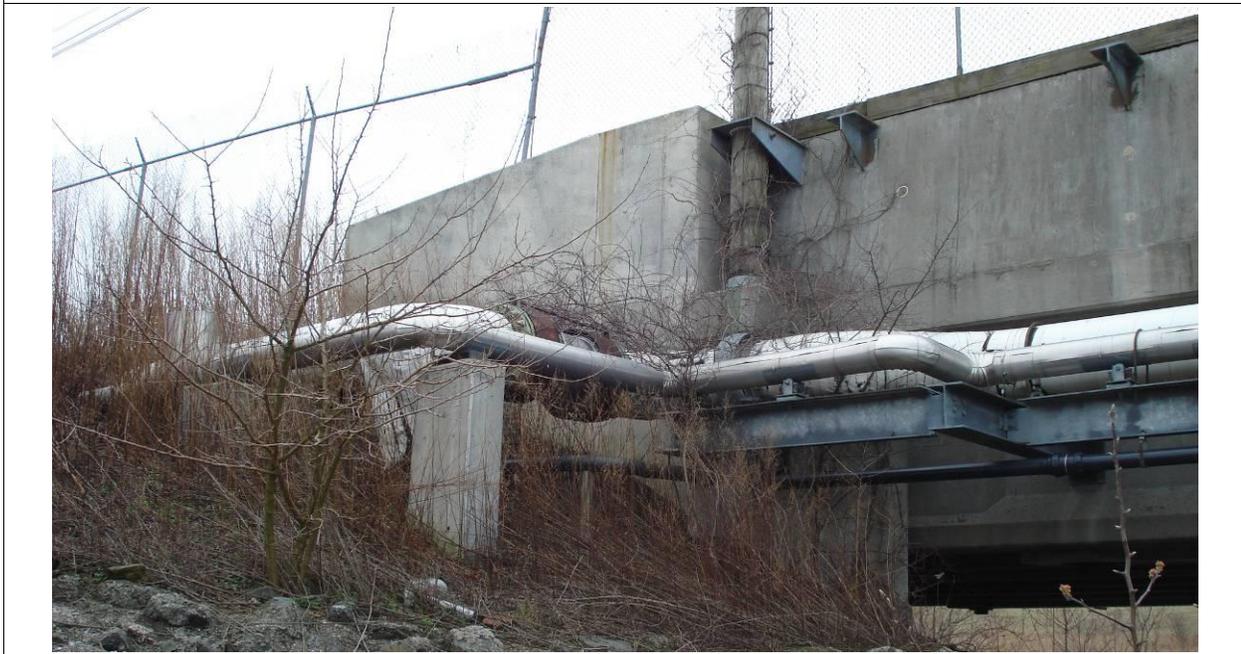
Photo No.: RC16
Location: East Abutment, north wingwall.
Description: Wingwall in good condition.
