ADDENDUM NO. 1

PROJECT: HBPED800Q, Pre-Scoping Services for the Porpoise Bridge in Flushing Meadows-Corona Park, Borough of Queens
PIN: 8502013HW0058P

Inspection Agency: 13 - Consultant Type of Inspection: 1 - BIENNIAL
 GTMS: --- -- Unknown - Unknown
 POSTINGS: See Gen Rec Page 1 for Postings at time of inspection.
 Further Investigation Needed: No
 State Highway Number: ----- Milepoint: ----- AADT/Yr: ----- / --
 Orientation: Political Unit: Year Built: ----
 Total Spans: 14 Ramp Bridge Attached To Span: --- BIN: -----
 General Recommendation: 4 Computed Condition Rating: 4.071

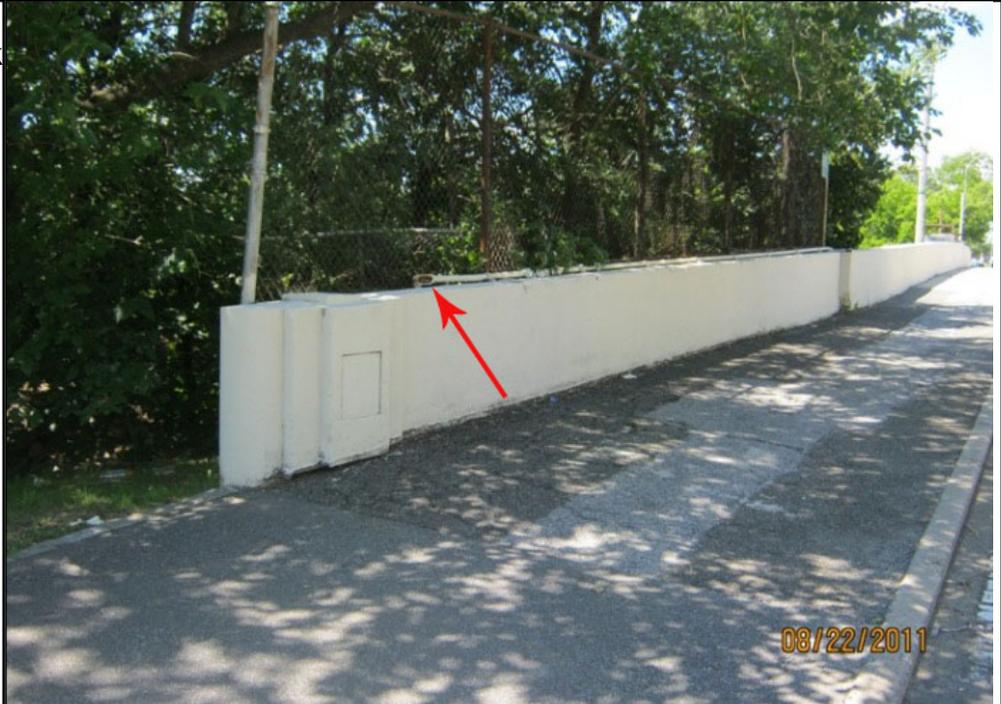
Photo Number: 5

At span 14, near the end of the right parapet at the end approach, the metal conduit atop has a missing 4" x 3" oval condulet cover exposing the insulated electrical wire inside (see photo #33). This condition poses a safety hazard to pedestrians using the adjacent sidewalk (see photo #5).

Location: End approach,
right parapet; looking back
and right (Ref.: Safety
Flag NB1100031).

The above conditions have been flagged under Safety Flag NB1100031 (see attached flag report).

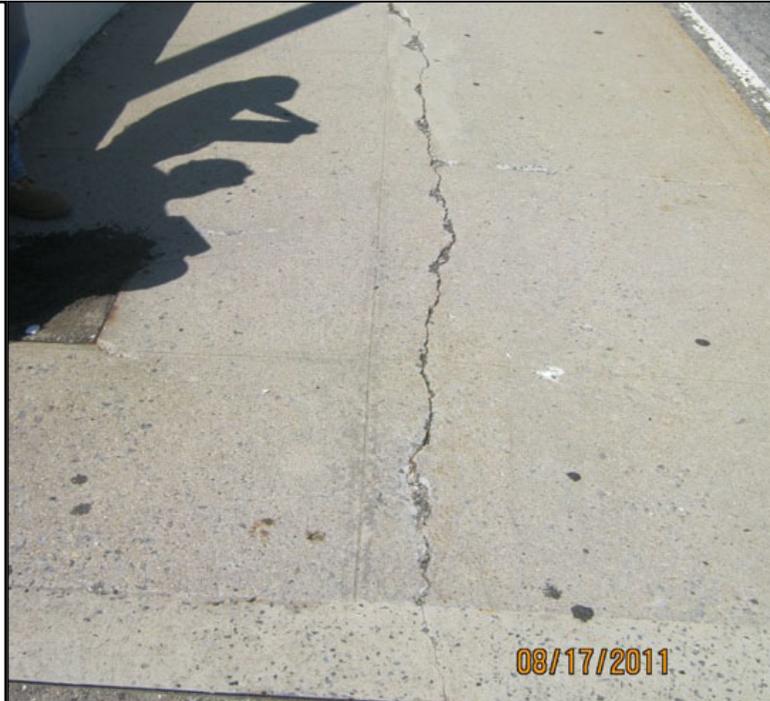
Photo Number: 18

The right sidewalk exhibits a wide longitudinal crack along the full span (see photo #18). At the left side, the safety walk is in good condition.

At span 13, the right sidewalk exhibits a wide longitudinal crack along the full span (see typical photo #18). The left safety walk and curb exhibit spall areas with exposed rebars up to 2" deep (see photo #14).

Location: Spans 12 to 13, right sidewalk; looking back (Typ.).

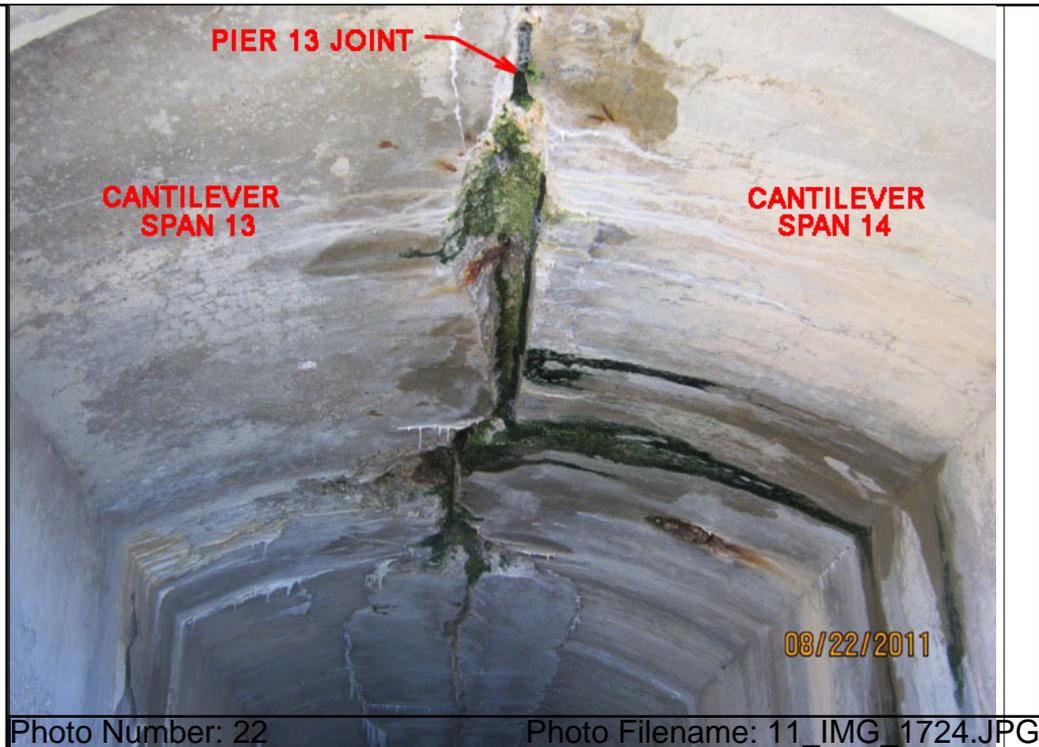
At cantilever span 13, the concrete frame underside along the right side of the joint is spalled with no exposed rebars for 12' long x up to 6" wide x up to 3" deep. In addition, approximately 30% of the surface area exhibits fine mapcracking and there are random longitudinal fine cracks with efflorescence. Also, there are wet stains due to leakage of the right side of the joint. The concrete patch under the left side of the joint exhibits several fine cracks with efflorescence but no hollow sounding areas (see attached sketch for details).

At pier 13, the concrete frame underside at span 13 along the right side of the joint is spalled with no exposed rebars for 12' long x up to 6" wide x up to 3" deep. This condition is due to active joint leakage as further evidenced by wet stains emanating from the right side of the joint (see photo #22). The concrete patch under the left side of the joint exhibits several fine cracks with efflorescence but no hollow sounding areas.

At cantilever span 14, approximately 30% of the surface area of the concrete frame underside exhibits fine mapcracking and there are several longitudinal fine cracks with/without efflorescence. Also, there are wet stains due to leakage of the right side of the joint. The concrete patch under the left side of the joint exhibits several fine cracks with efflorescence but no hollow sounding areas (see attached sketch for details).

Location: Spans 13 and 14, frame underside; looking up and left.

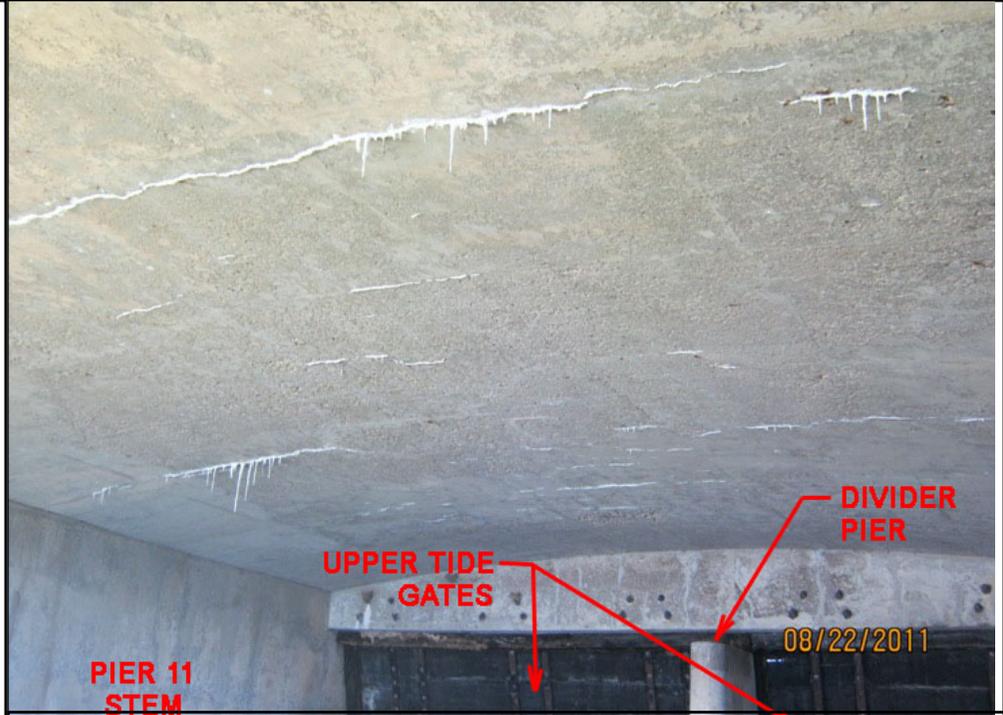
Photo Number: 25

In addition, approximately 40% of the surface area exhibits fine mapcracking and light scaling. There are also random longitudinal fine cracks with efflorescence (see attached sketch for details and photo #25).

Location: Span 12,
frame underside; looking
up, back and left
(Typ.).

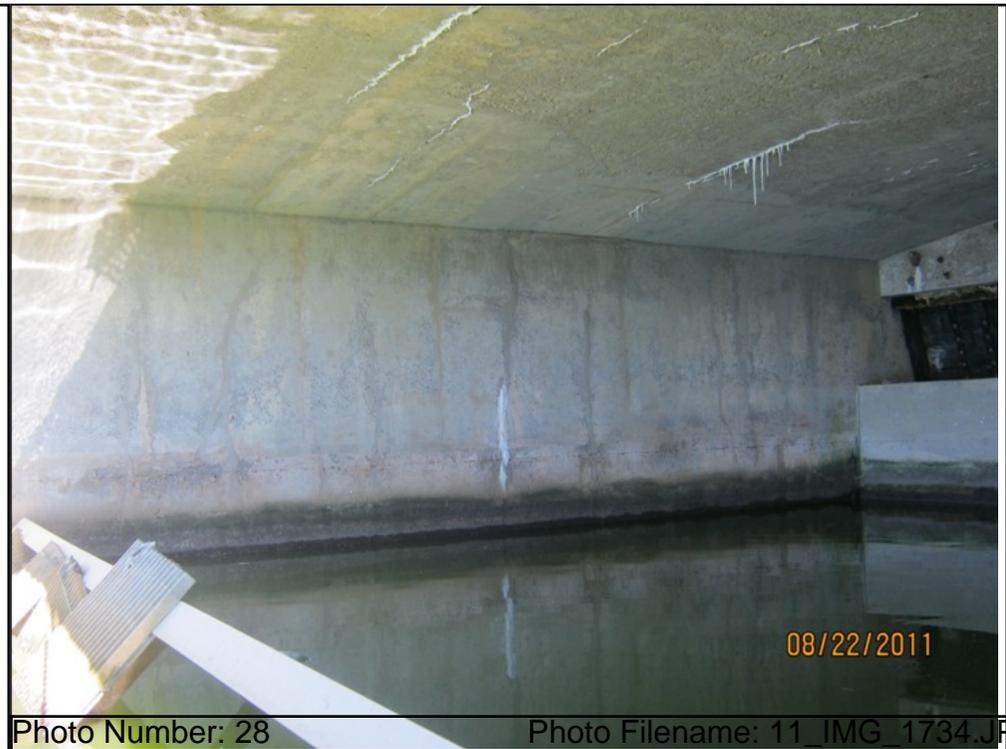
At pier 12, the solid stem is in overall good condition with scattered fine vertical cracks for full height with less than 20% of the surface area of both begin and end faces exhibiting light concrete scaling. No hollow areas were found (see photo #28).

Location: Pier 12, end
face of solid stem; looking
back and left (Typ.).

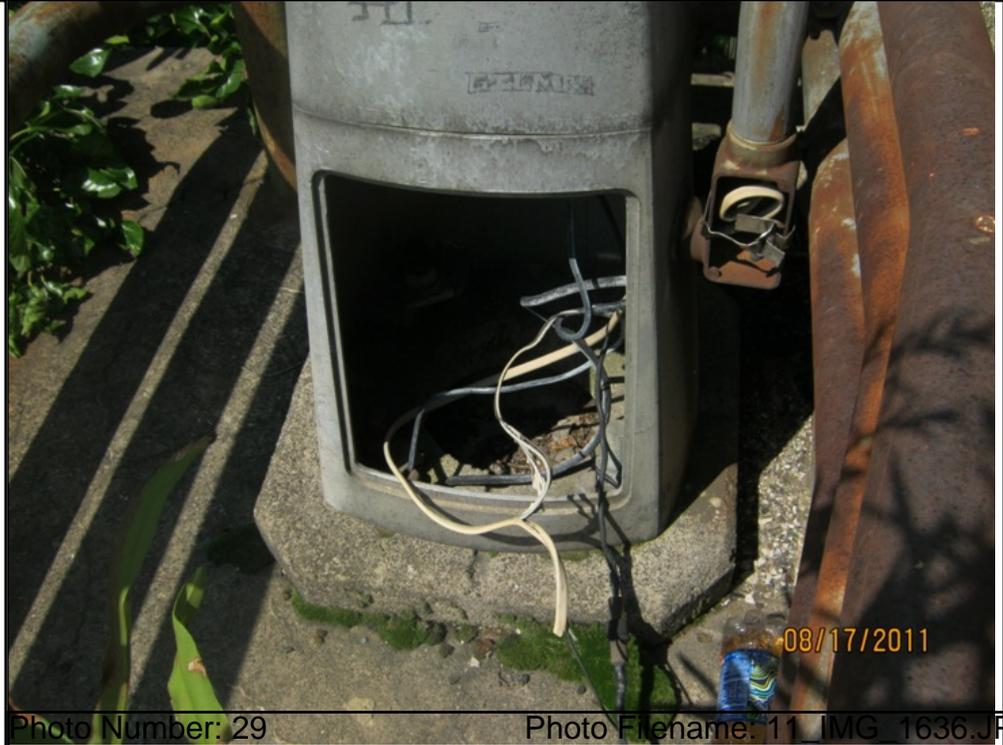
Location: Span 1,
outside face of right
parapet; looking
ahead (Ref.: CMR
Report).

At span 1, at the right parapet near pier 1 joint, the lighting standard has a missing 12" H x 10" W cover plate at the base with exposed wires. The adjacent metal conduit has a broken conduit box with a missing cover and exposed electrical wires. This location is at the outside face of the parapet on the maintenance platform.

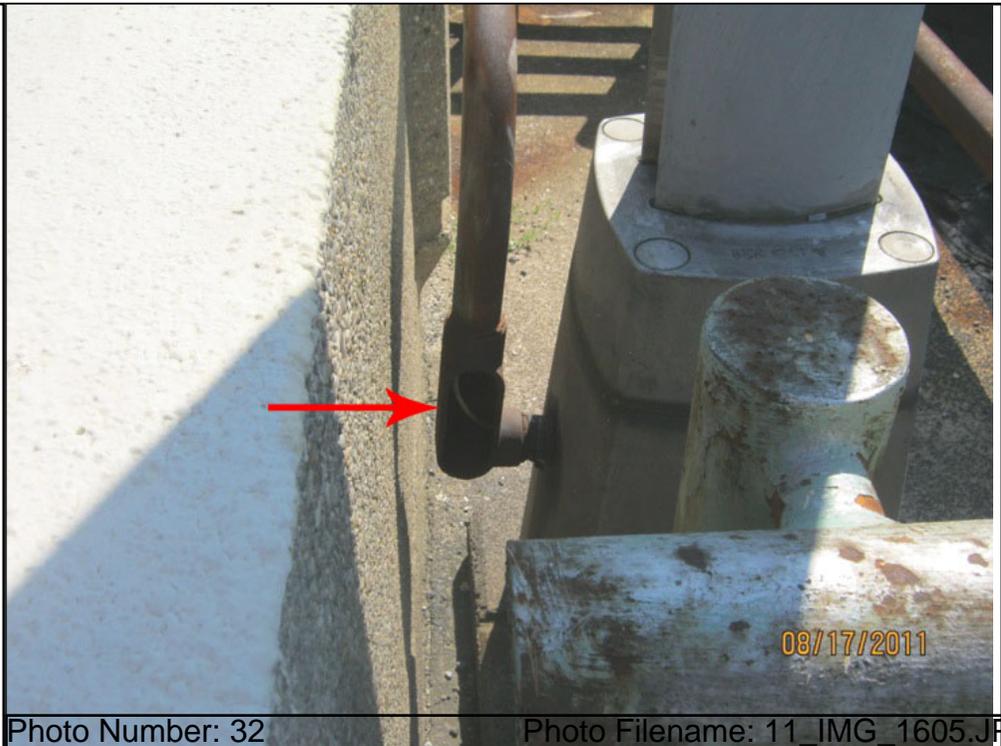
At span 13, at the right parapet, adjacent to the light standard there is a broken conduit box with a missing cover and exposed electrical wires. This location is at the outside face of the parapet on the maintenance platform and has been reported as Corrective Maintenance Repairs (see attached CMR report).

Location: Span 13, outside face of right parapet; looking ahead (Ref.: CMR Report).

At span 13, at the right parapet, adjacent to the light standard there is a broken conduit box with a missing cover and exposed electrical wires. This location is at the outside face of the parapet on the maintenance platform.

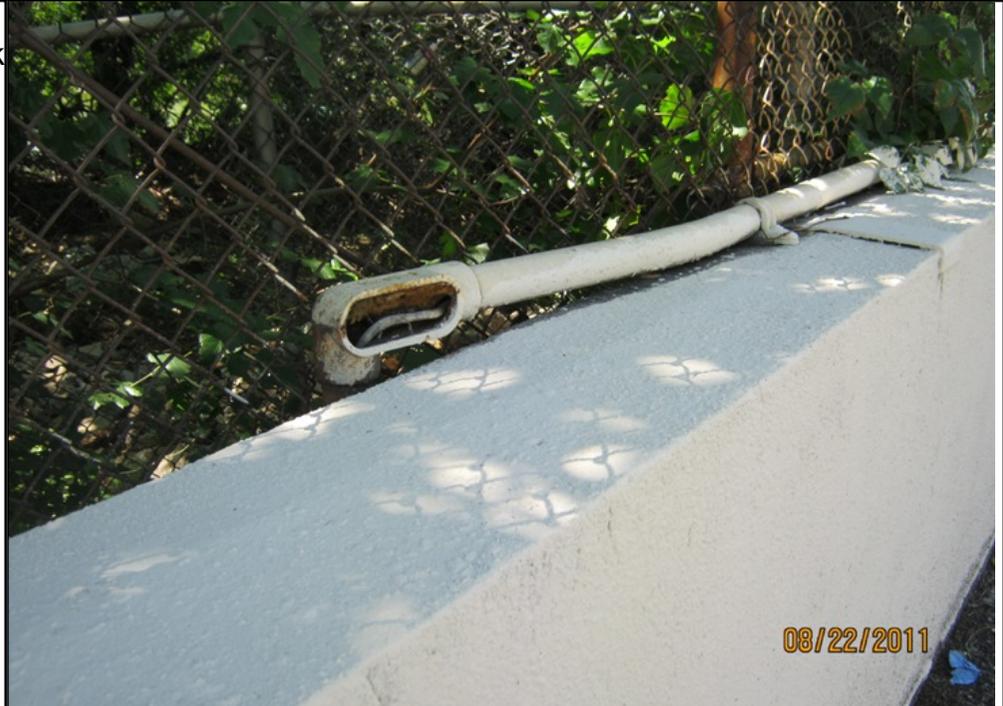
Photo Number: 33

Location: End approach,
right parapet; looking back
and right (Ref.: Safety
Flag NB1100031).

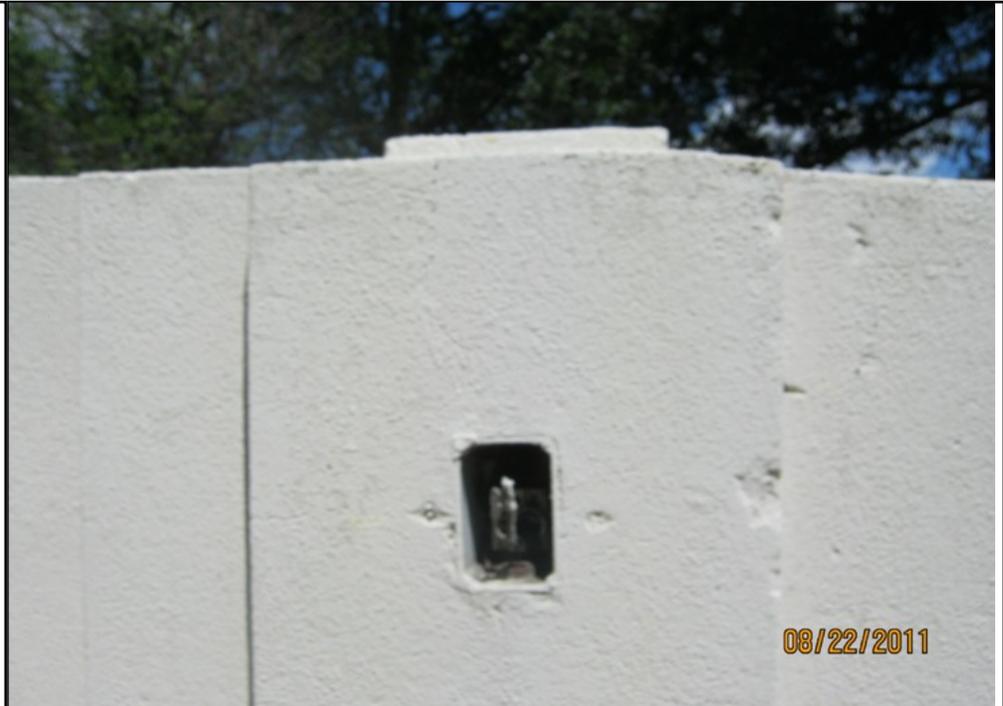
Photo Number: 34

In addition, at the left parapet, the embedded junction box near the end of the parapet has a missing 5" x 2.5" cover exposing the electrical wires inside (see photo #34). Even though this area is not adjacent to a sidewalk, pedestrian traffic has been noted along the parapet due to light vehicular traffic on the bridge (see photo #6). Therefore, this condition poses a safety hazard to pedestrians walking along this area.

Location: End approach,
left parapet; looking left
(Ref.: Safety Flag
NB1100031).

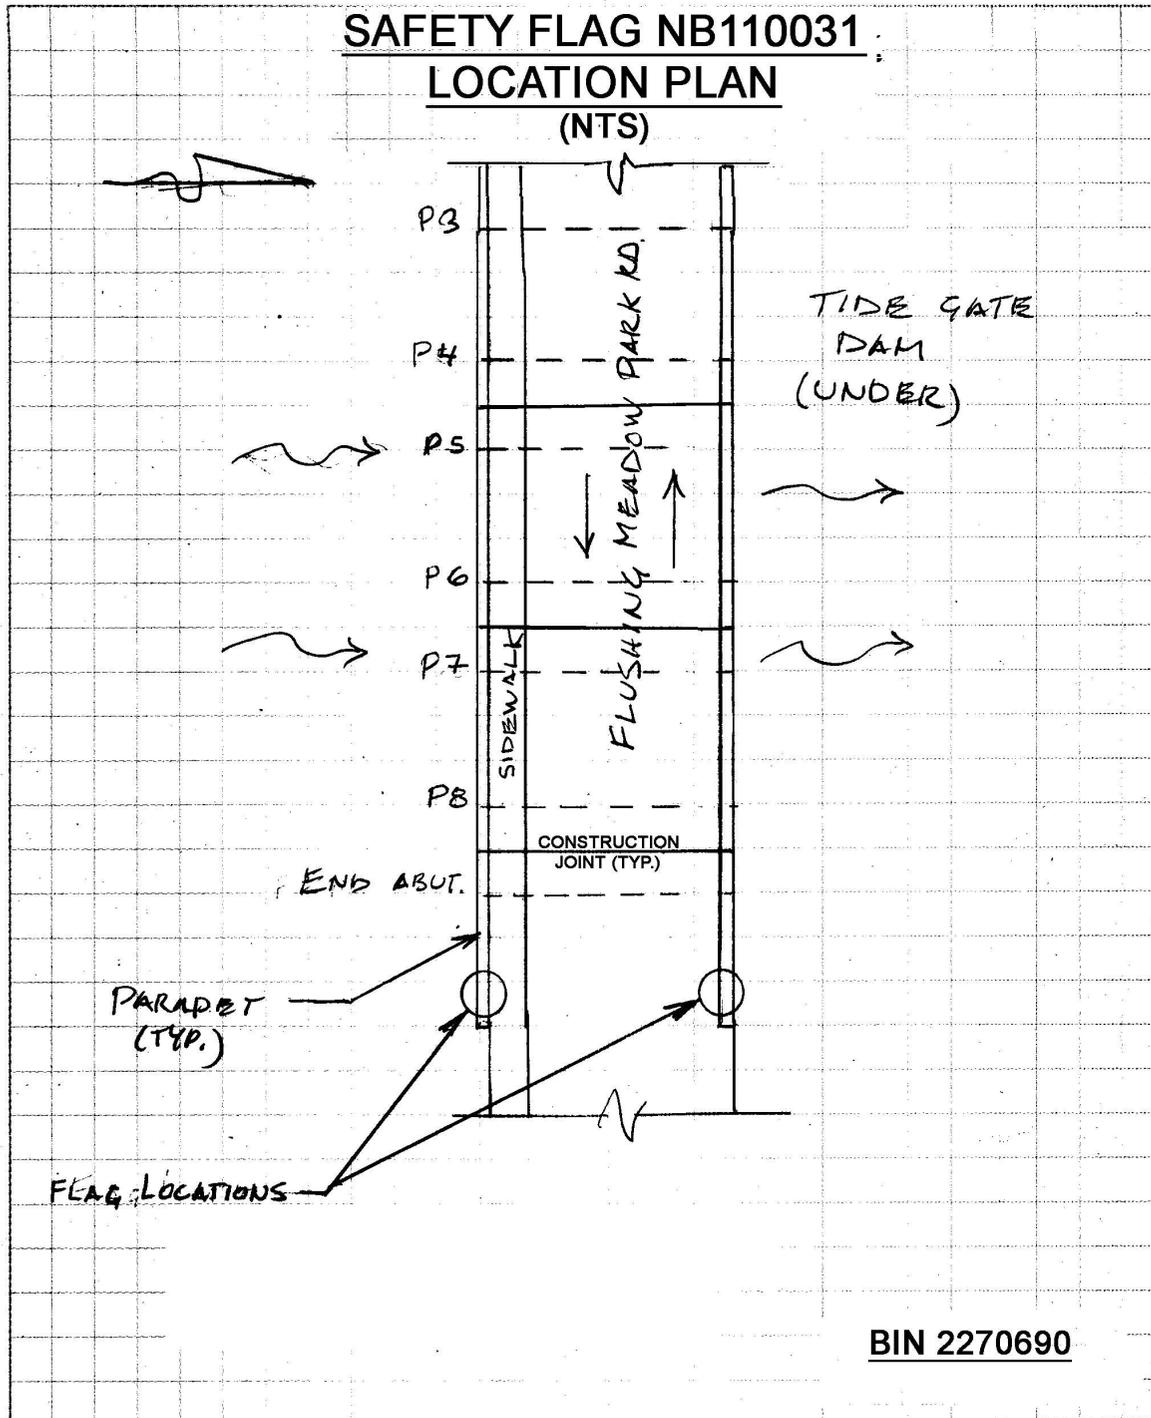
11_01NB110031Sketch.tif - Attached to Safety Flag NB110031

Near the end of the right parapet, the metal conduit atop has a missing 4" x 3" oval conduit cover exposing the insulated electrical wire inside (see photo 2). This condition poses a safety hazard to pedestrians using the adjacent sidewalk (see photo 1).

In addition, at the left parapet, the embedded junction box near the end of the parapet has a missing 5" x 2.5" cover exposing the electrical wires inside (see photo 4). Even though this area is not adjacent to a sidewalk, pedestrian traffic has been noted along the parapet due to light vehicular traffic on the bridge (see photo 3). Therefore, this condition poses a safety hazard to pedestrians walking along this area.

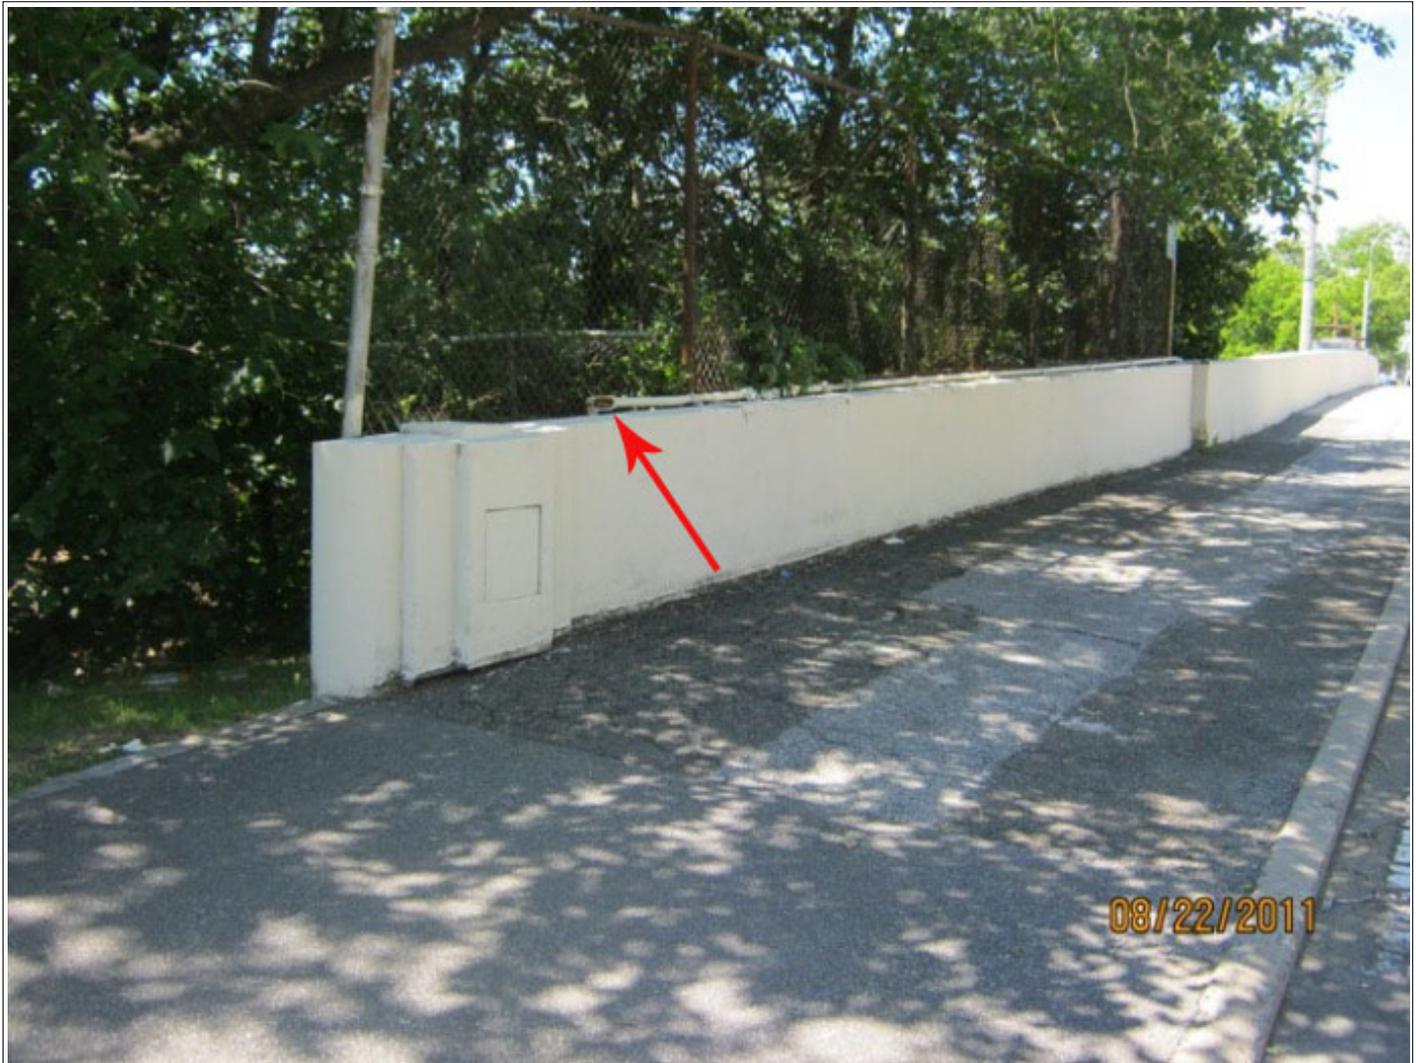
11_02IMG_1757.JPG - Attached to Safety Flag NB110031

Photo 1 - Location: End approach, right parapet; looking back and right (General Photo).

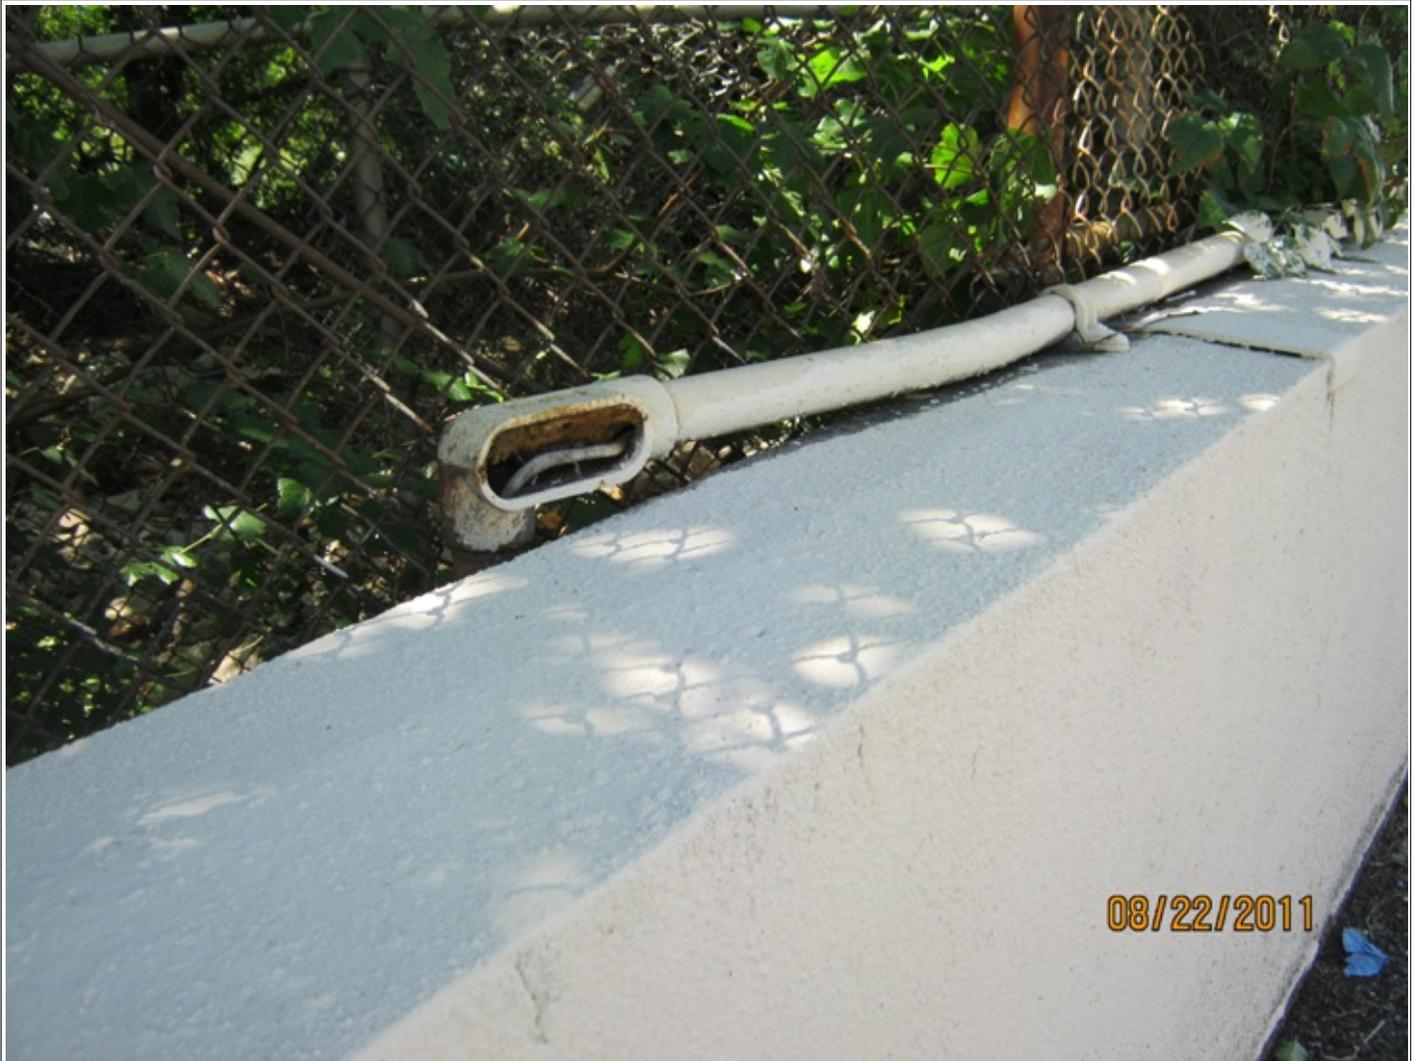
11_03IMG_1758.JPG - Attached to Safety Flag NB110031

Photo 2 - Location: End approach, right parapet; looking back and right (Close-up Photo).

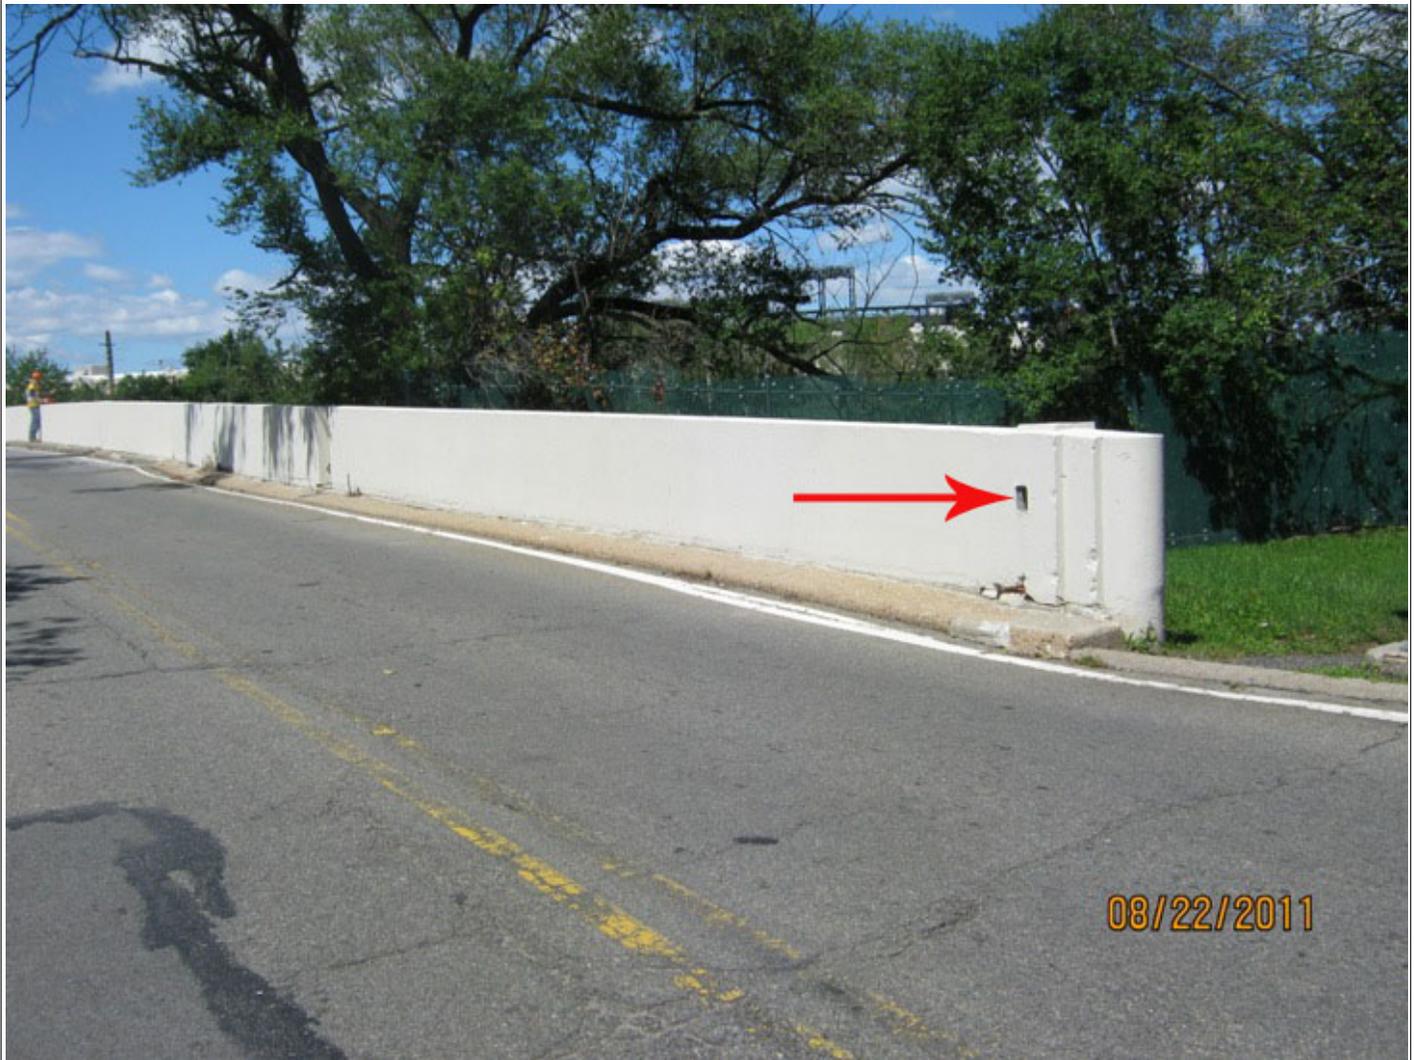
11_04IMG_1759.JPG - Attached to Safety Flag NB110031

Photo 3 - Location: End approach, left parapet; looking back and left (General Photo).

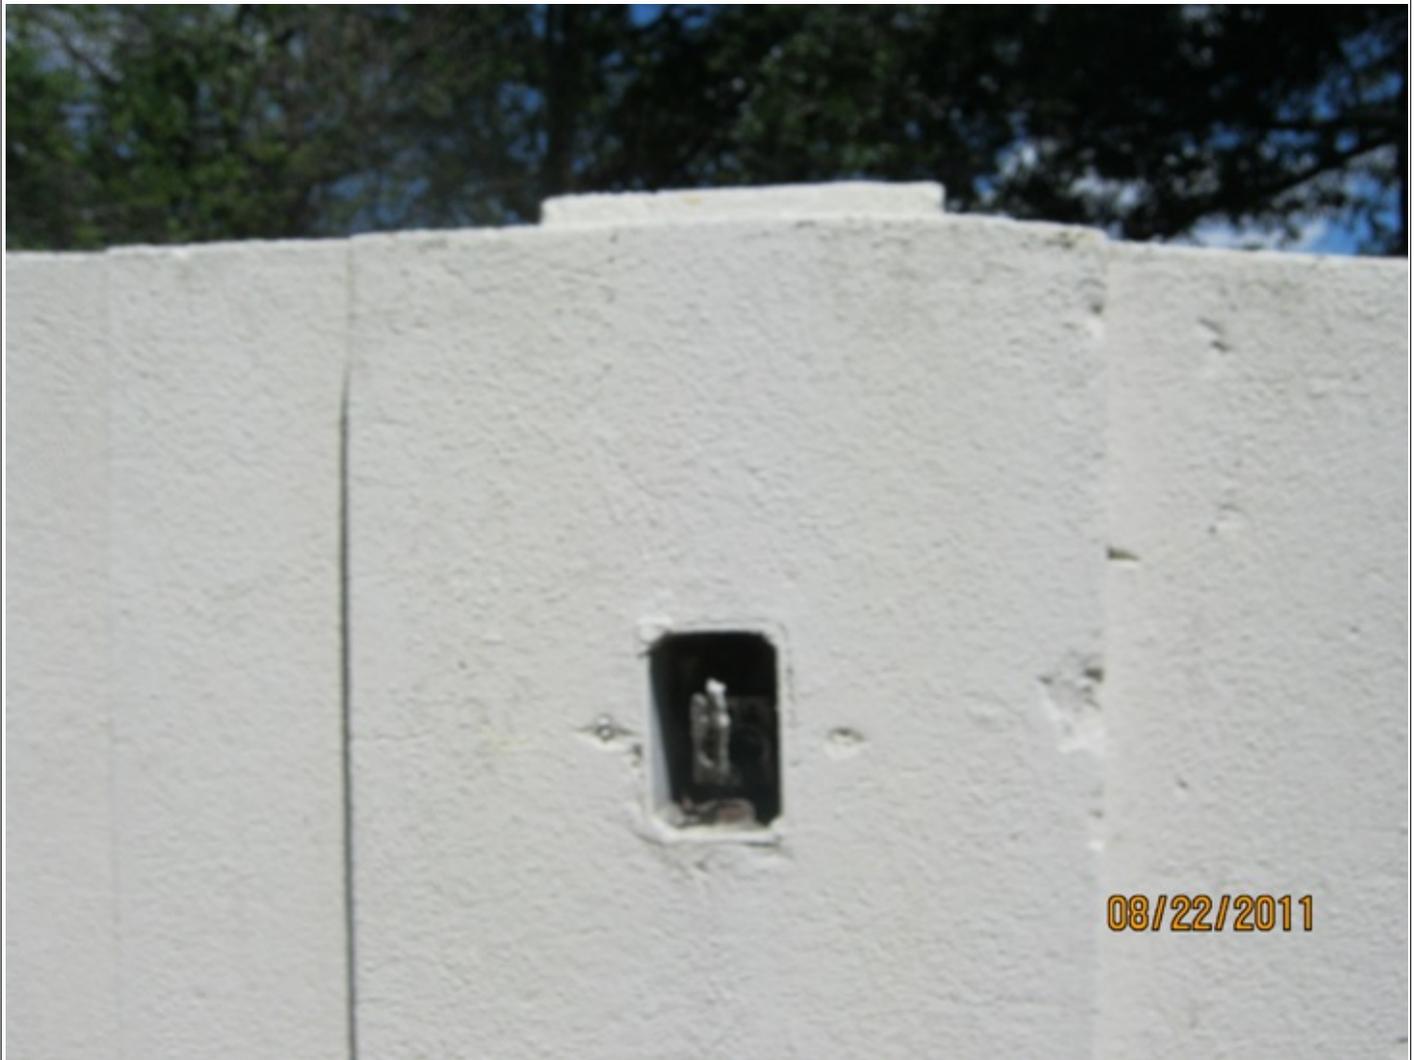
11_05IMG_1760.JPG - Attached to Safety Flag NB110031

Photo 4 - Location: End approach, left parapet; looking left (Close-up Photo).
