Fresh Kills Park

Phase 3A
Task 8.4.3
**Bridge Inspection
Report**

Final Report

August 2008

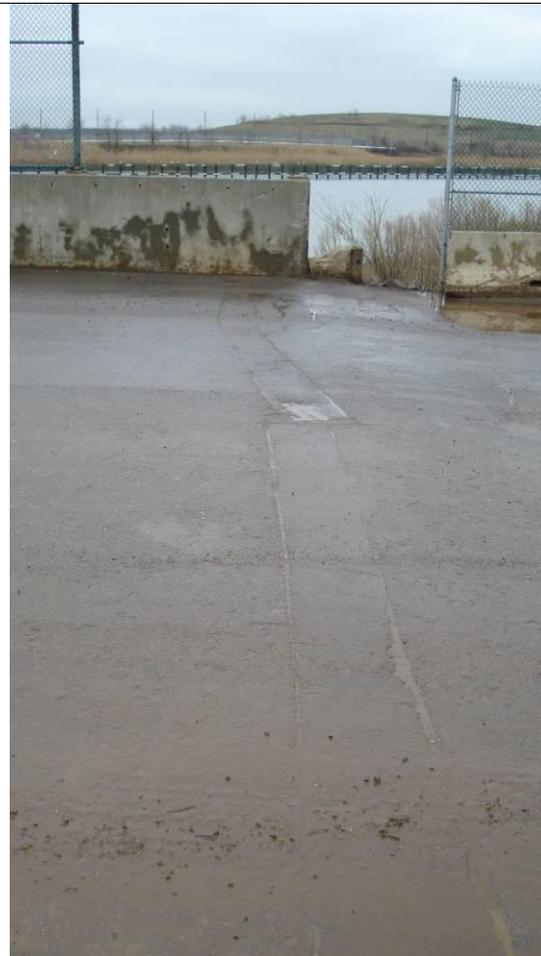
Photo No.: MC10
Location: West approach near abutment
Description: Transverse grooves in pavement above or near abutment may indicate distress.

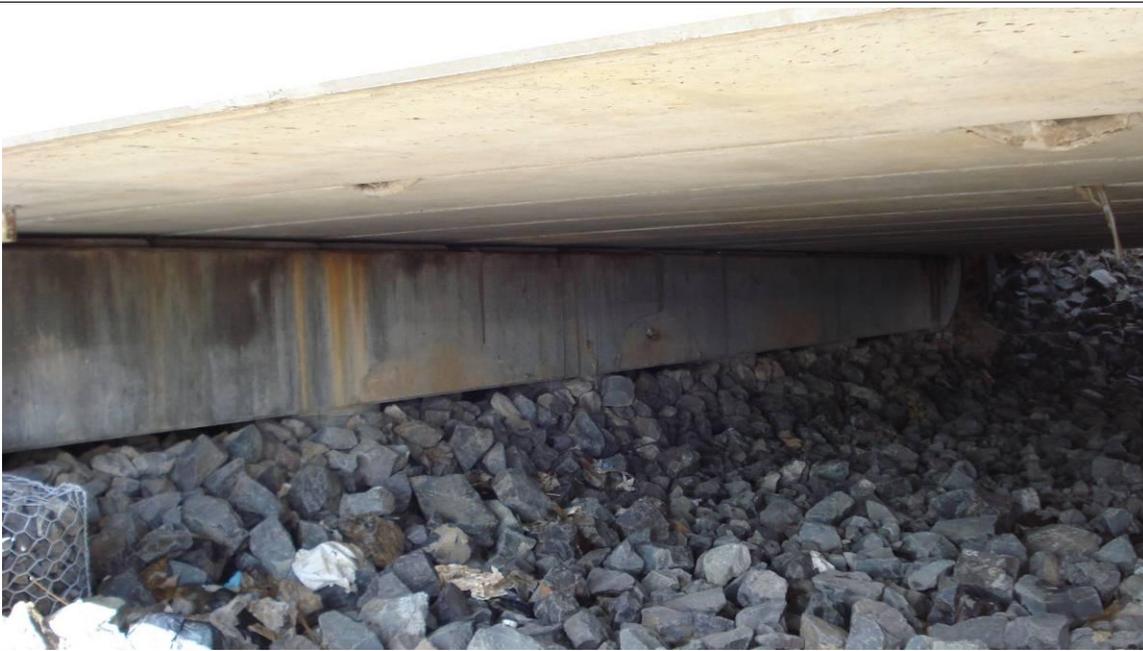
Photo No.: MC11

Location: West abutment elevation, looking from south fascia

Description: Abutment stem (pier cap) and pedestals are in good condition. Stone rip-rap on abutments slope below is in good condition.

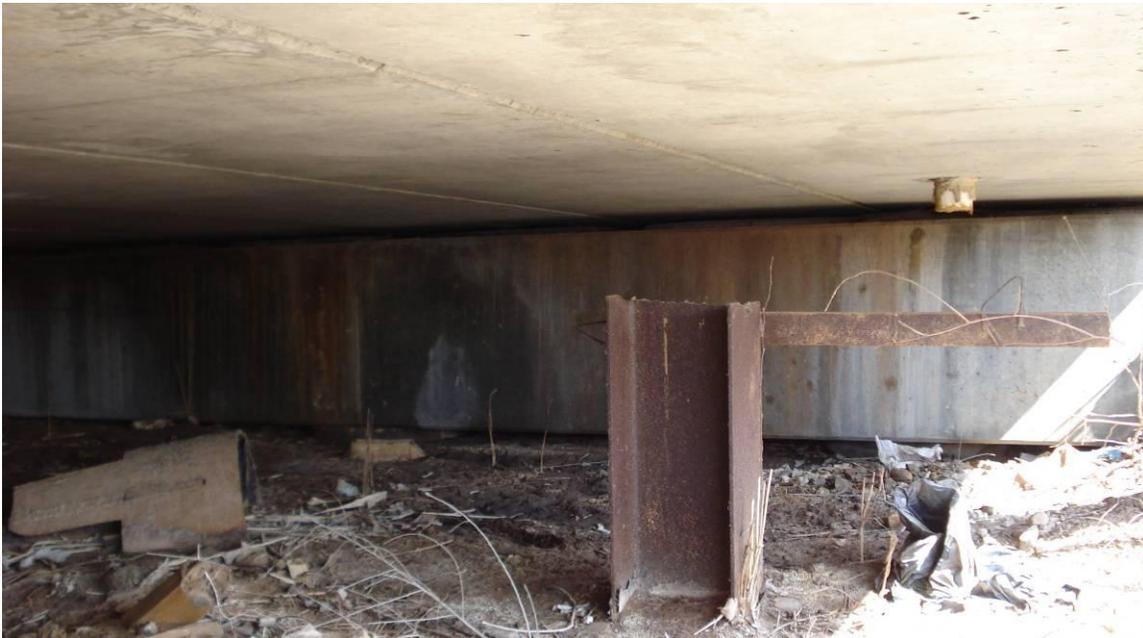
Photo No.: MC12

Location: East abutment.

Description: Abutment stem (pier cap) and pedestals in good condition. Less than 5 ft. clearance above shoreline grade.

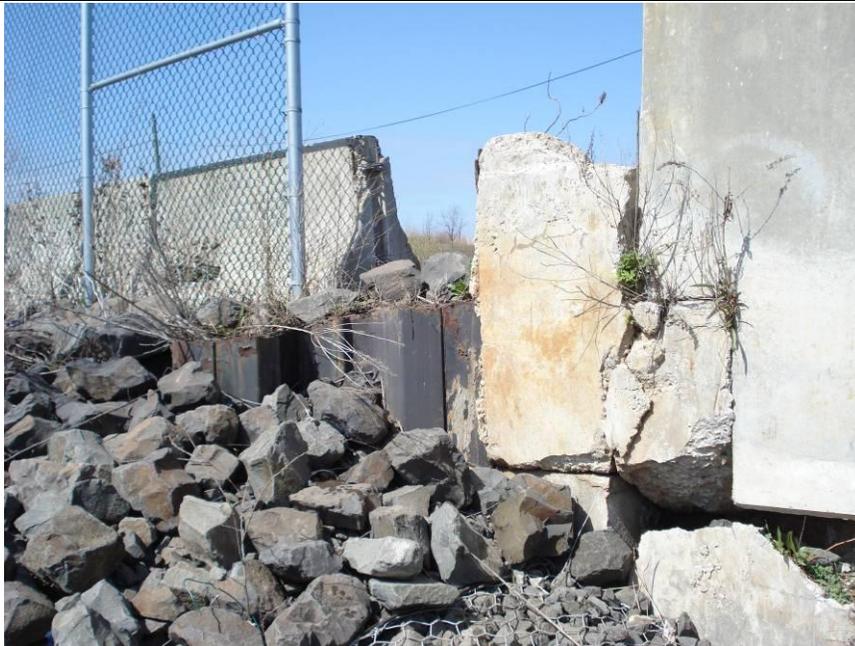
Location: Southwest wingwall elevation, looking north.

Description: Concrete wingwall is extensively broken up.

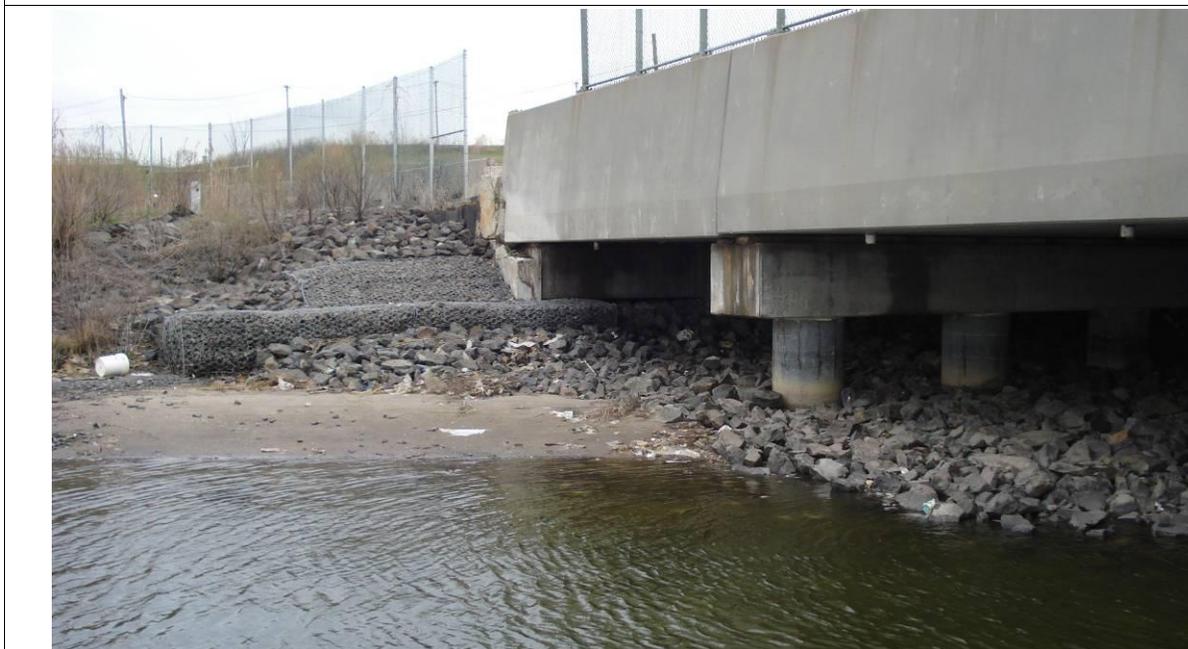
Photo No.: MC17

Location: Below bridge, north fascia looking east.

Description: High water line is clearly visible on piles. Freeboard is about 6 ft. at high water.

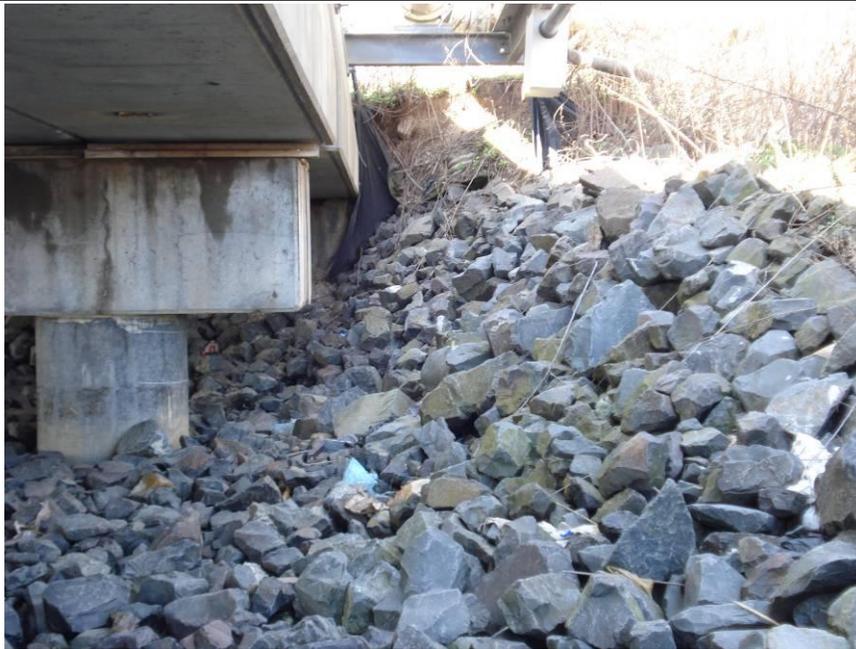
Photo No.: MC18

Location: West abutment and shoreline south fascia looking west.

Description: Shoreline is stabilized with stone rip-rap and gabions in good condition.

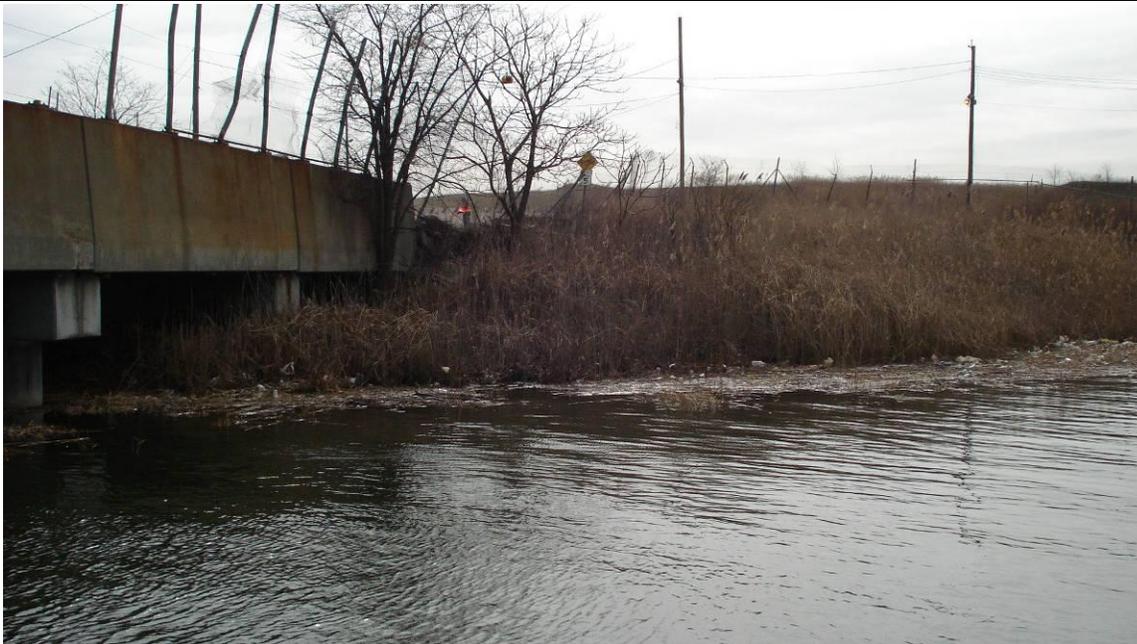
Photo No.: MC19

Location: West abutment, north fascia looking west.

Description: Shoreline is stabilized with stone rip-rap in good condition.

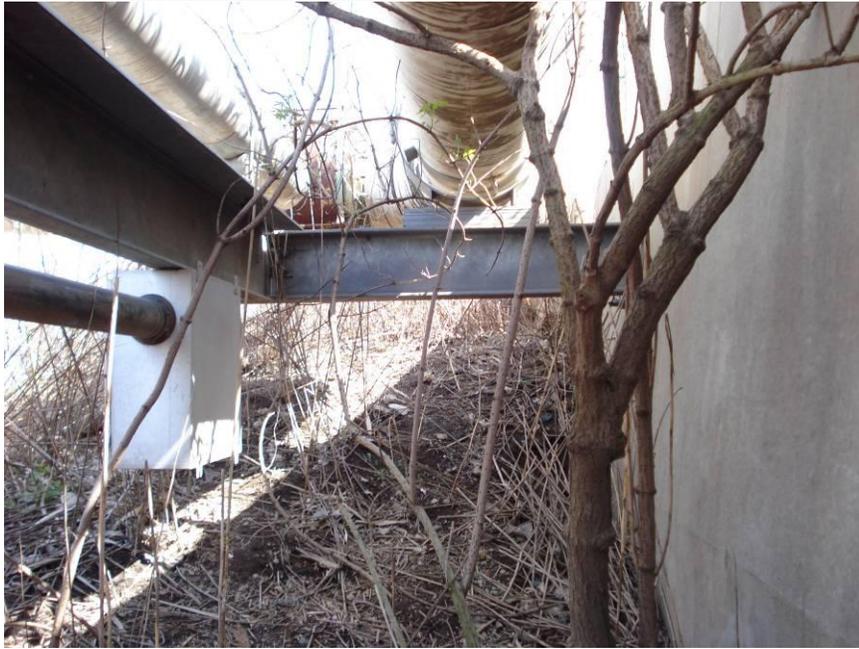
Photo No.: MC21

Location: Northeast wingwall, looking east.

Description: Embankment is stable and vegetated.

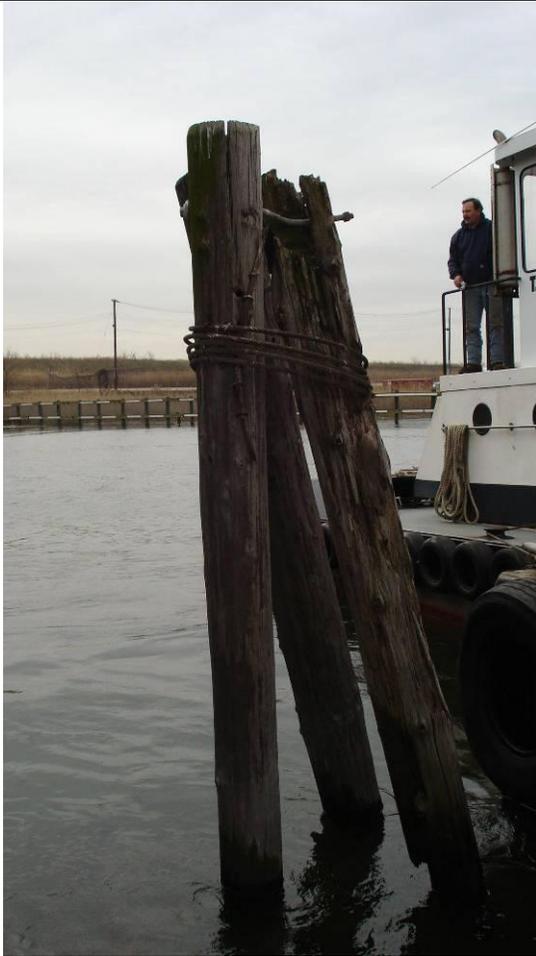
Photo No.: MC22
Location: Pile dolphin at Pier 8, south side.
Description: Dolphin in poor condition.

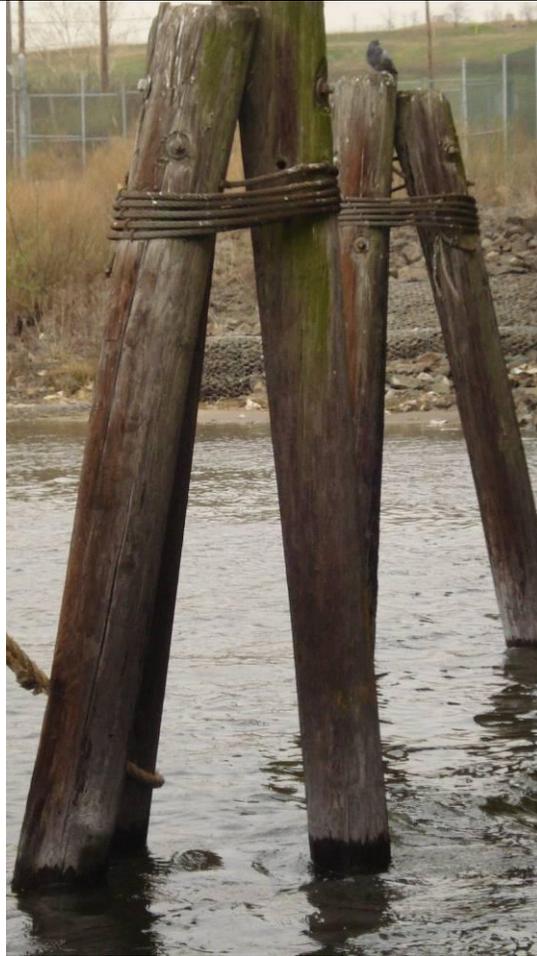
Photo No.: MC23
Location: Pile dolphins at Piers 6 and 5, south side.
Description: Dolphins in fair condition.

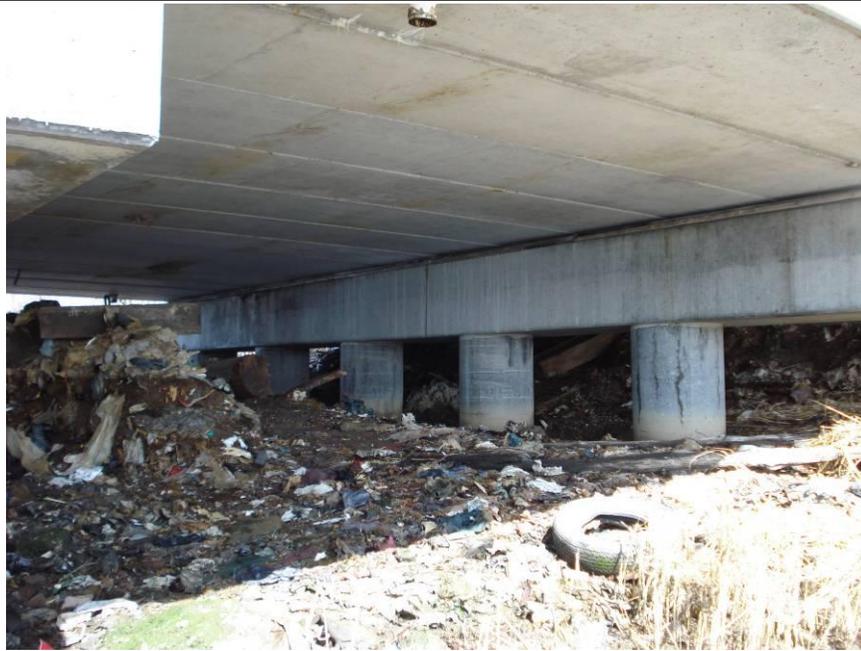
Photo No.: MC24

Location: Below Span 19 (foreground) and 20 (behind Pier 19) looking from south fascia.

Description: Debris, flotsam and earth piled up almost to the underside of the superstructure.

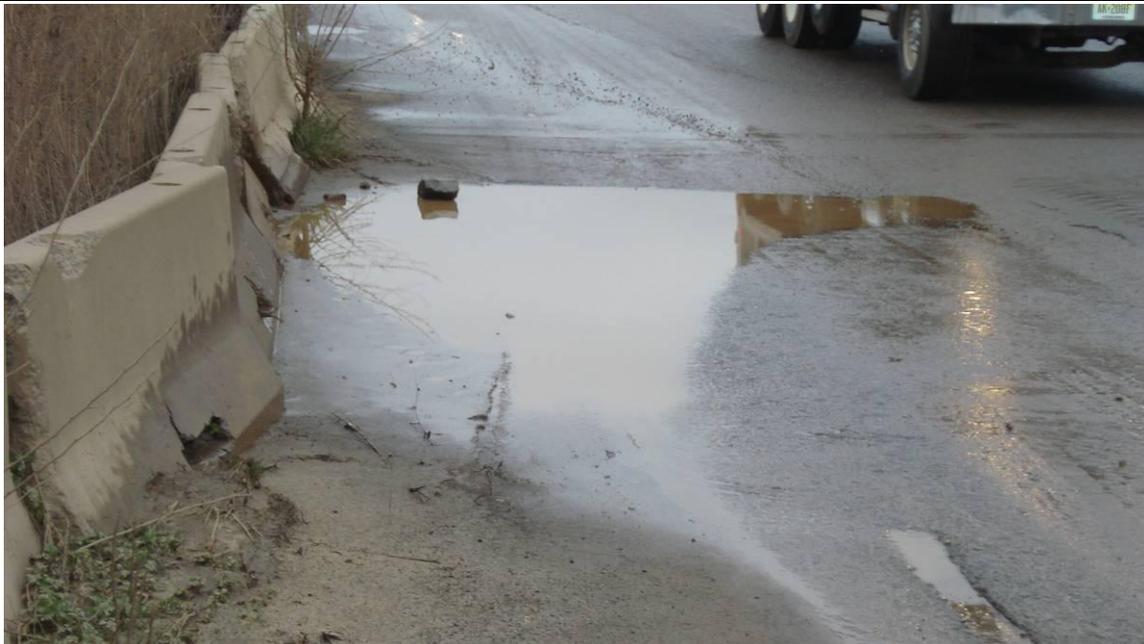
Photo No.: MC25

Location: West approach, north side, just behind west abutment, looking east.

Description: Settlement of roadway behind abutment causing ponding. Pavement uneven and breaking up. Barriers uneven and damaged.

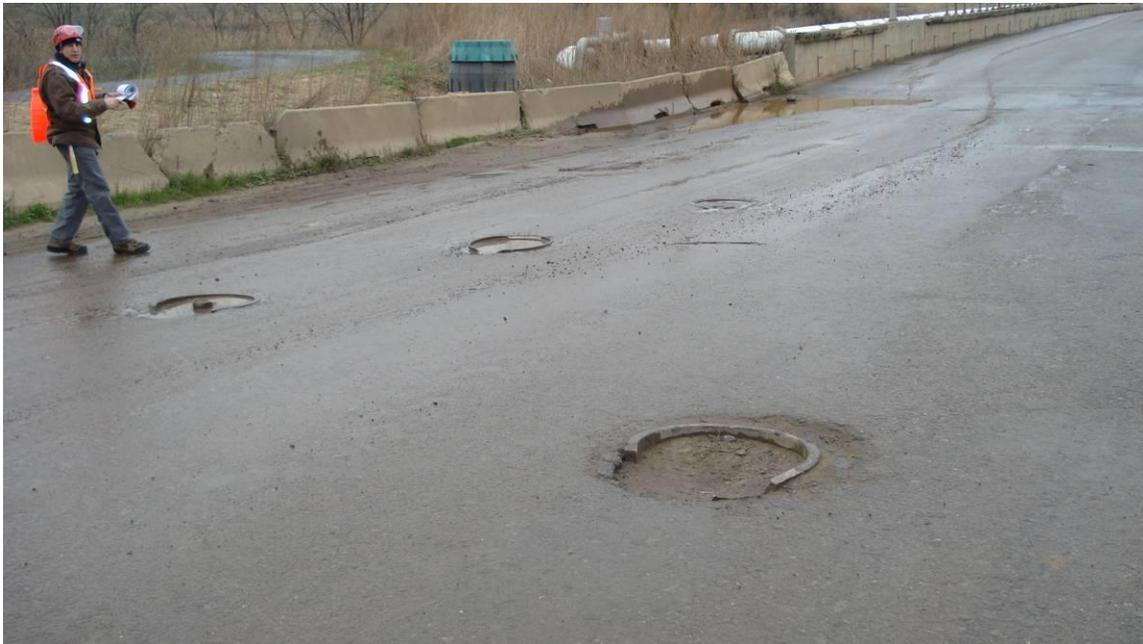
Photo No.: MC27

Location: West approach looking northeast.

Description: Manholes in poor condition. Concrete barriers in poor condition as well. Note depression near northwest corner of abutment with water ponding – see Photo MC25 above.

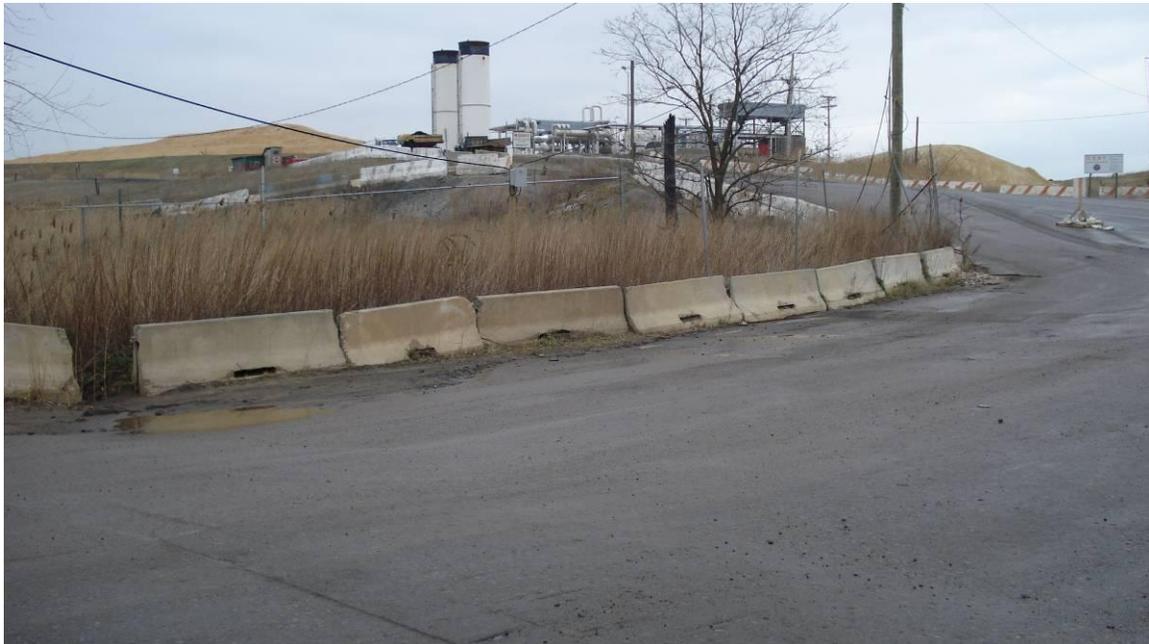
Photo No.: MC29

Location: East approach, north side, near east abutment, looking northeast.

Description: Roadway surface uneven. Note settlement and ponding. Barriers uneven and damaged. Fence in fair condition.

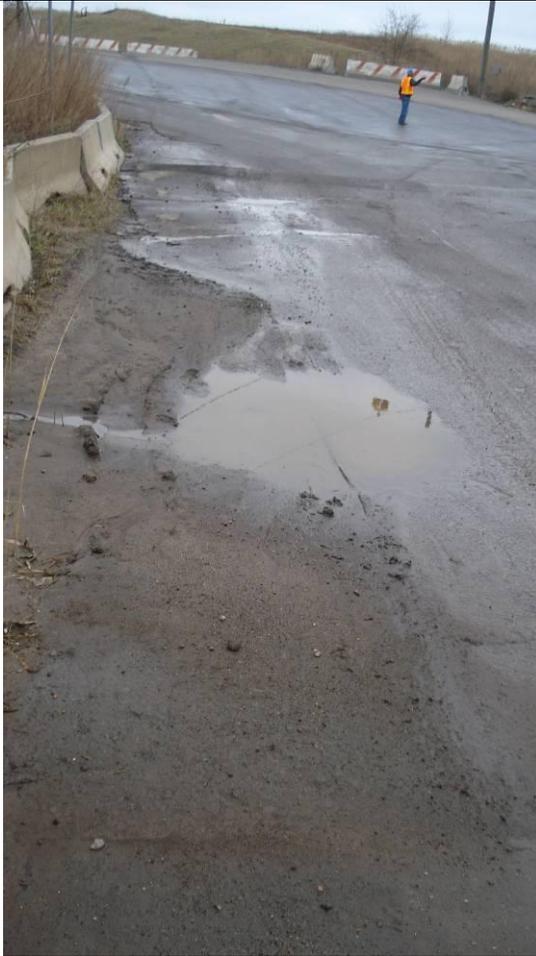
Photo No.: MC30
Location: East approach, north side just behind east abutment, looking east.
Description: Pavement in poor condition.

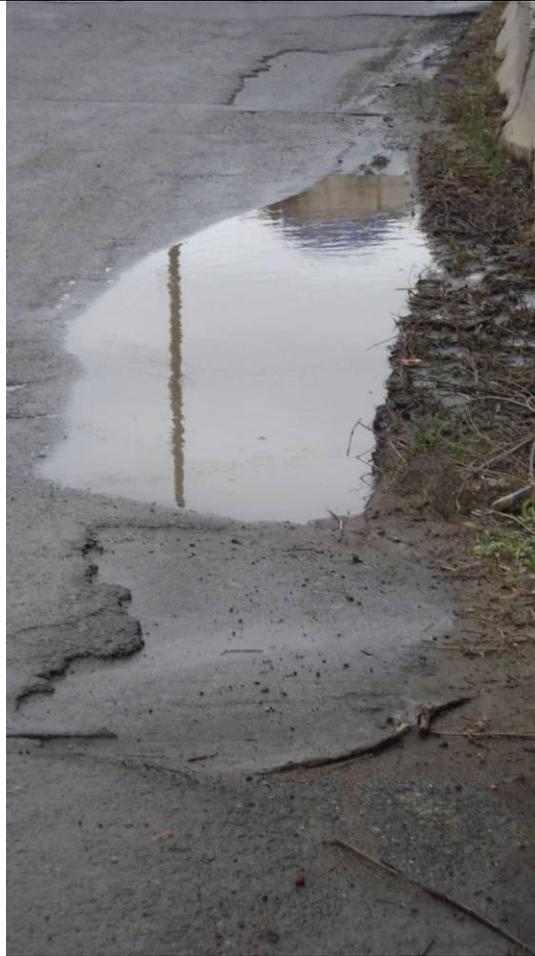
Photo No.: MC31
Location: East approach, south side just behind east abutment, looking east.
Description: Pavement in poor condition.

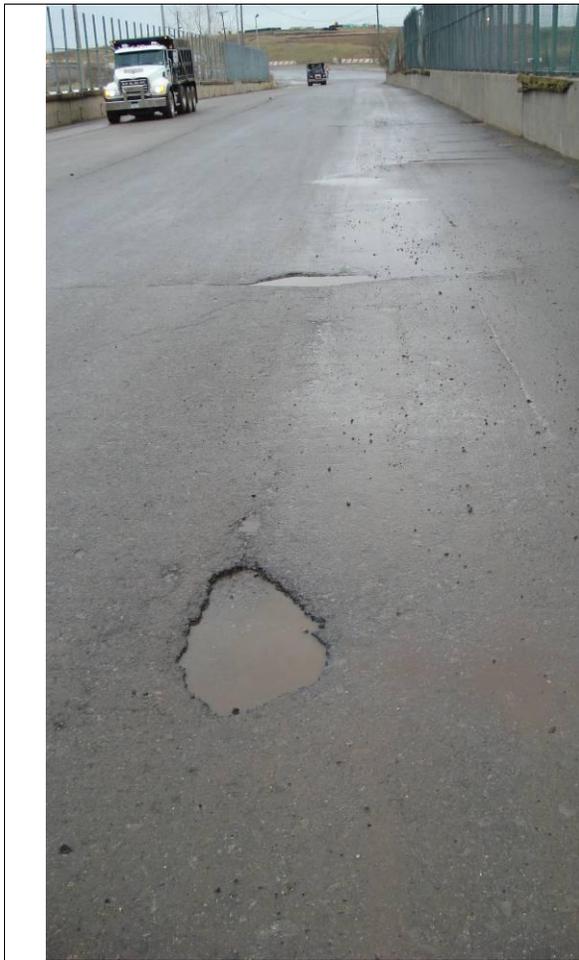
Photo No.: MC32
Location: Span 2, south side
Description: Potholes in pavement.

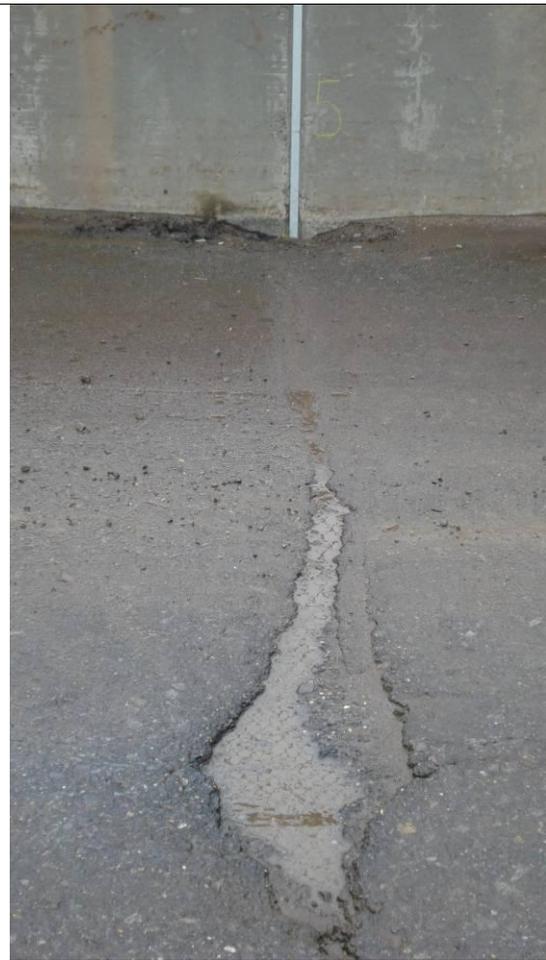
Photo No.: MC33
Location: Roadway over Pier 5, looking south
Description: Pavement breakup over pier and at parapet.

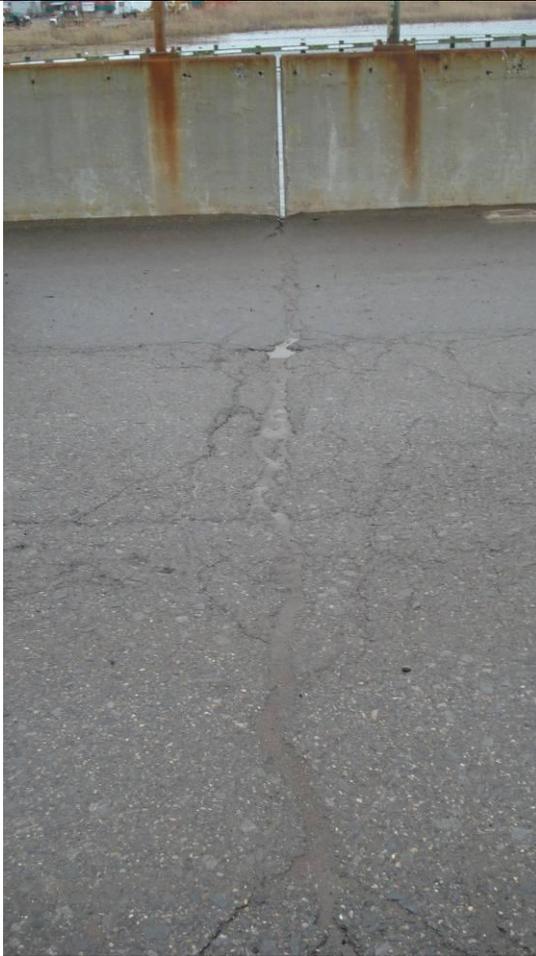
Photo No.: MC34
Location: Roadway over Pier 14, south side
Description: Pavement breakup over pier.

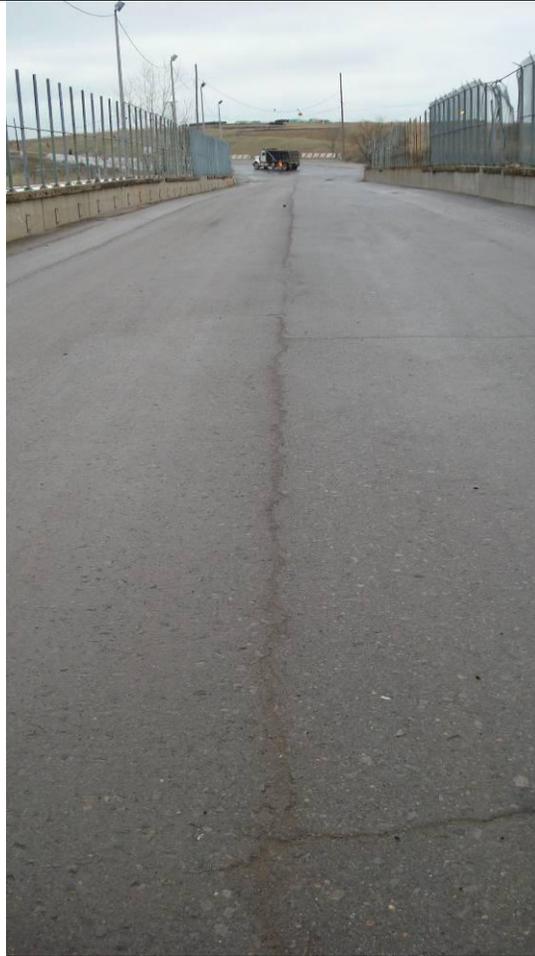
Photo No.: MC35
Location: Bridge centerline looking east
Description: Pavement crack extends full length of bridge.

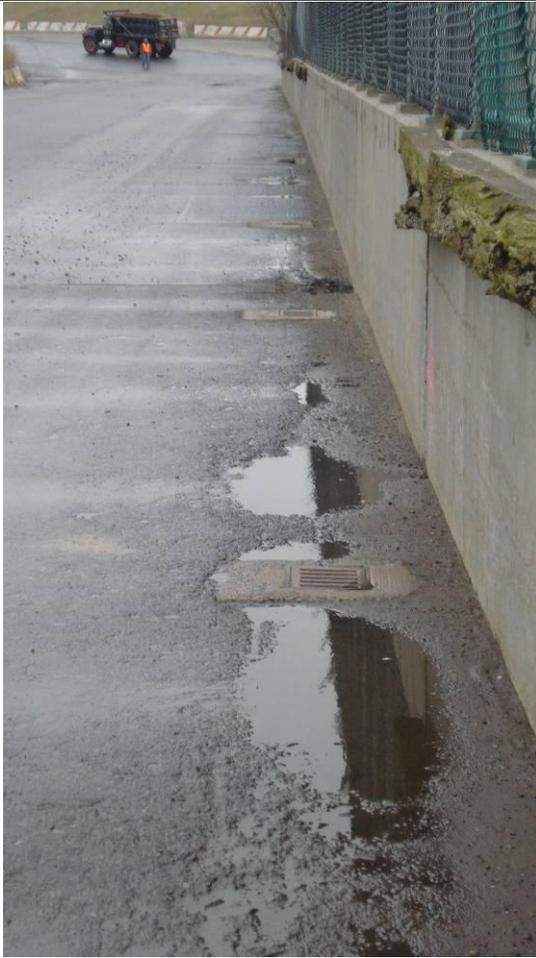
Photo No.: MC37
Location: South side looking east from Span 3
Description: Uneven pavement and extensive ponding indicate loss of granular subbase.

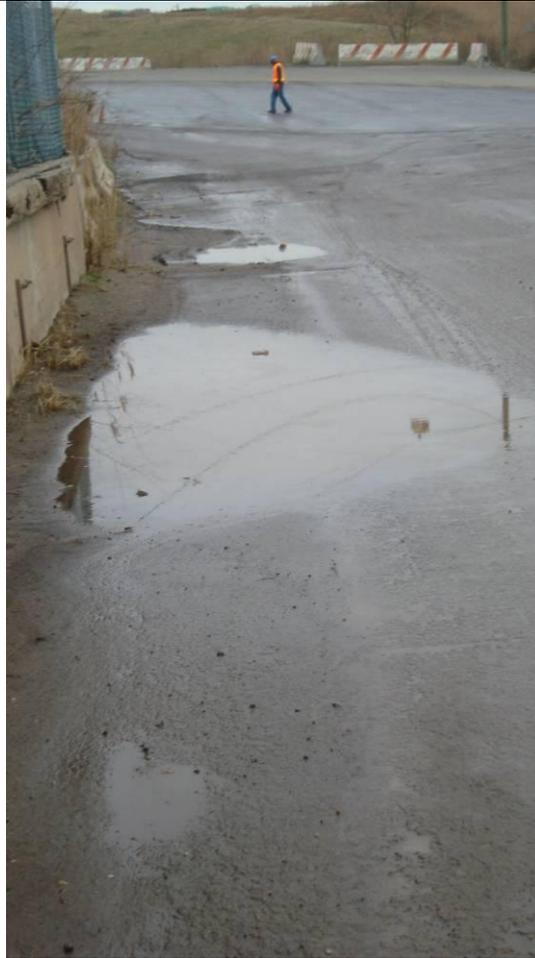
Photo No.: MC38
Location: North side looking east, Span 21.
Description: Deep pavement depression and ponding indicate loss of granular subbase.

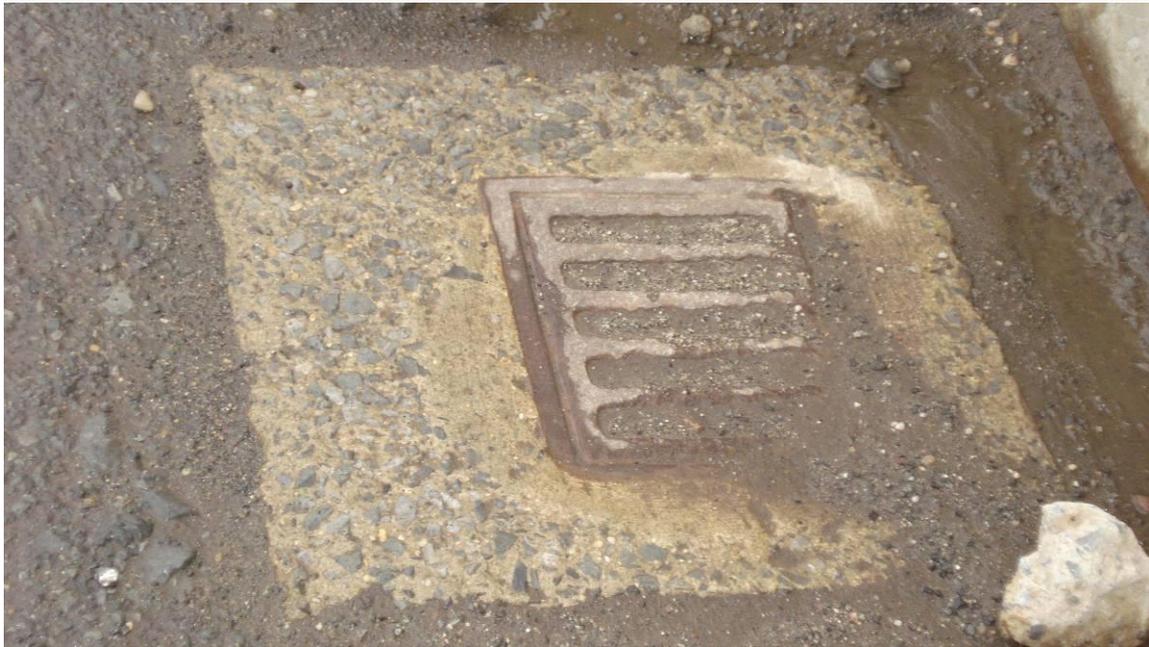
Photo No.: MC39

Location: Span 2 south side.

Description: Typical clogged scupper. Note concrete header.

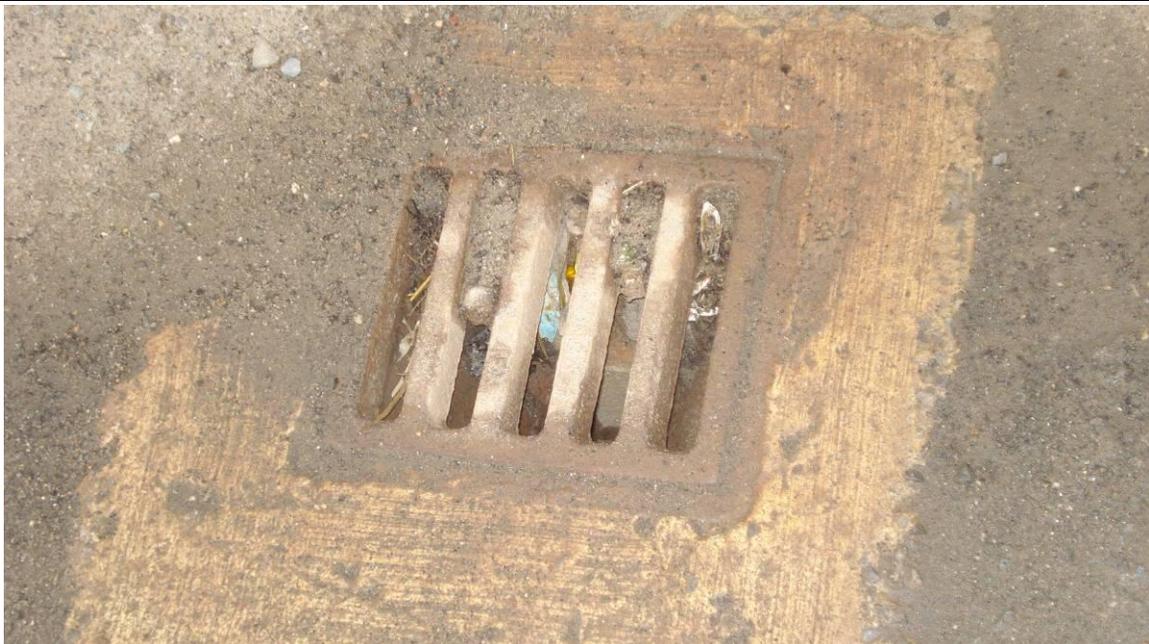
Photo No.: MC40

Location: Span 1 north side.

Description: Typical partially clogged scupper.

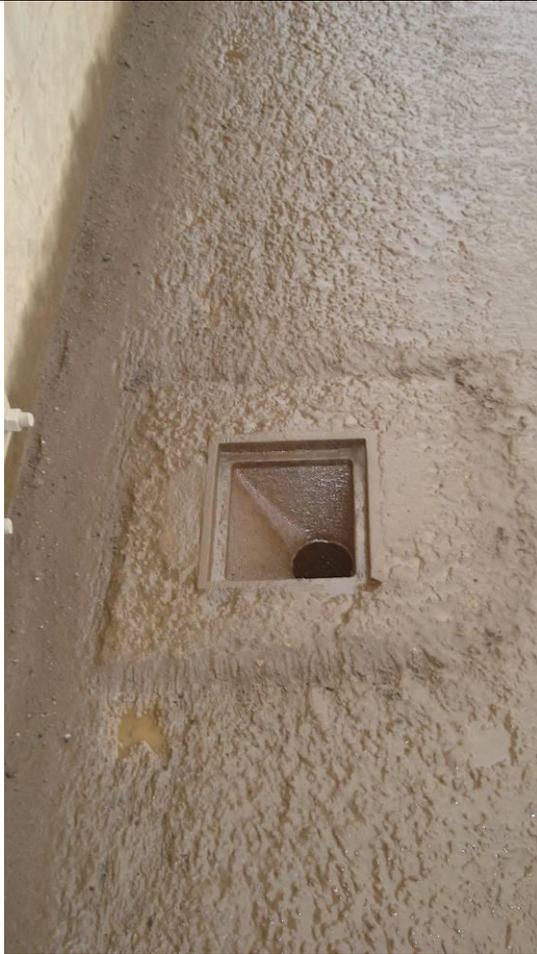
Photo No.: MC41
Location: Span 5 north side.
Description: Scupper missing grating.

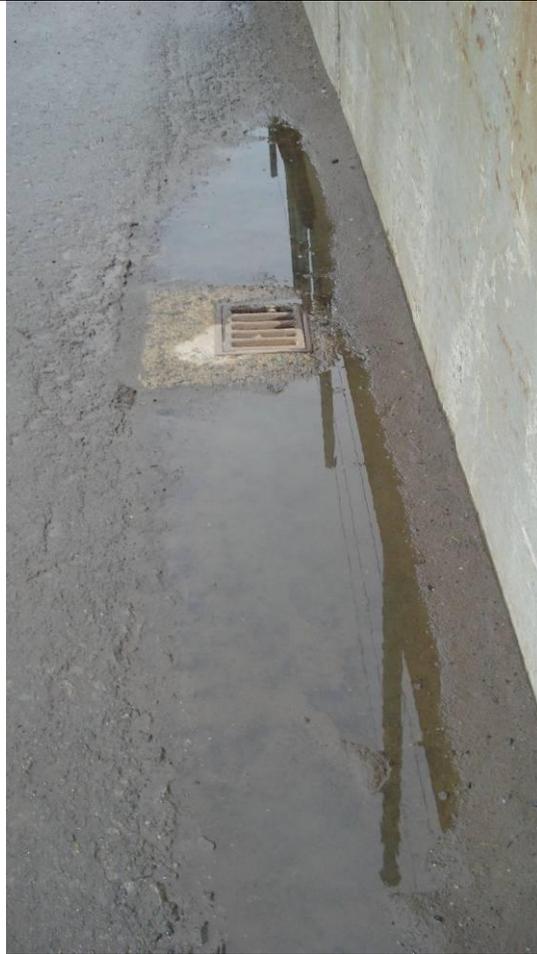
Photo No.: MC42
Location: Span 5 north side.
Description: Scupper open, but depressions on either side make scupper ineffective.

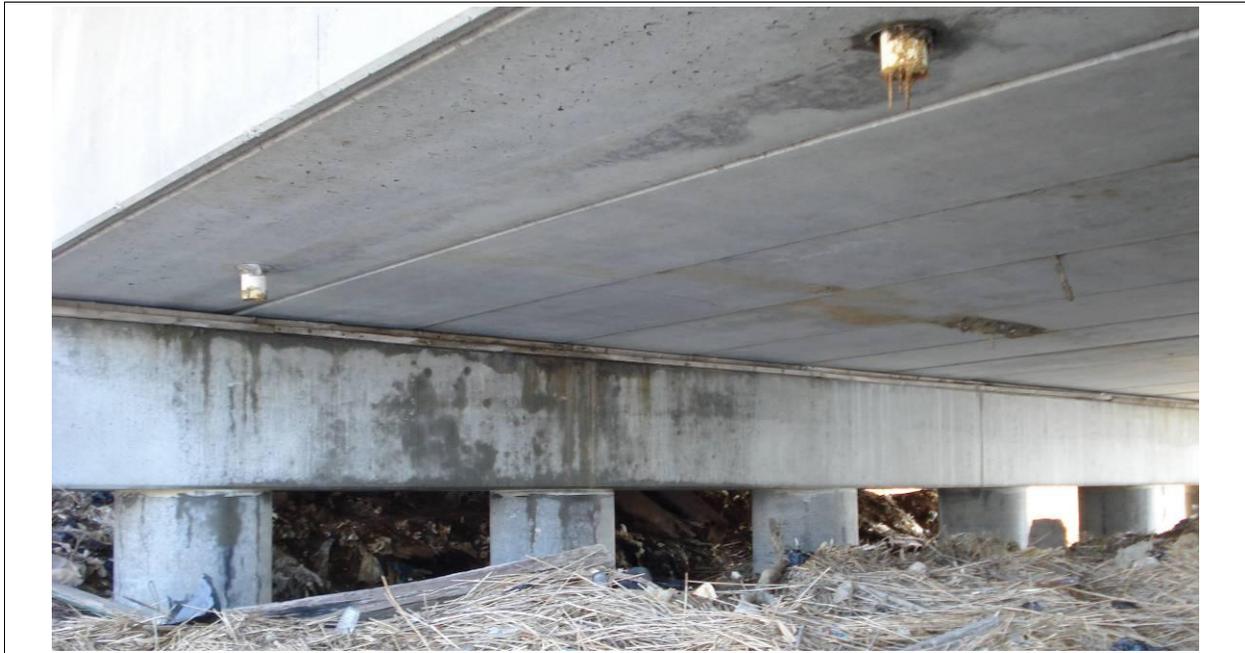
Photo No.: MC43

Location: Span 19 underside of superstructure, north side.

Description: The far downspout is from the roadway drainage scupper. The near downspout is from the underdrain scupper; note indication that the earth fill is washing out.

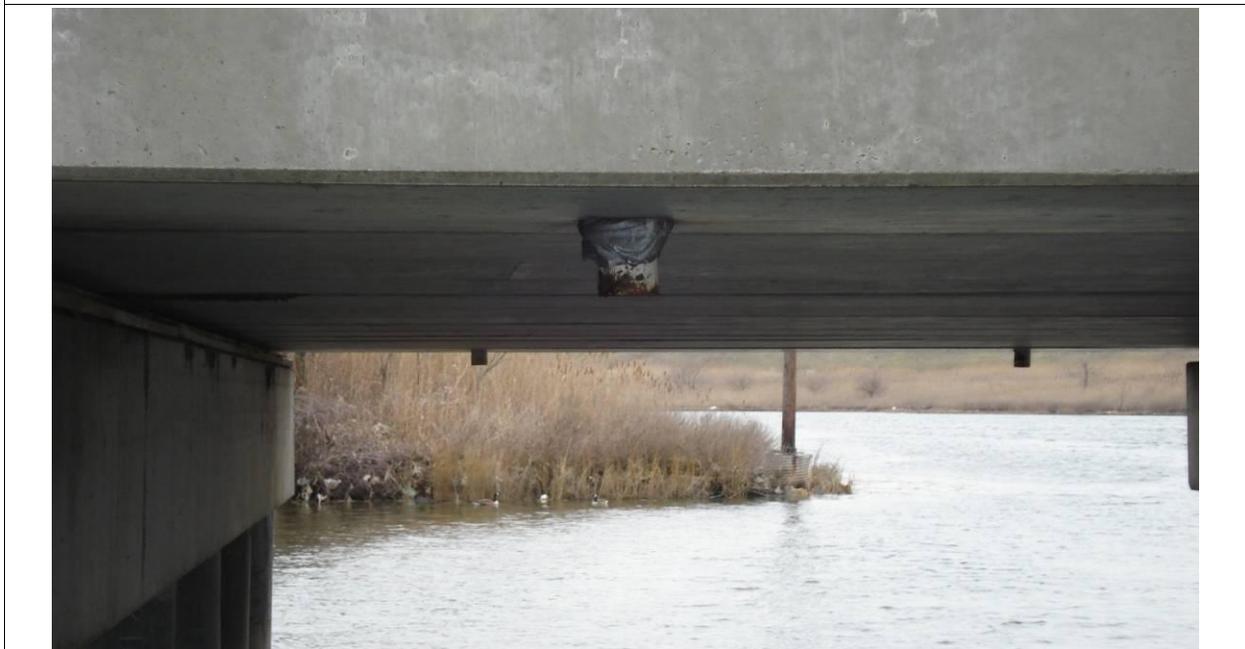
Photo No.: MC44

Location: Span 4 underside of superstructure, south side.

Description: Downspout has been wrapped in tape, indicating that the washing out of earth fill has been noted as a problem by maintenance forces.

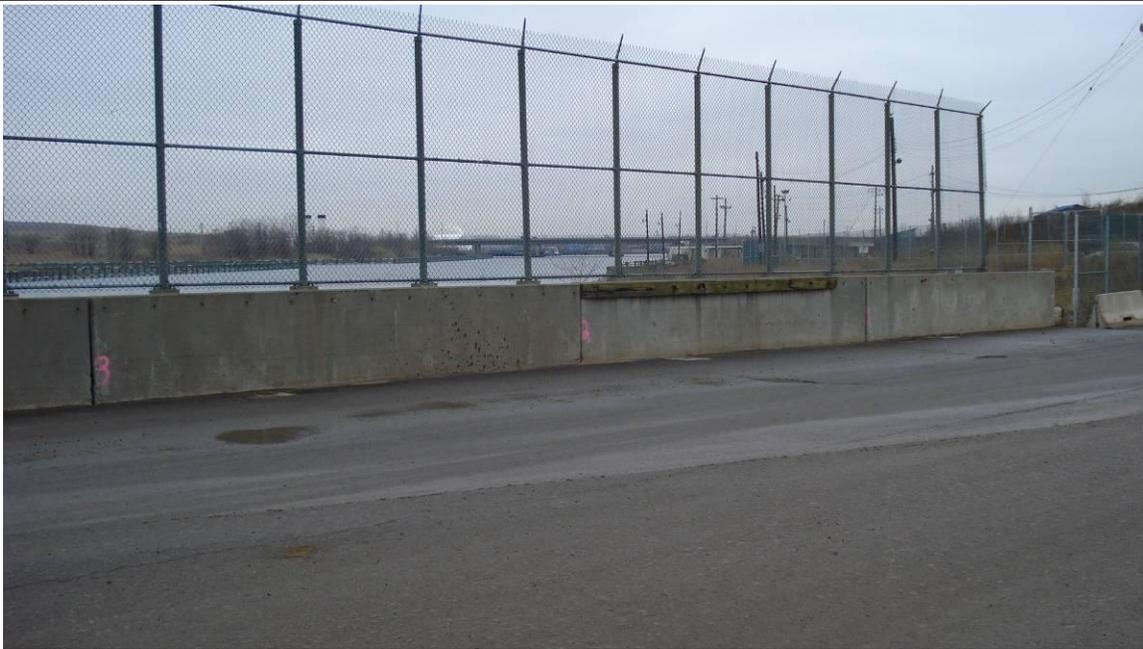
Photo No.: MC45

Location: South parapet Spans 1, 2 and 3 looking southwest.

Description: Concrete is sound. Timber rub rail is missing in Spans 1 and 3 and badly deteriorated in Span 2. Fence in fair condition but missing 10 ft. section at beginning of Span 1.

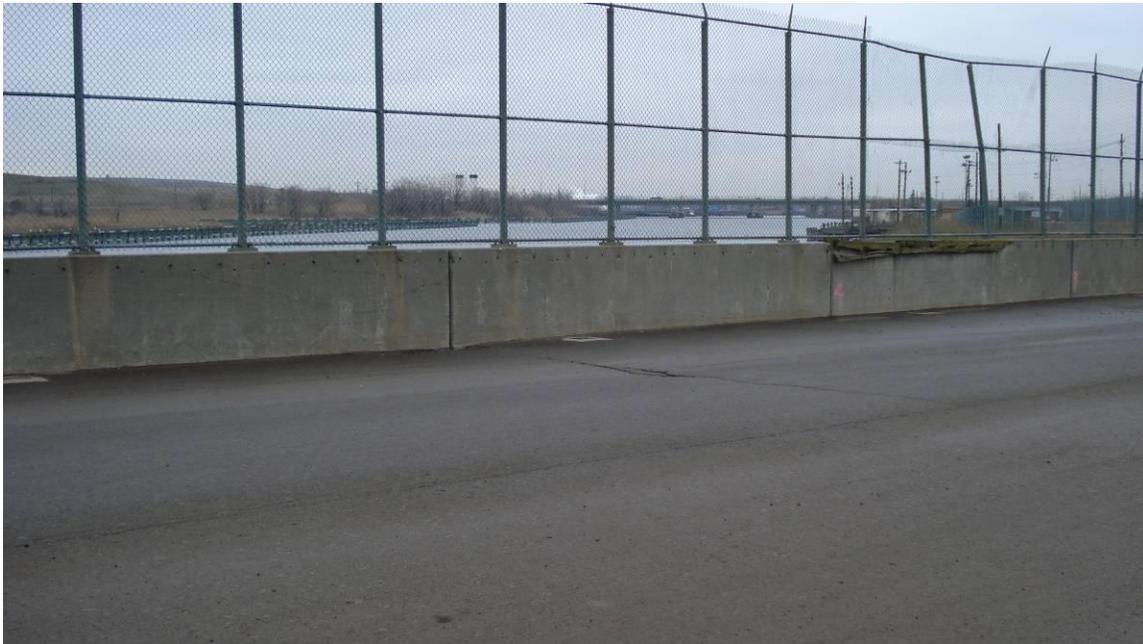
Photo No.: MC46

Location: South parapet Spans 4, 5 and 6 looking southwest.

Description: Concrete is sound. Timber rub rail is missing in Spans 5 and 6 and badly deteriorated in Span 2. Fence in fair condition with bent posts and missing top extensions in Span 4.

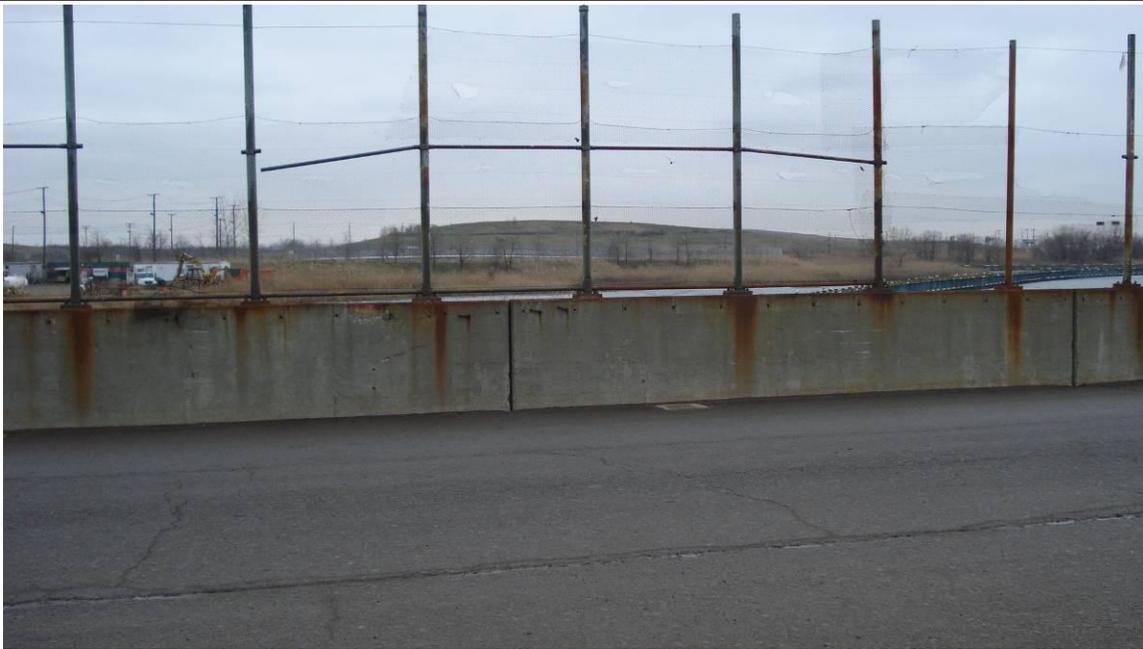
Photo No.: MC49

Location: South parapet Spans 13, 14 and 15 looking southwest.

Description: Concrete is sound. Timber rub rail is missing. Fence in poor condition with missing horizontal rails.

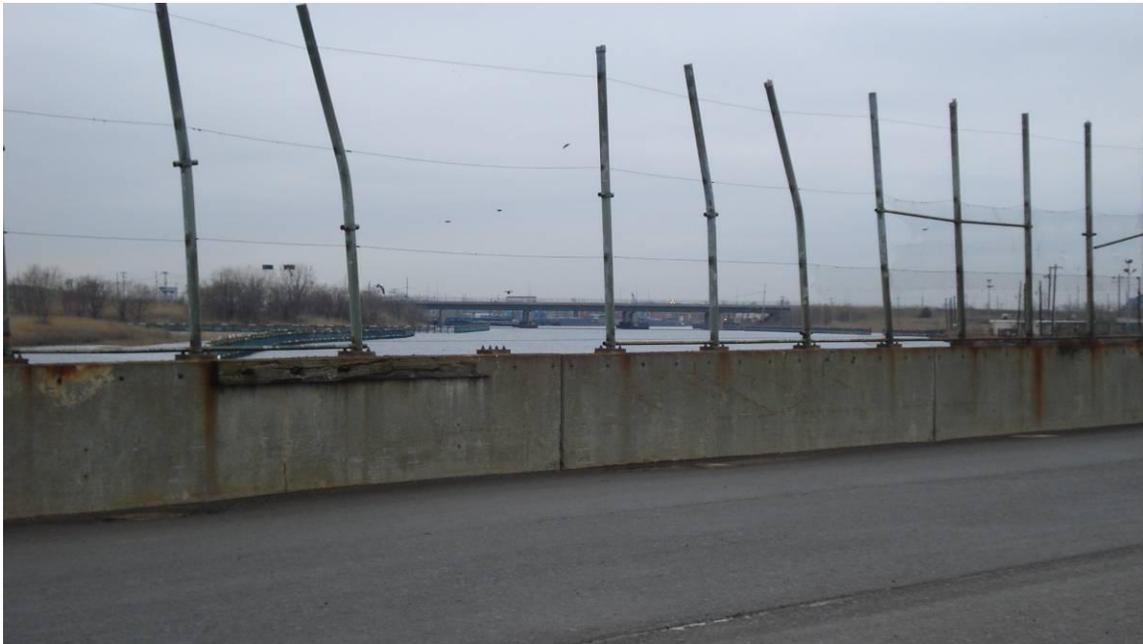
Photo No.: MC50

Location: South parapet Spans 16, 17, and 18 looking southwest.

Description: Concrete is sound. Timber rub rail is missing in Spans 16 and 17 and badly deteriorated in Span 17. Fence in poor condition with missing and bent posts and missing horizontal rails.

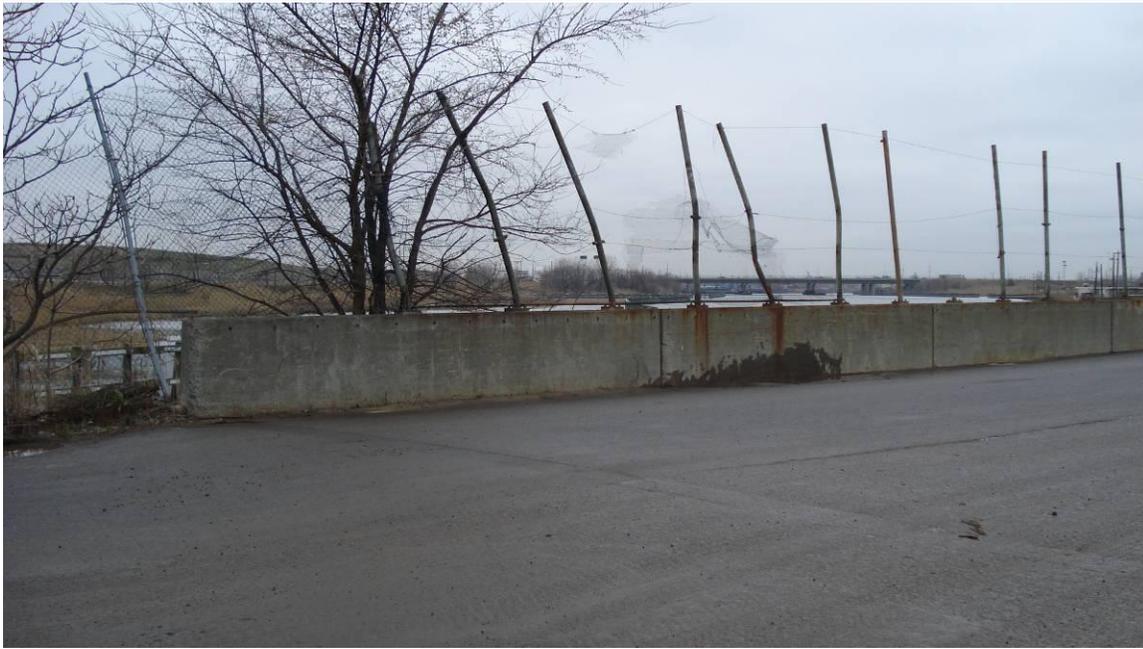
Photo No.: MC53

Location: South parapet Spans 19, 20 and 21 looking southwest.

Description: .Concrete is sound. Timber rub rail is missing. Fence in poor condition.

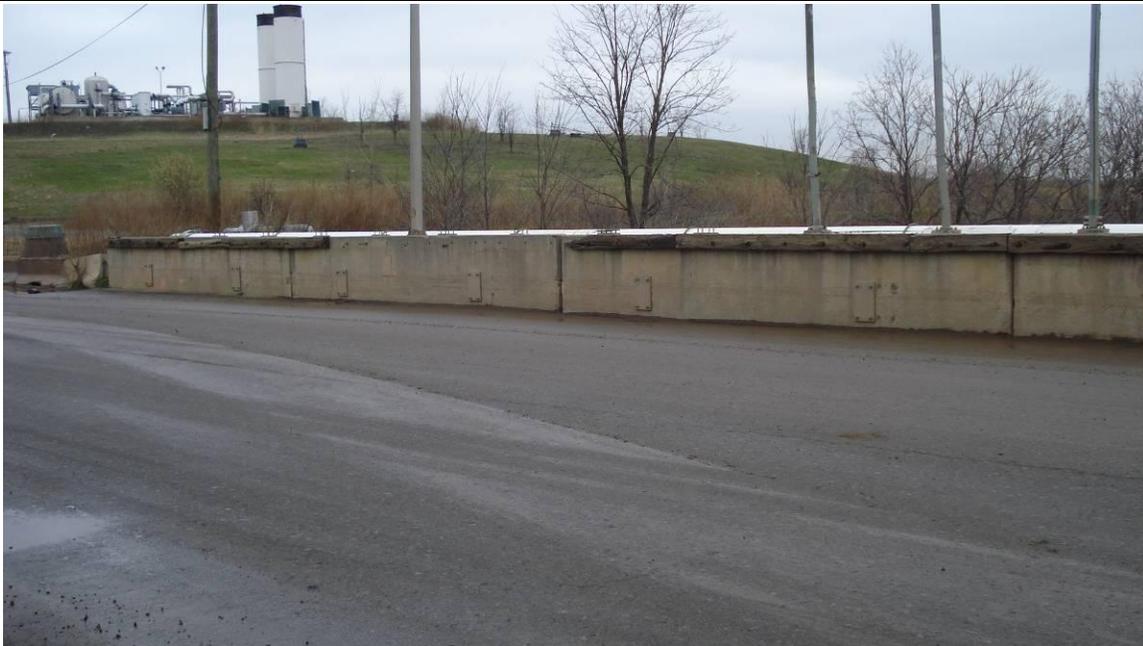
Photo No.: MC54

Location: North parapet Spans 1, 2, and 3 looking northwest.

Description: Concrete is sound. Timber rub rail is missing in Span 2 and badly deteriorated in Spans 1 and 3. Fence chain link mesh and horizontal rails are missing; some posts remain.
