Fresh Kills Park

Phase 3A
Task 8.4.3
**Bridge Inspection
Report**

Final Report

August 2008

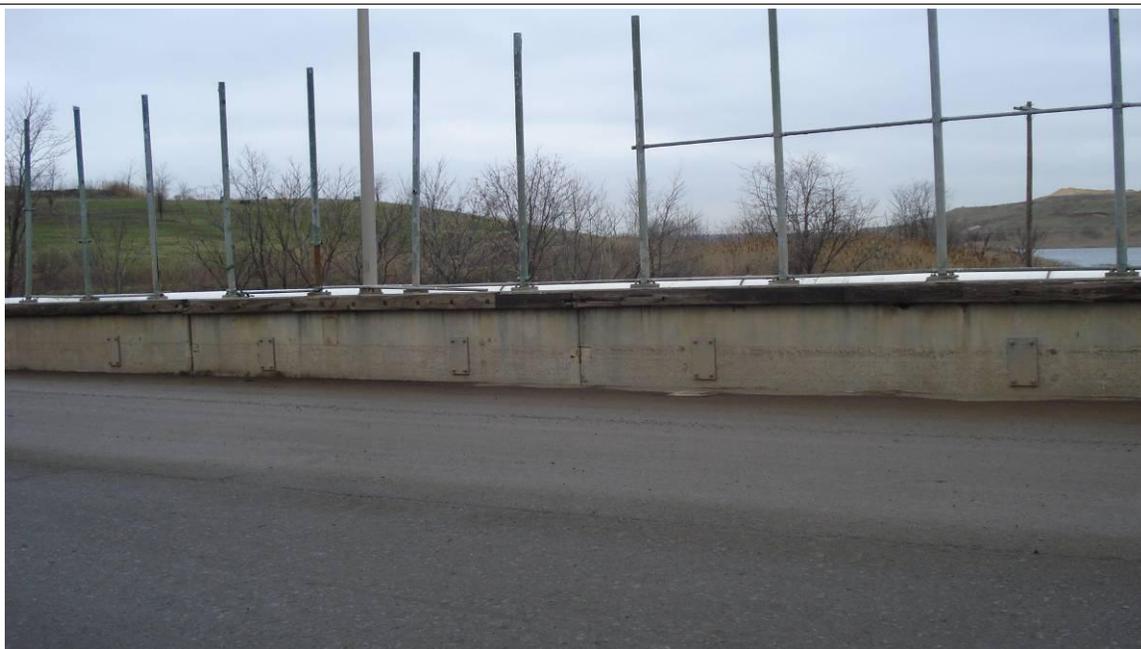
Photo No.: MC55

Location: North parapet Spans 4, 5 and 6 looking southwest.

Description: Concrete is sound. Timber rub rail is deteriorated. Fence chain link mesh and most horizontal rails are missing; posts remain.

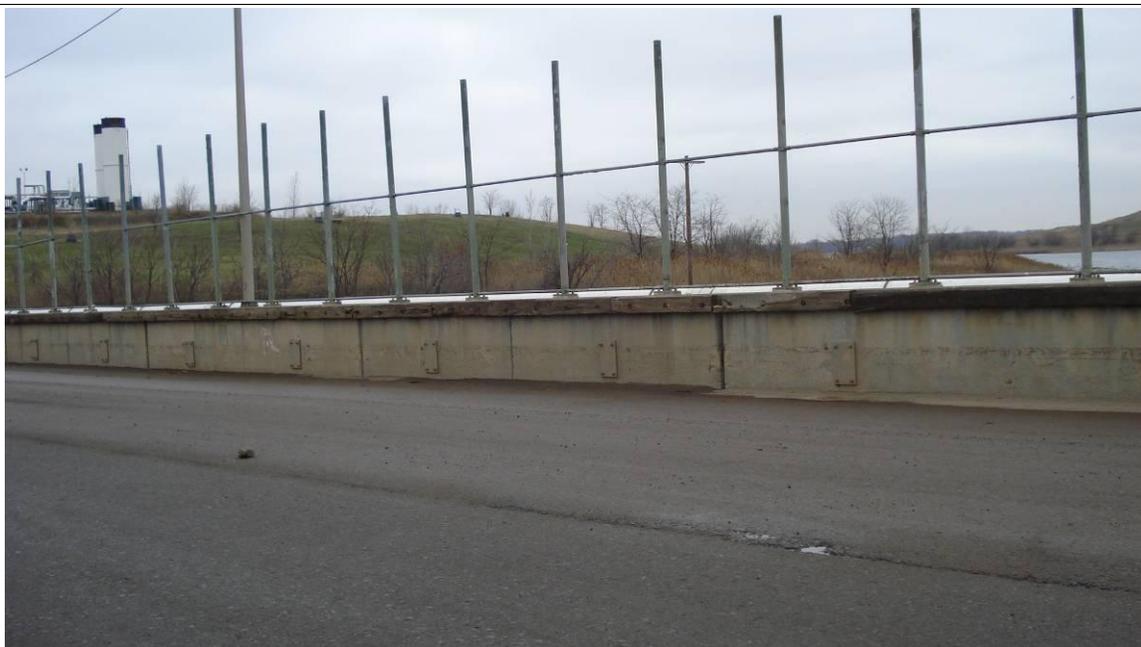
Photo No.: MC56

Location: North parapet Spans 7, 8, and 9 looking northwest.

Description: Concrete is sound. Timber rub rail is deteriorated. Fence chain link mesh and top horizontal rails are missing; posts remain.

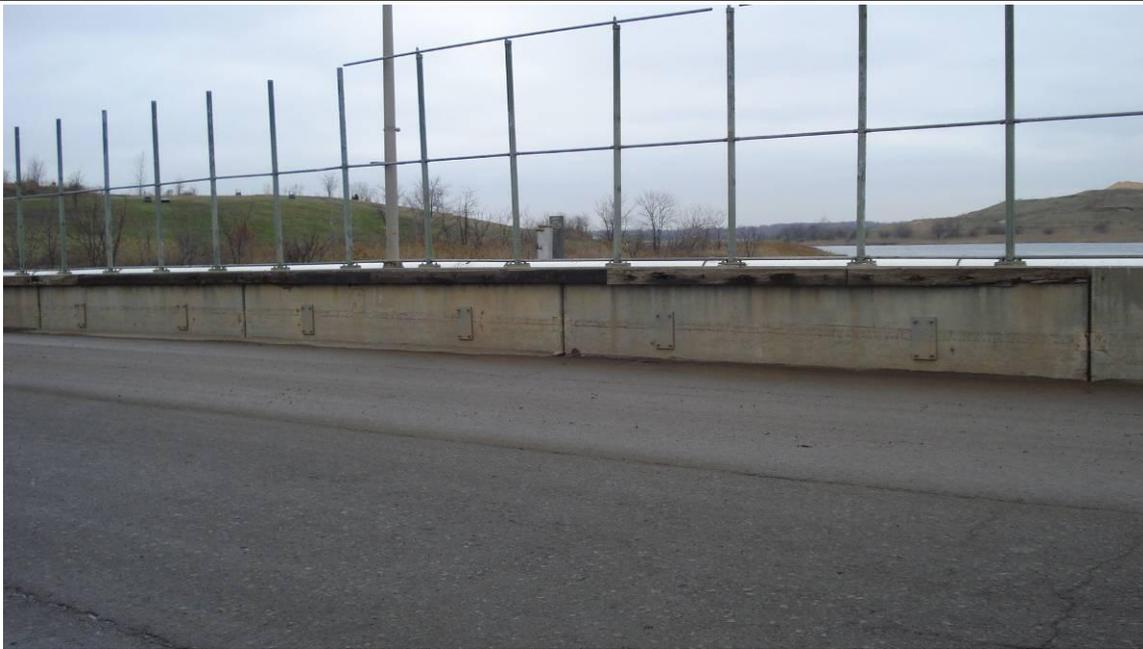
Photo No.: MC57

Location: North parapet Spans 10, 11 and 12 looking southwest.

Description: Concrete is sound. Timber rub rail is deteriorated. Fence chain link mesh and top horizontal rails are missing; posts remain.

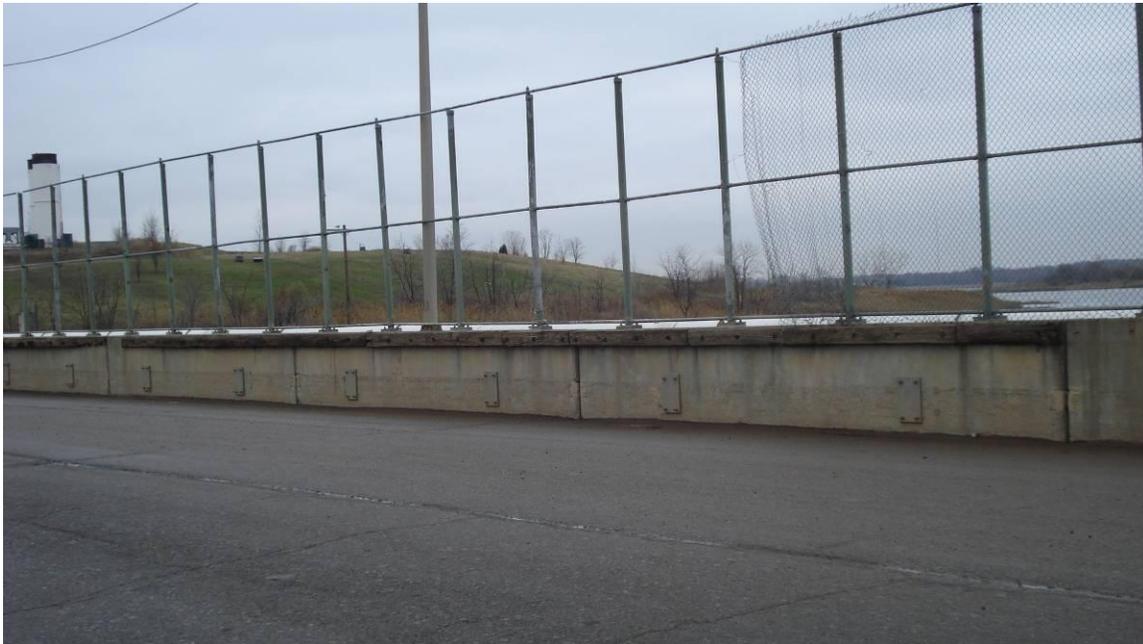
Photo No.: MC58

Location: North parapet Spans 13, 14, and 15 looking northwest.

Description: Concrete is sound. Timber rub rail is deteriorated. Fence chain link mesh missing in Spans 13, 14 and part of 15; top extension missing.

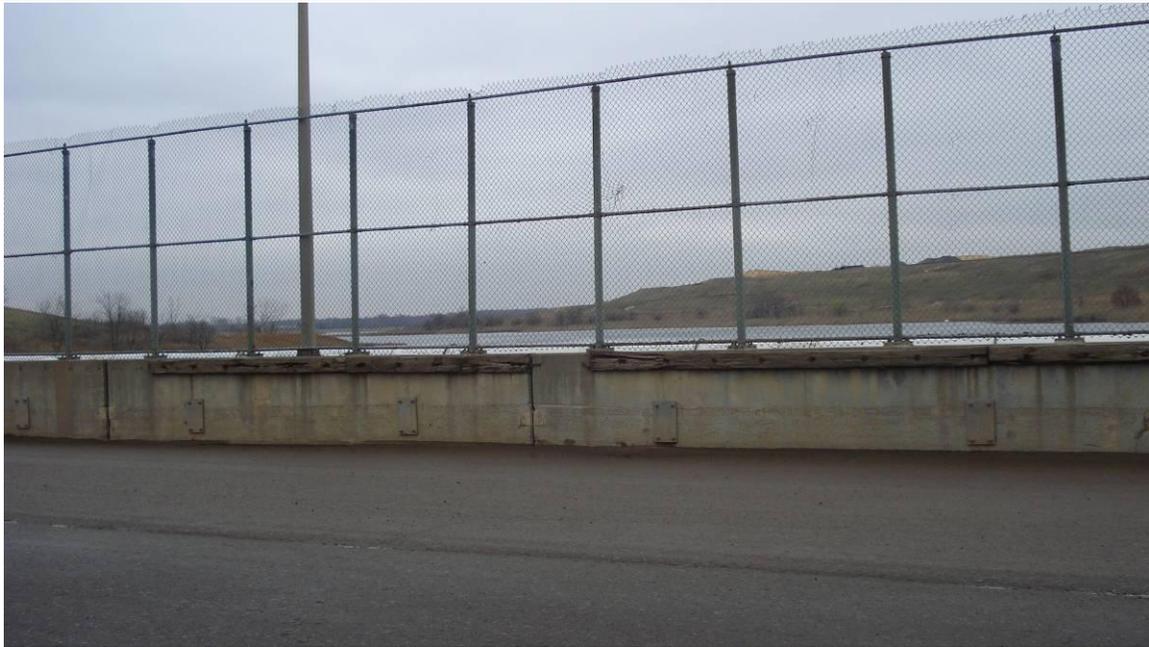
Photo No.: MC59

Location: North parapet Spans 16, 17 and 18 looking southwest.

Description: Concrete is sound. Timber rub rail is deteriorated. Fence in fair condition.

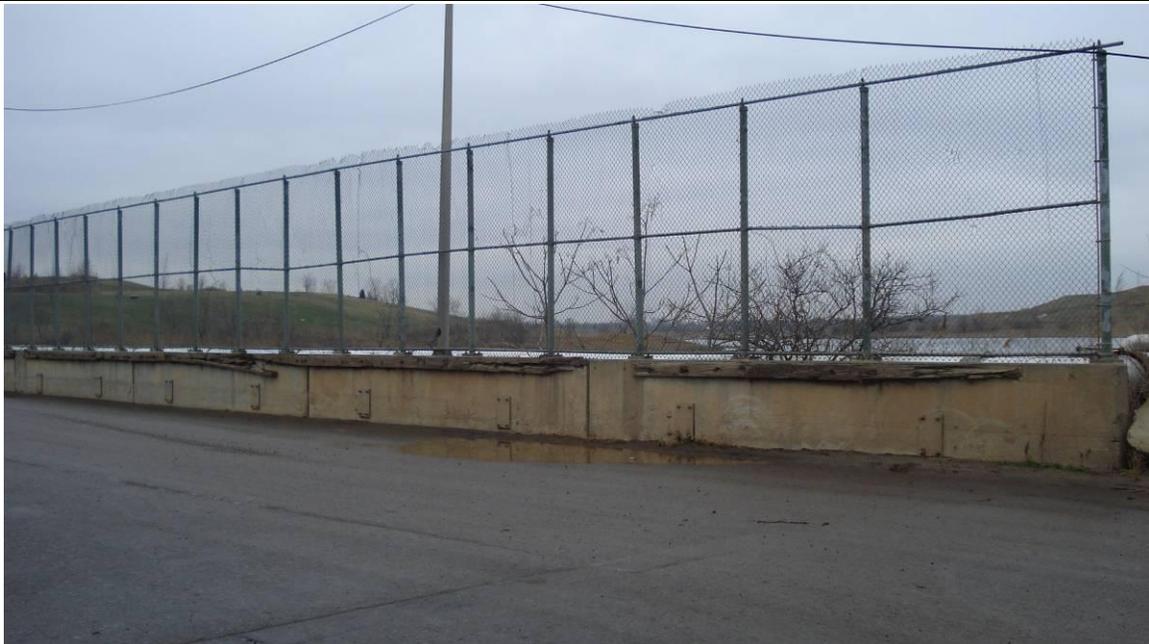
Photo No.: MC60

Location: North parapet Spans 19, 20, and 21 looking northwest.

Description: Concrete is sound. Timber rub rail is badly deteriorated. Fence in fair condition.

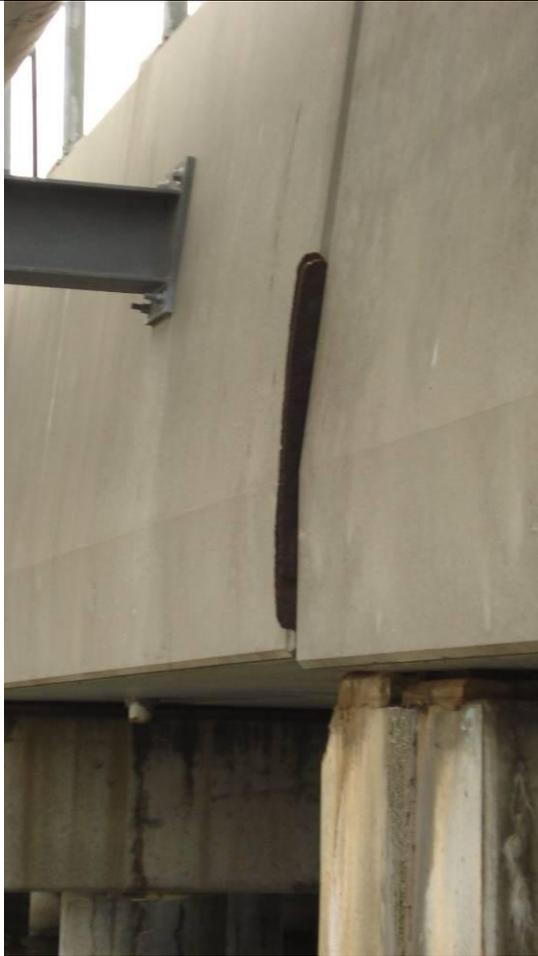
Photo No.: MC61
Location: Pier 65 north fascia.
Description: Bituminous joint filler between adjacent parapet sections working out. Note water stains on end face of cap beam.

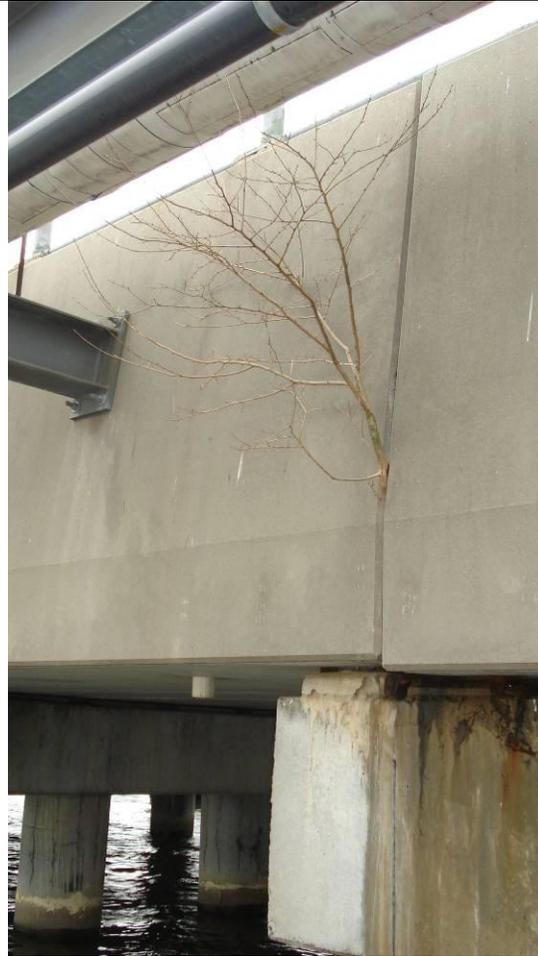
Photo No.: MC62
Location: Pier 5 north fascia.
Description: Bituminous filler between spans has worked out, allowing vegetation to grow out of the earth fill.

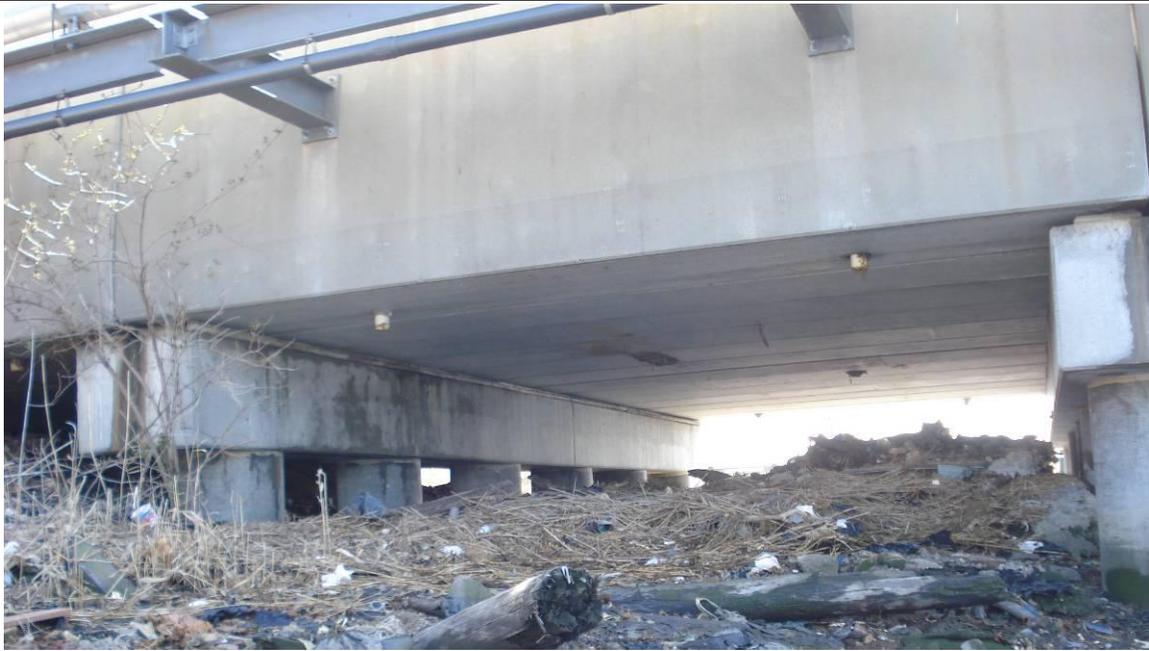
Photo No.: MC63

Location: Span 19 underside of superstructure looking south.

Description: General view. Undersides of prestressed slabs are in good condition. Note staining from debris contacting the underside at high water.

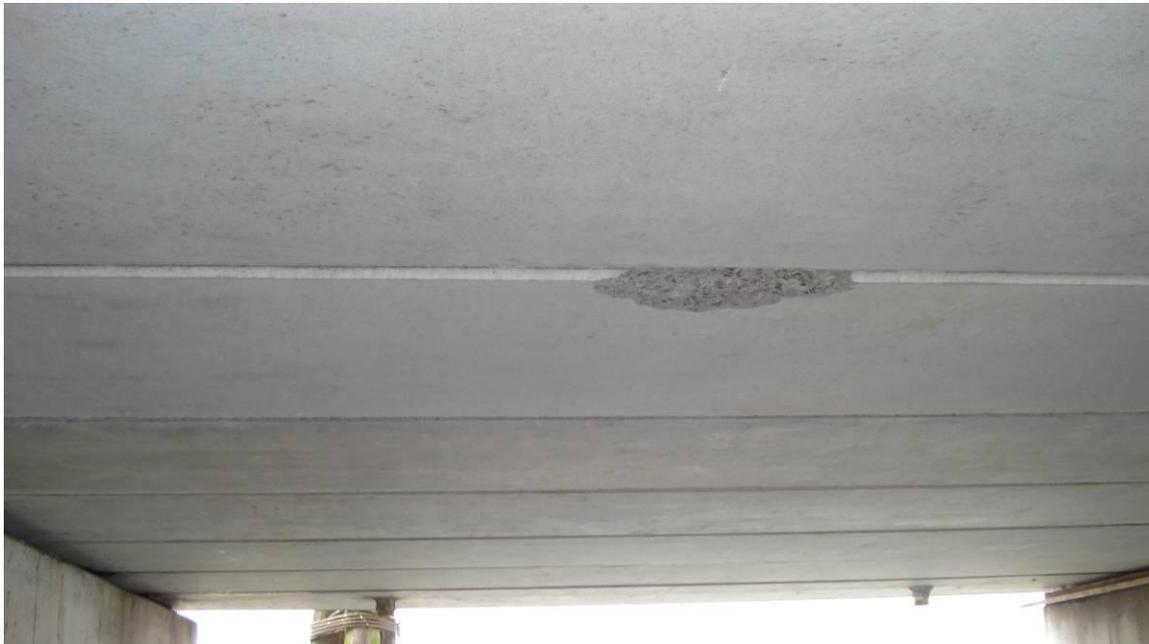
Photo No.: MC64

Location: Span 6 underside of superstructure.

Description: Undersides of prestressed slabs are in good condition. Note small damaged area on Slab 6, likely caused in handling during construction. Damage is inconsequential.

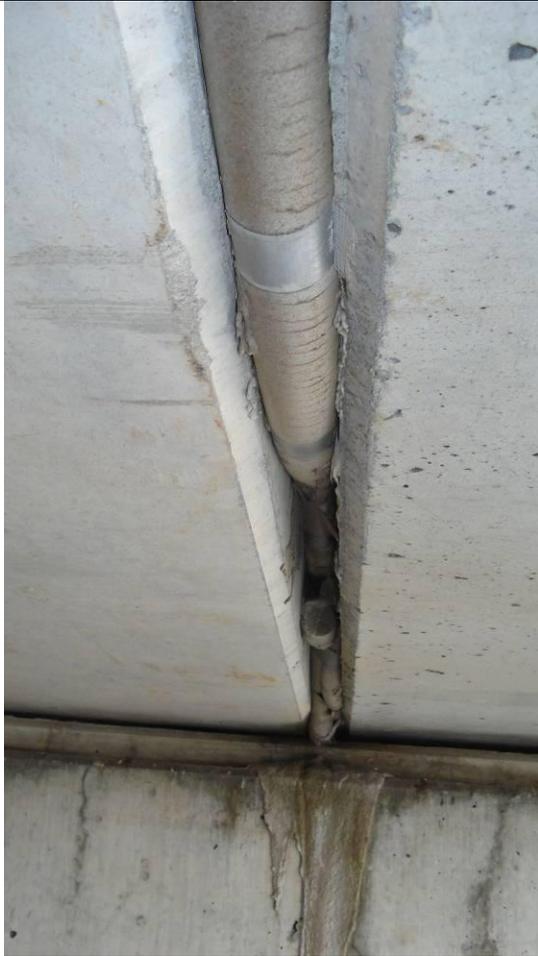
Photo No.: MC65
Location: Span 11 underside of superstructure between Slabs 12 and 13.
Description: Foam filler rods working out . Gap is larger than typical.

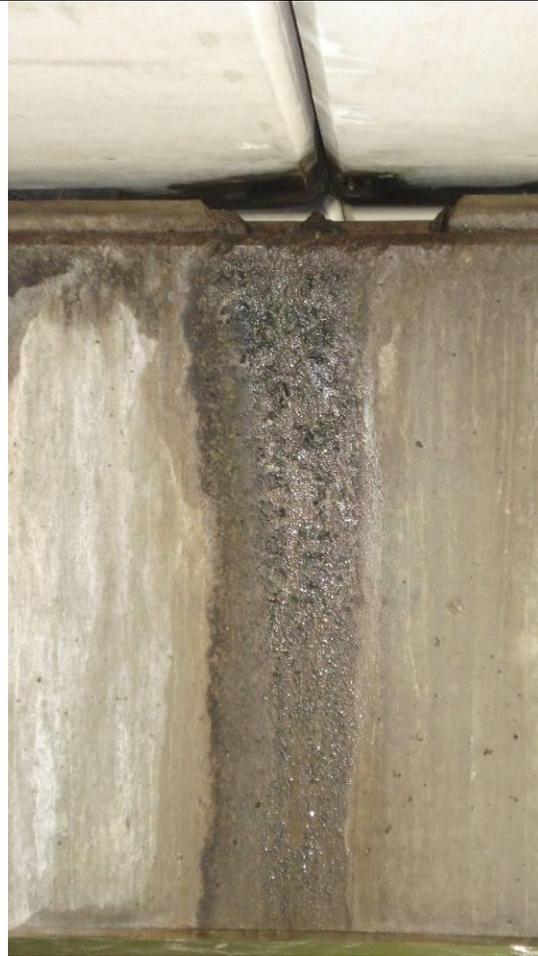
Photo No.: MC66
Location: Pier 5, east face at Slabs 11 and 12.
Description: Active water leakage, either through the deck joints or cracks in the deck.

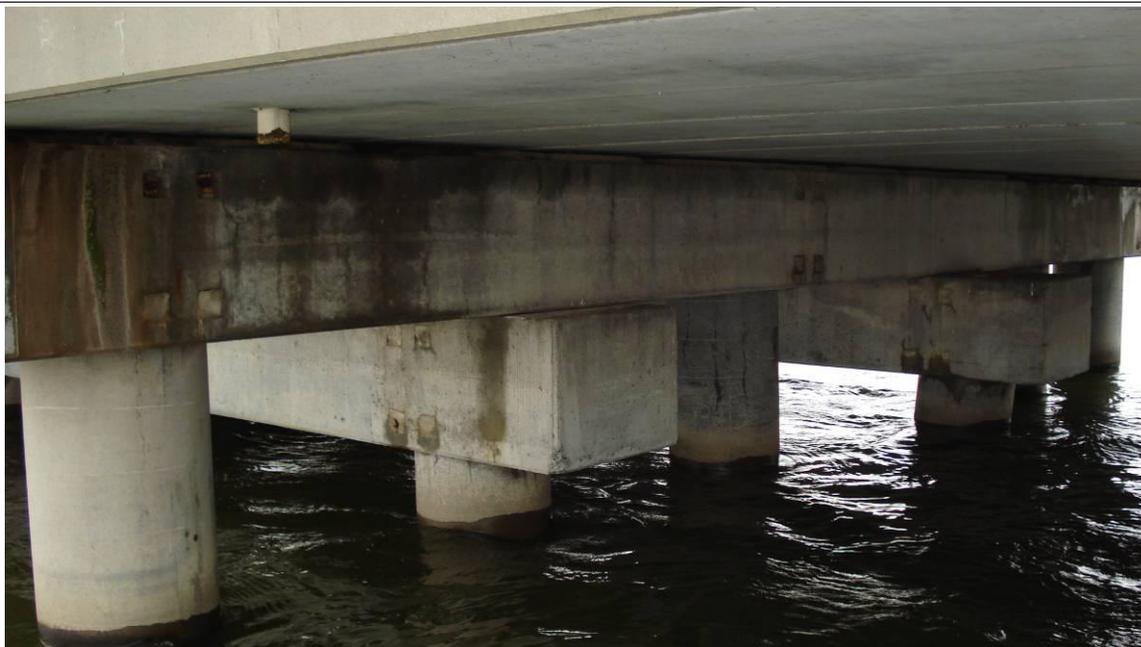
Photo No.: MC67

Location: Pier 9, west face.

Description: .Extensive active water leakage is typical for many piers. Note sub-cap beams. Two piles were driven out-of-plumb, which was corrected by adding the sub-cap beams.

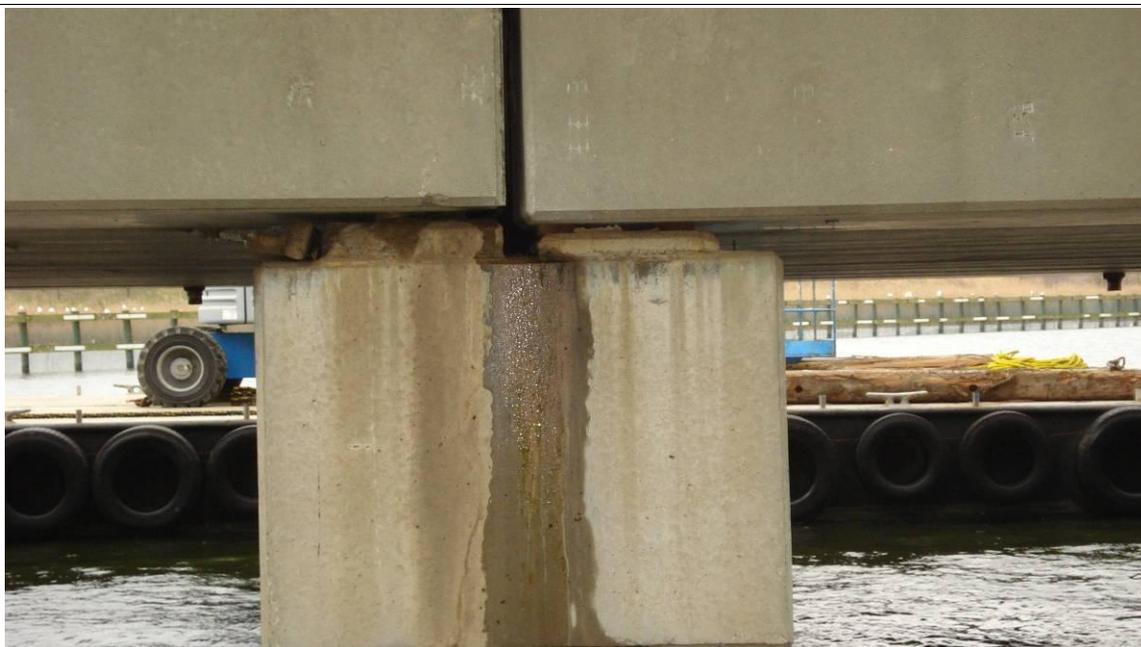
Photo No.: MC68

Location: Pier 7, north fascia.

Description: Active water leakage may be through deck joint, between parapet sections or through deck cracks. Typical for many locations.

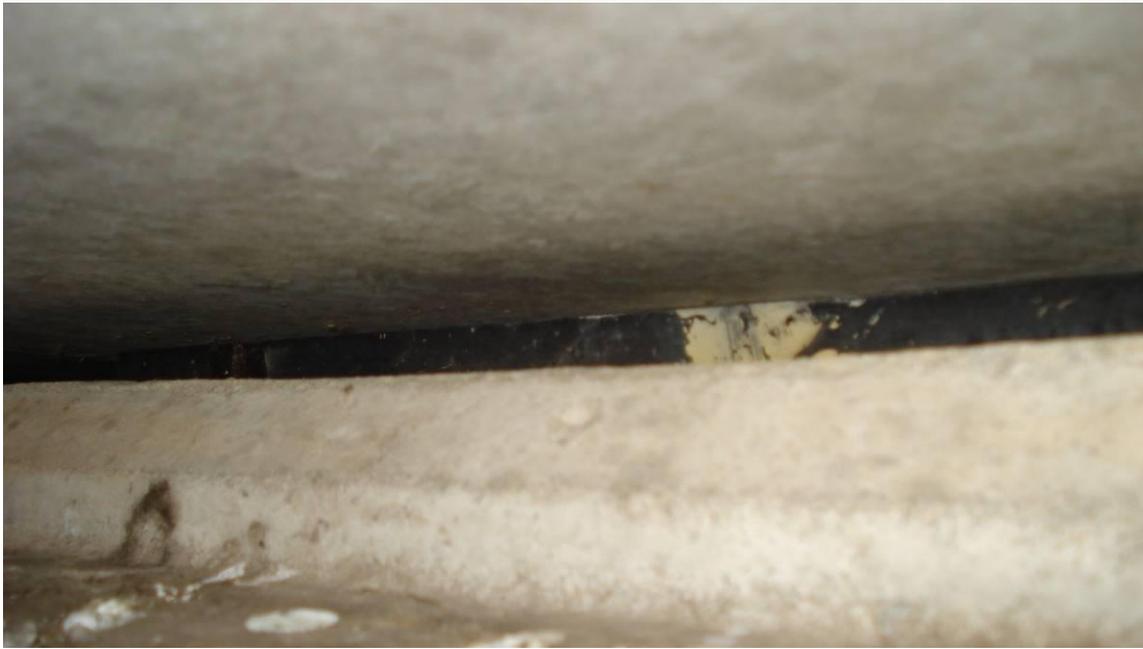
Photo No.: MC69

Location: Pier 4 Slab 6.

Description: Typical elastomeric bearing pad in good condition.

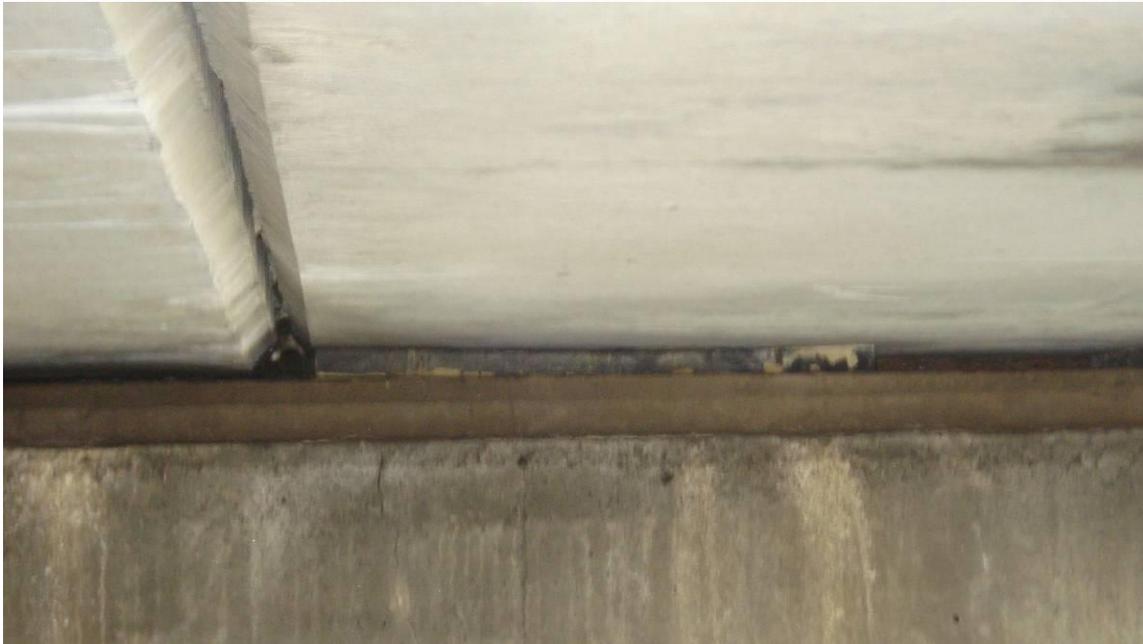
Photo No.: MC70

Location: P11, Slab 2.

Description: Bearing pad is slightly damaged, probably during construction. Bearing is still functioning as designed.

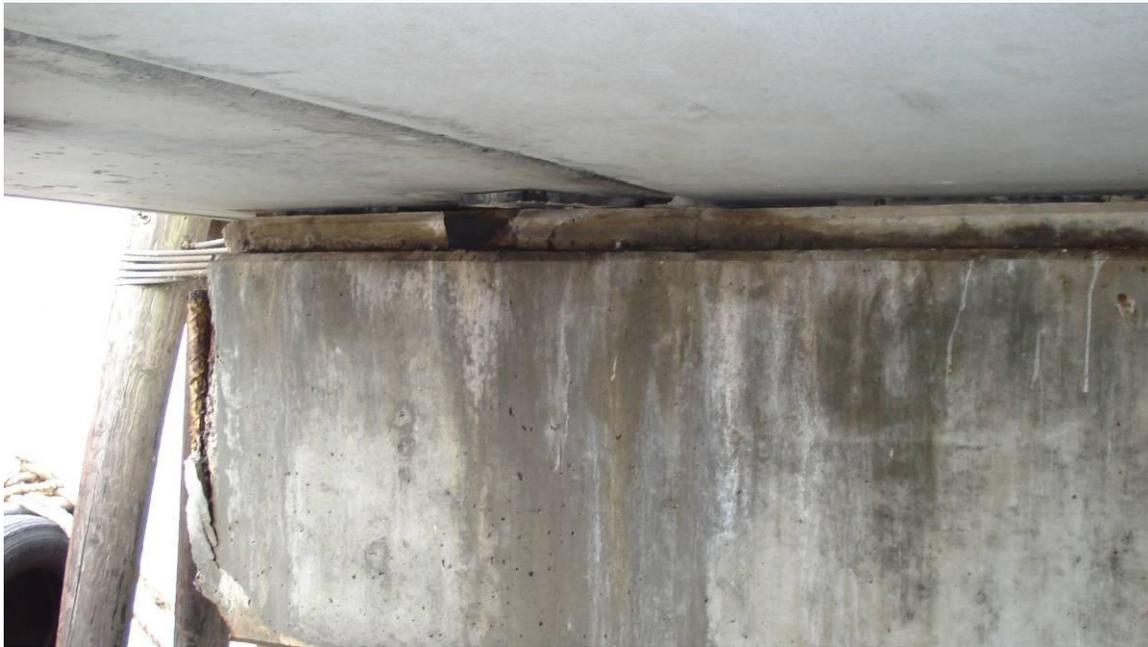
Photo No.: MC71

Location: Pier 6 east face, Slab 1, south fascia.

Description: Portion of an elastomeric bearing pad is projecting out. It could not be determined if the bearing pad has torn and moved, or if this was used as a shim of some kind during construction.

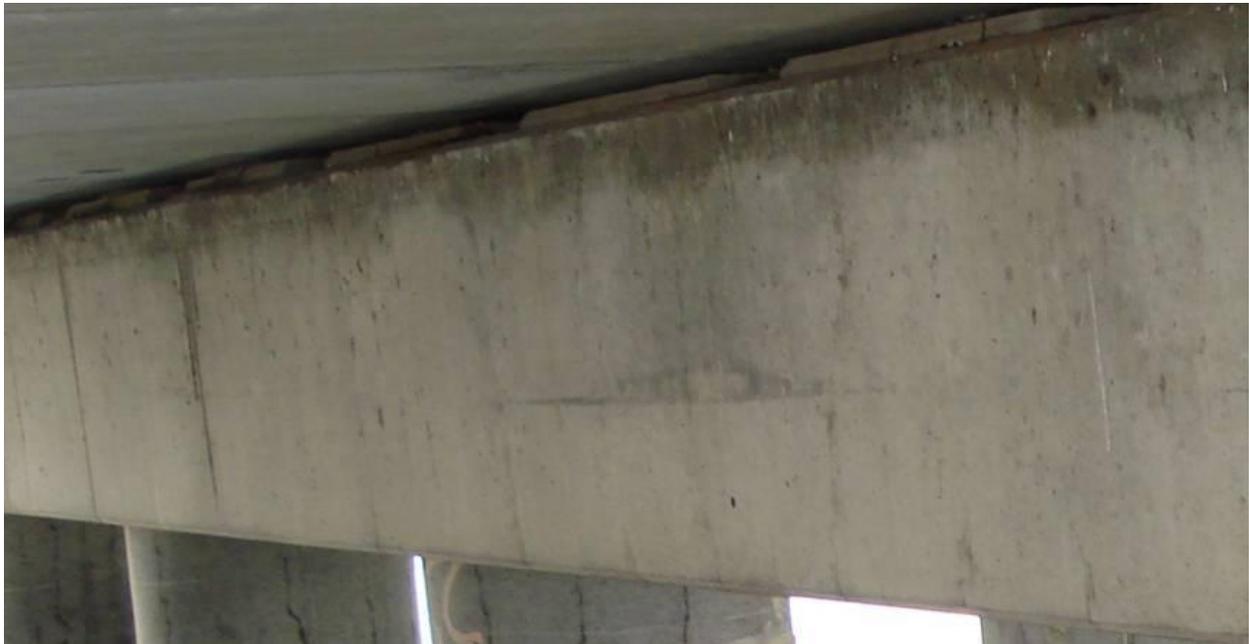
Photo No.: MC72

Location: Pier 5.

Description: Typical pedestals, generally in good condition.

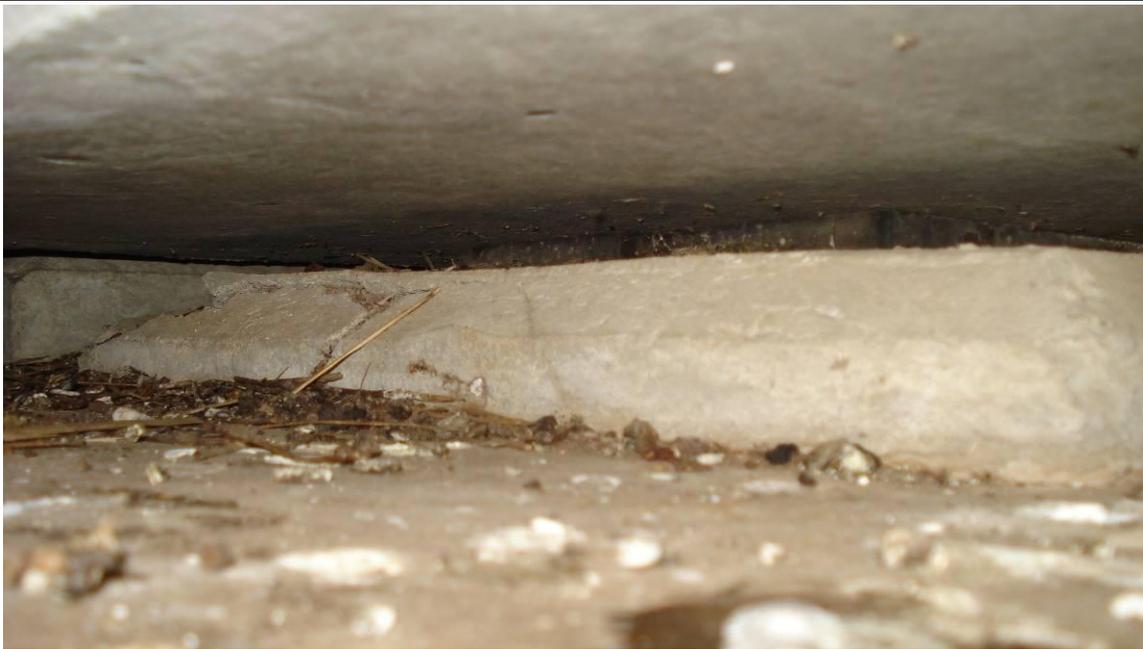
Photo No.: MC73

Location: Pier 4, Slab 4

Description: Close view of pedestal. Typical. Concrete is sound. Bearing is in good condition.

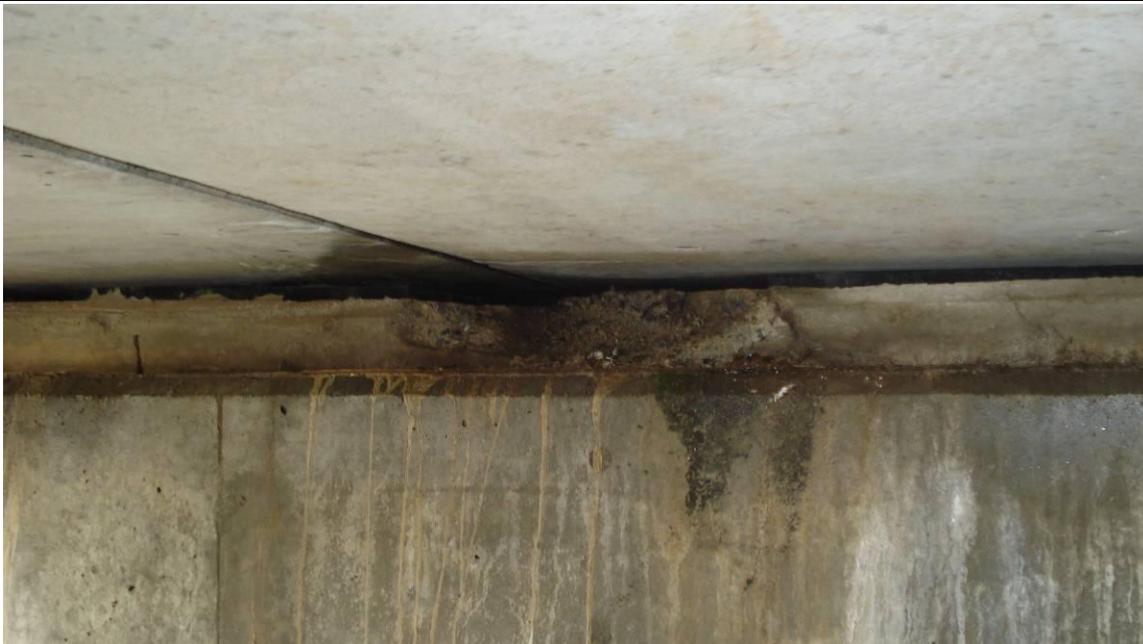
Photo No.: MC74

Location: Pier 12, west face, Slabs 1 and 2

Description: Typical small spall in pedestal. Bearing is not undermined. Condition is minor.

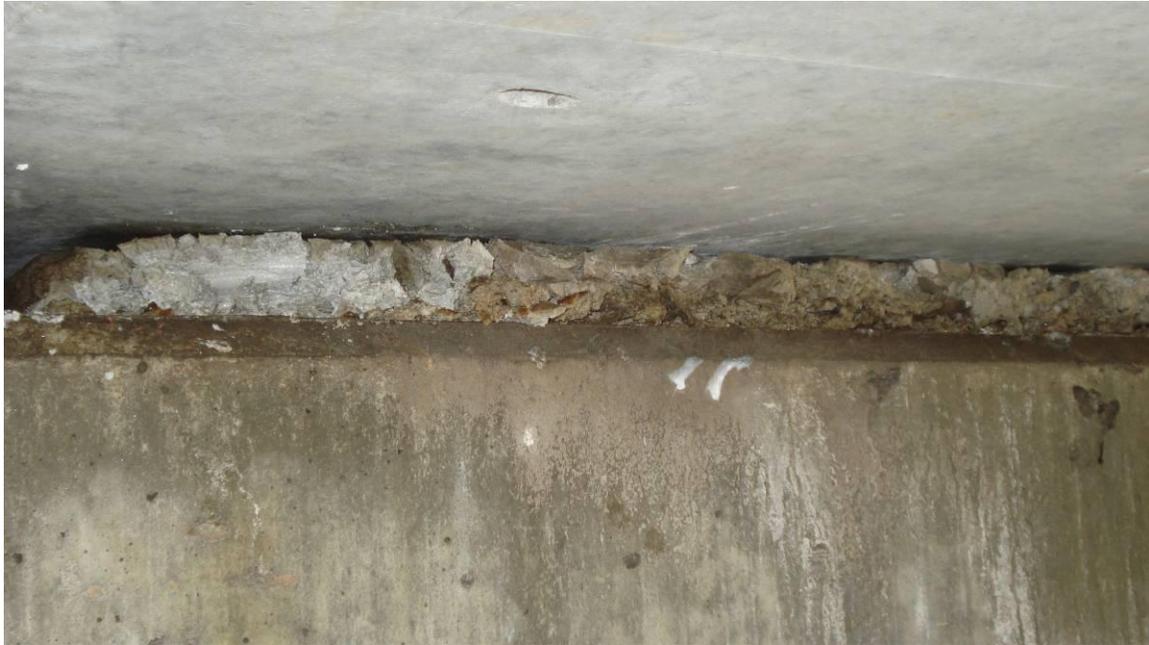
Photo No.: MC75

Location: Pier 13, east face, Slab 3.

Description: Pedestal concrete is soft and crumbling.

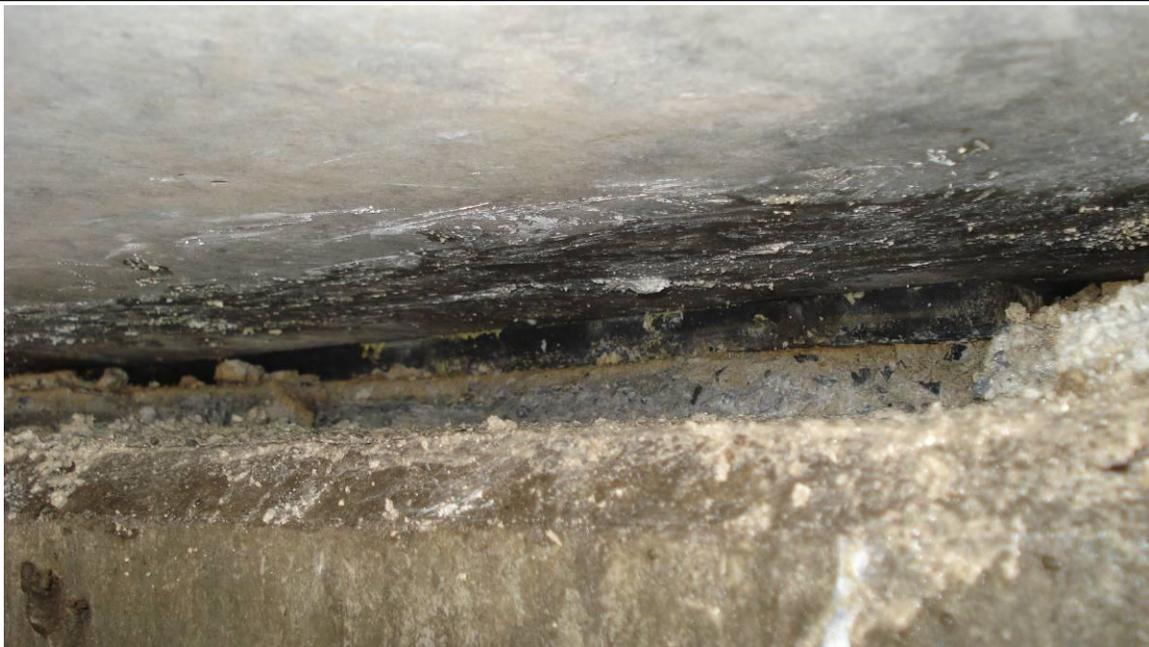
Photo No.: MC76

Location: Same as MC75.

Description: Soft pedestal concrete removed with a chipping hammer down to sound concrete. The bearing is not undermined, and is in good condition.

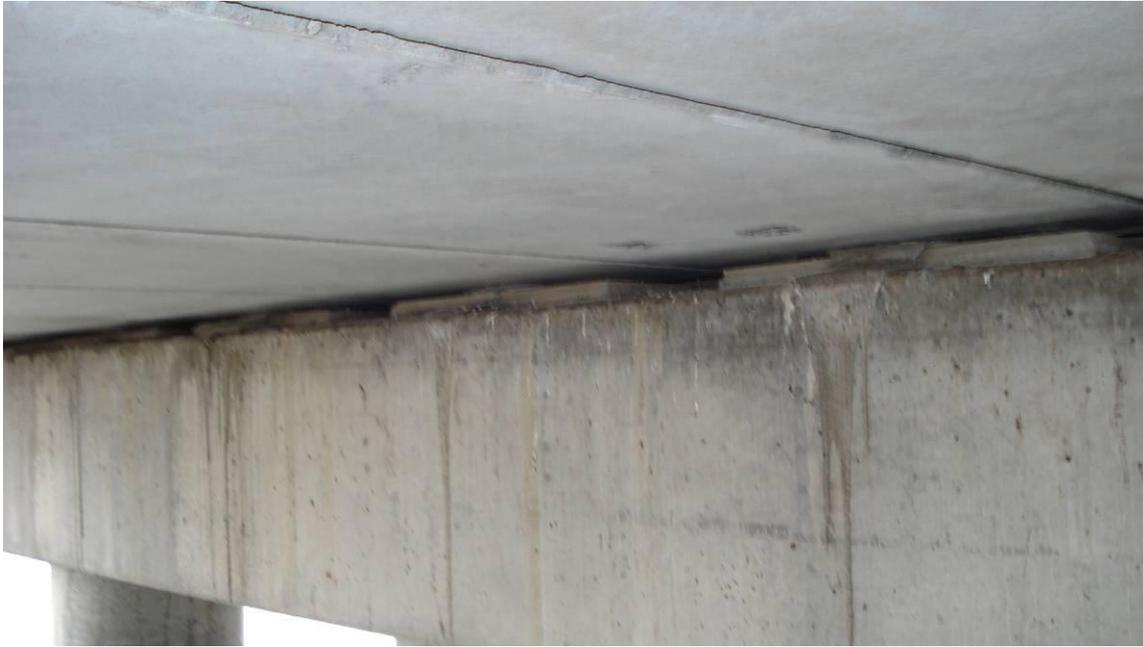
Photo No.: MC77

Location: Pier 5.

Description: Grout from bearing installation overflowed onto pedestal and face of pier cap. Condition is unsightly but inconsequential.

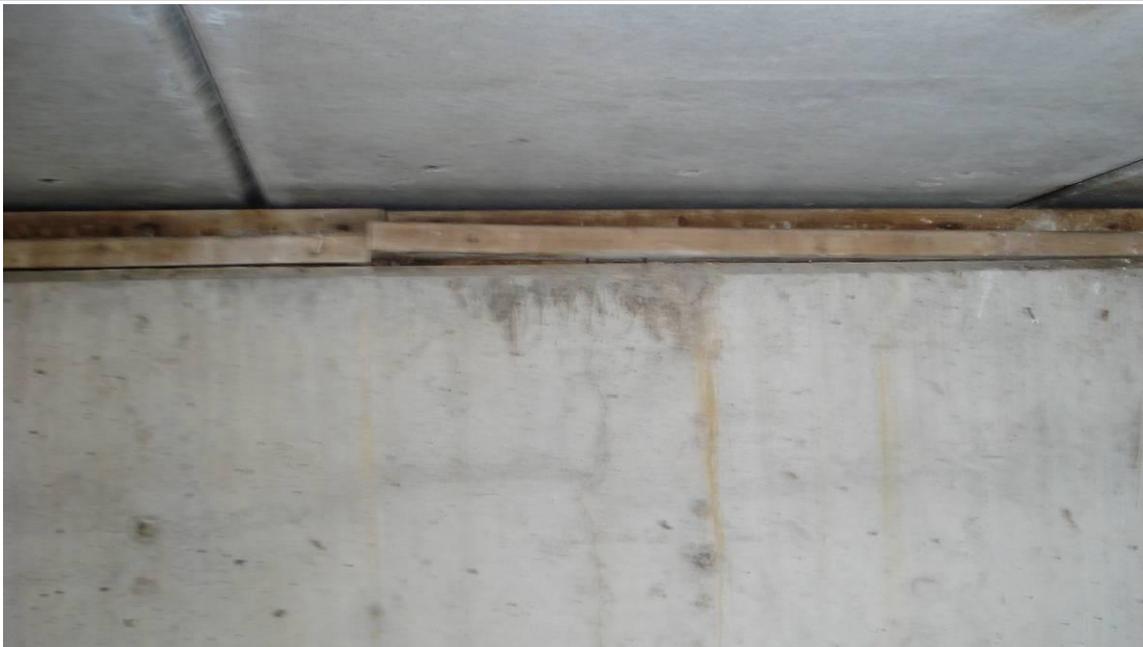
Photo No.: MC78

Location: Pier 12, west face, slabs 1 and 2.

Description: Typical small spall in pedestals. Bearing is not undermined. Condition prevents visual inspection of bearings and pedestals.

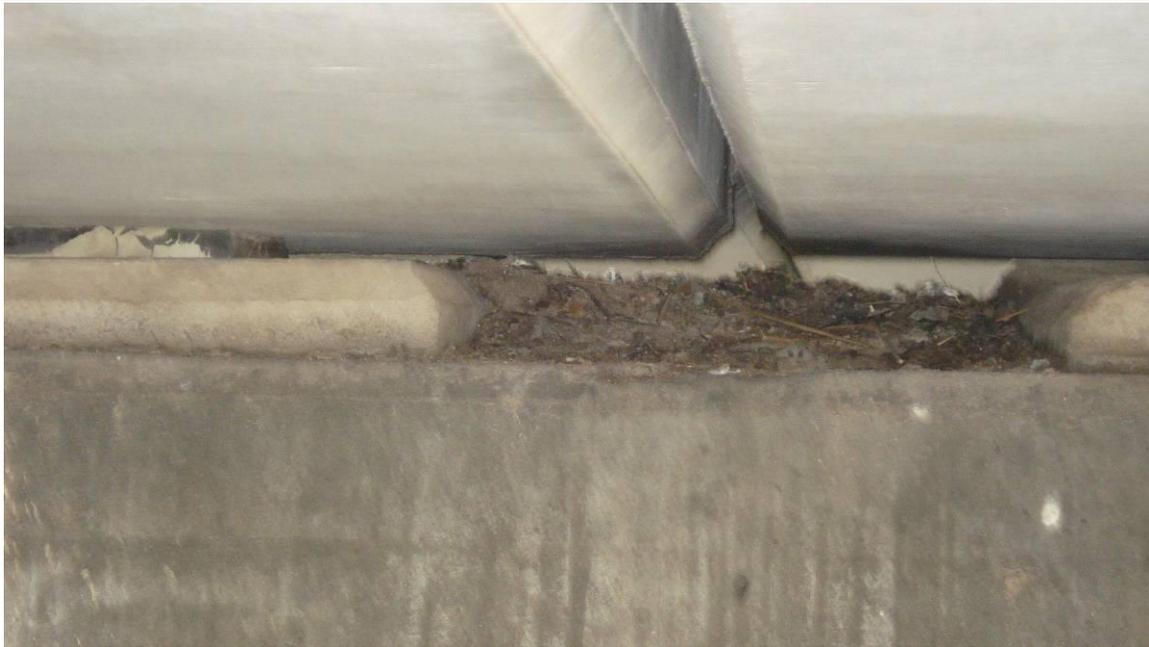
Photo No.: MC79

Location: Pier 11, east face, slabs 5 and 6.

Description: Small accumulation of dirt and debris on top of cap beam. Pedestals and bearings in good condition.

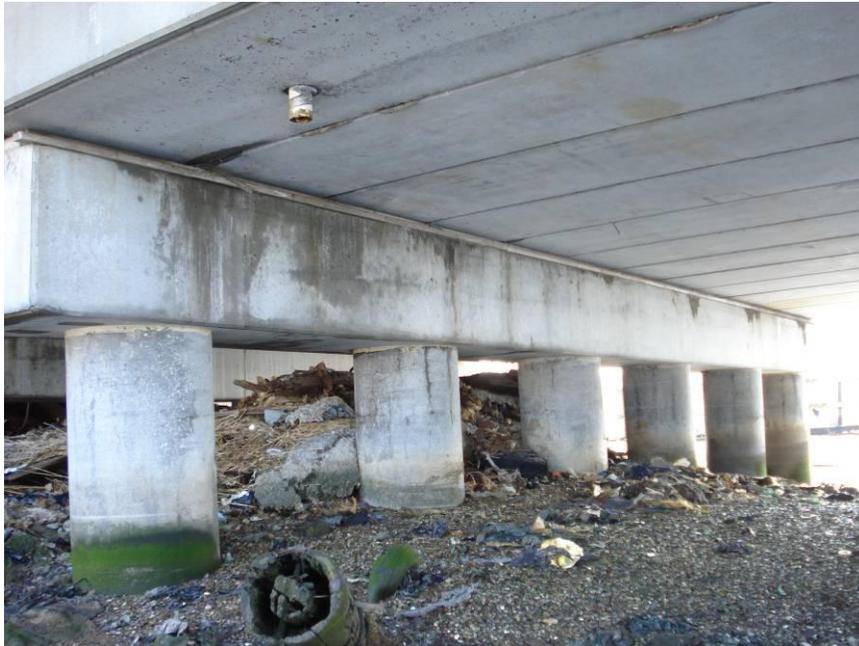
Photo No.: MC80

Location: Pier 18, west face.

Description: Pier caps generally in good condition with only minor cracks and wetness. Typical. Note lumber used in forming pedestals has been left in place.

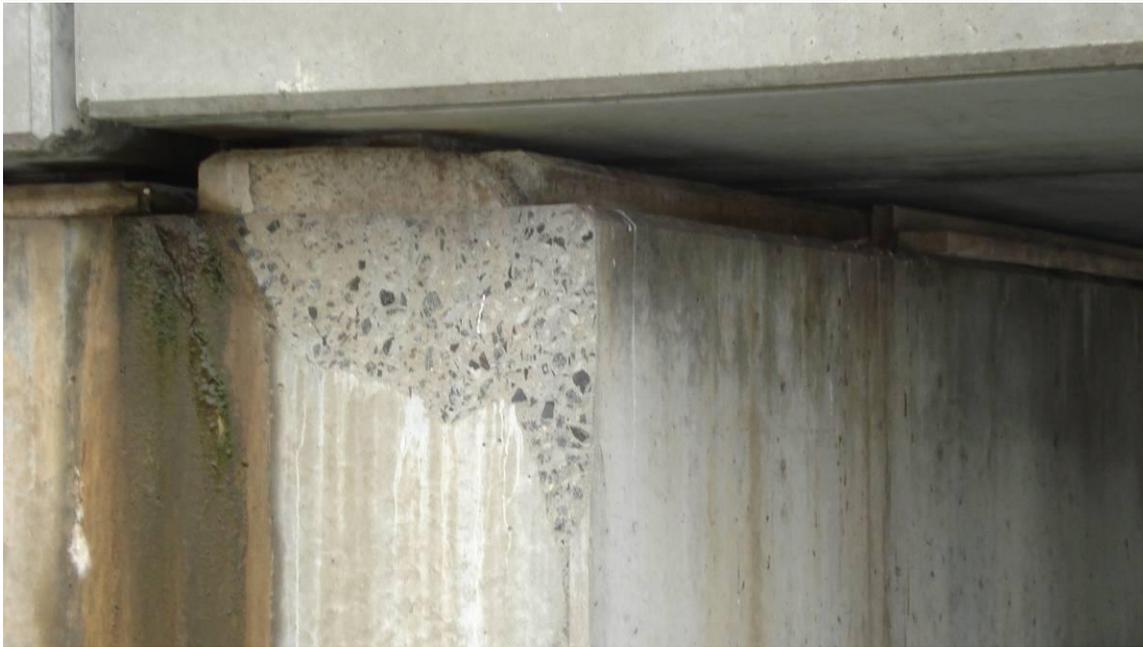
Photo No.: MC81

Location: Pier 4, southeast corner of cap beam.

Description: Small spall in cap beam and pedestal, probably caused during construction. Bearing is not undermined. Note wetness.

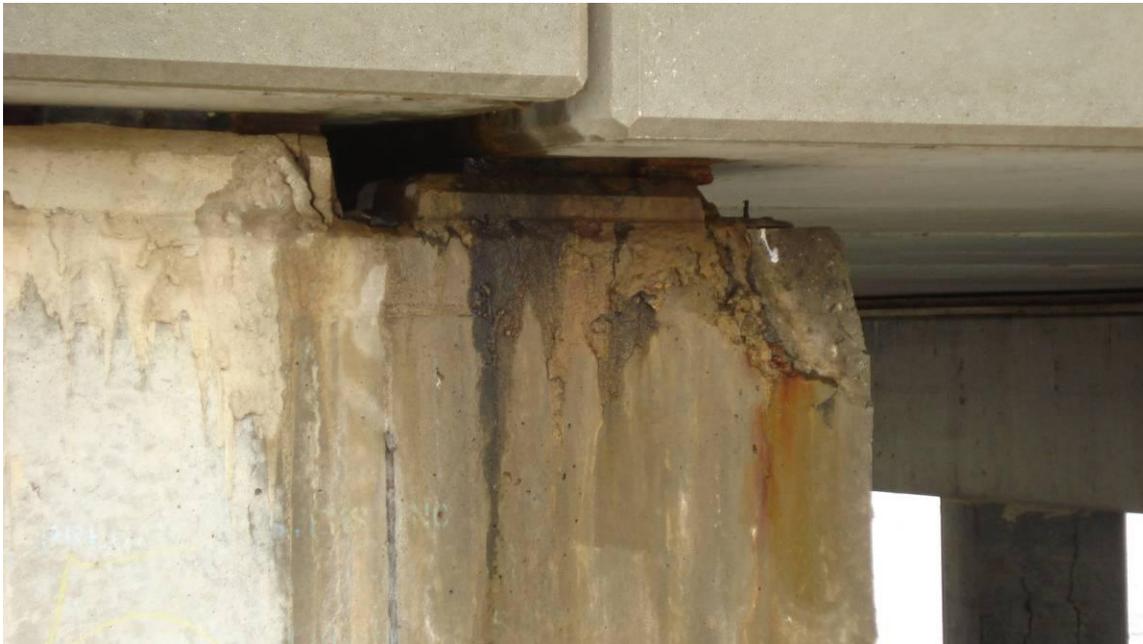
Photo No.: MC82

Location: Pier 5, northwest corner of cap beam.

Description: Small spall, no exposed rebar, probably caused during construction. Bearing is not undermined. Note wetness.

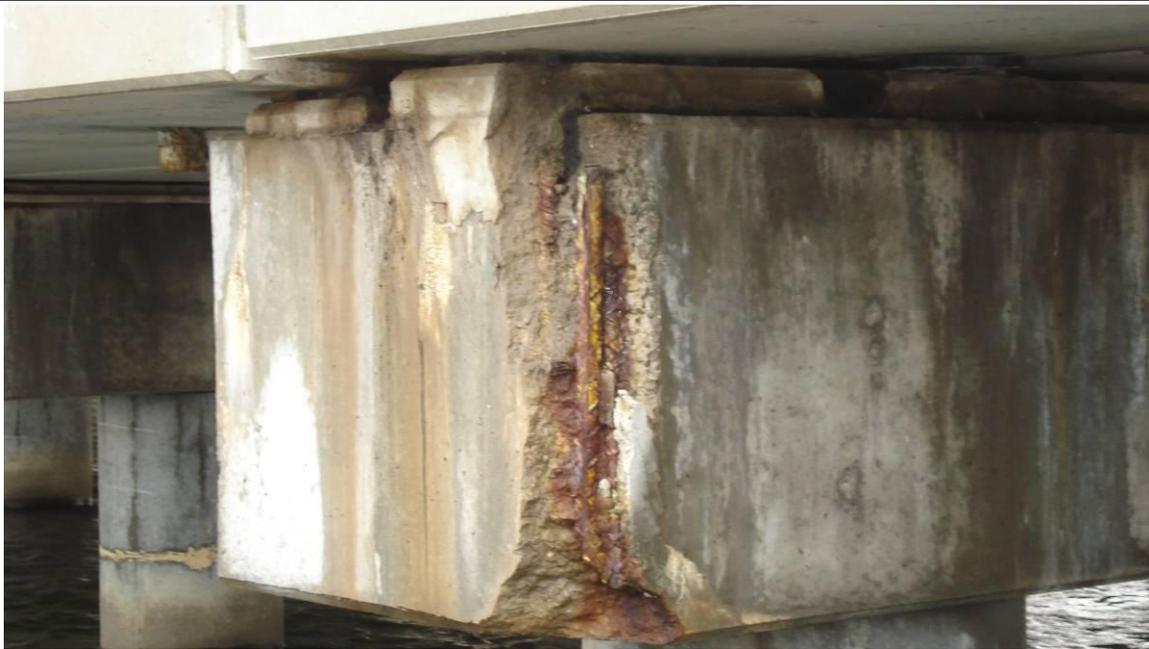
Photo No.: MC83

Location: Pier 6, southeast corner of cap beam.

Description: Large spall in cap beam and pedestal, probably due to water intrusion and corrosion of the rebar. Bearing is not undermined.

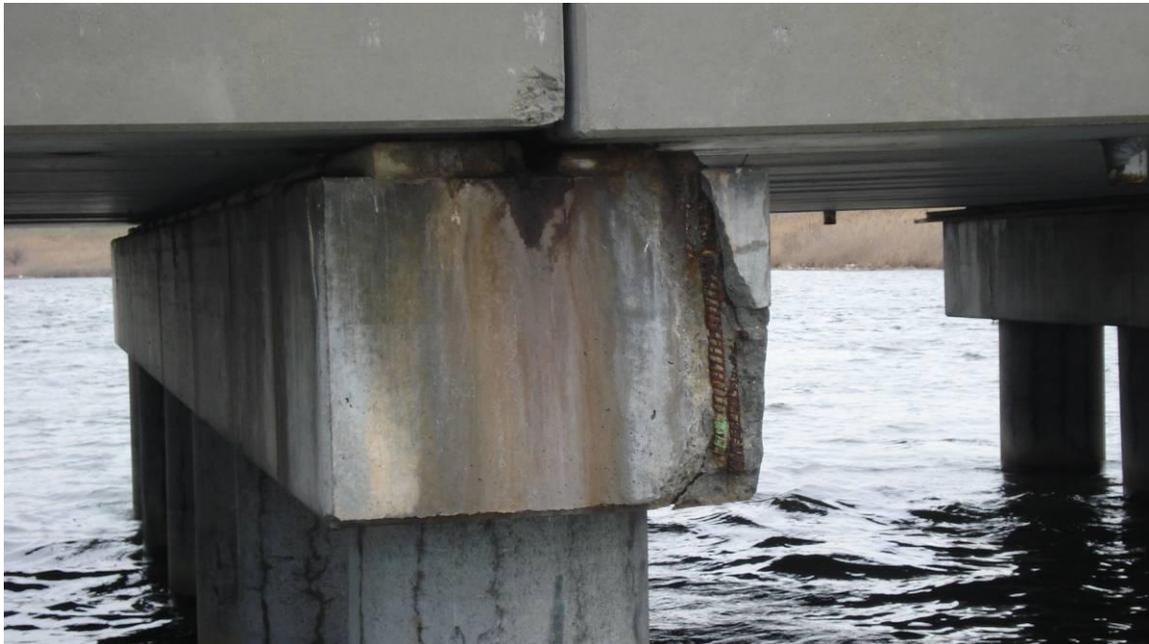
Photo No.: MC84

Location: Pier 12, southeast corner of cap beam.

Description: Large spall, probably due to intrusion of water and corrosion of rebar. Bearing is not undermined. Note wetness.

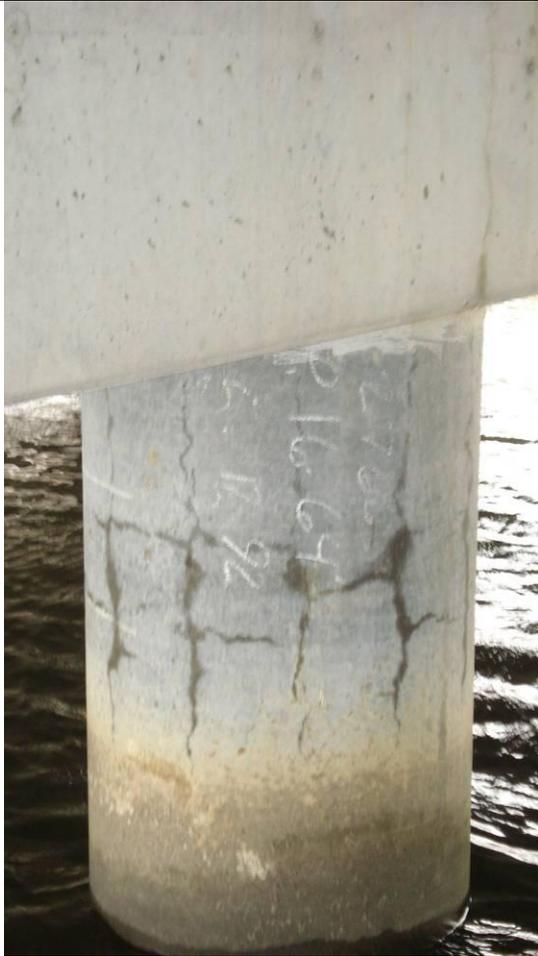
Photo No.: MC85
Location: Pier 4, typical pile.
Description: Good condition with some tight cracks.
