Fresh Kills Park

Phase 3A
Task 8.4.3
**Bridge Inspection
Report**

Final Report

August 2008

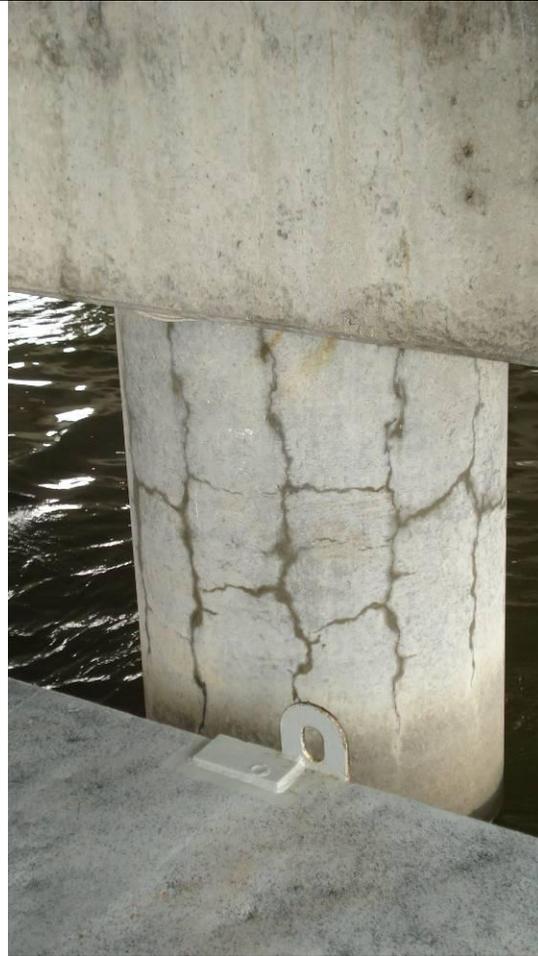
Photo No.: MC86
Location: Pier 4, typical pile.
Description: Good condition with some tight map cracking.

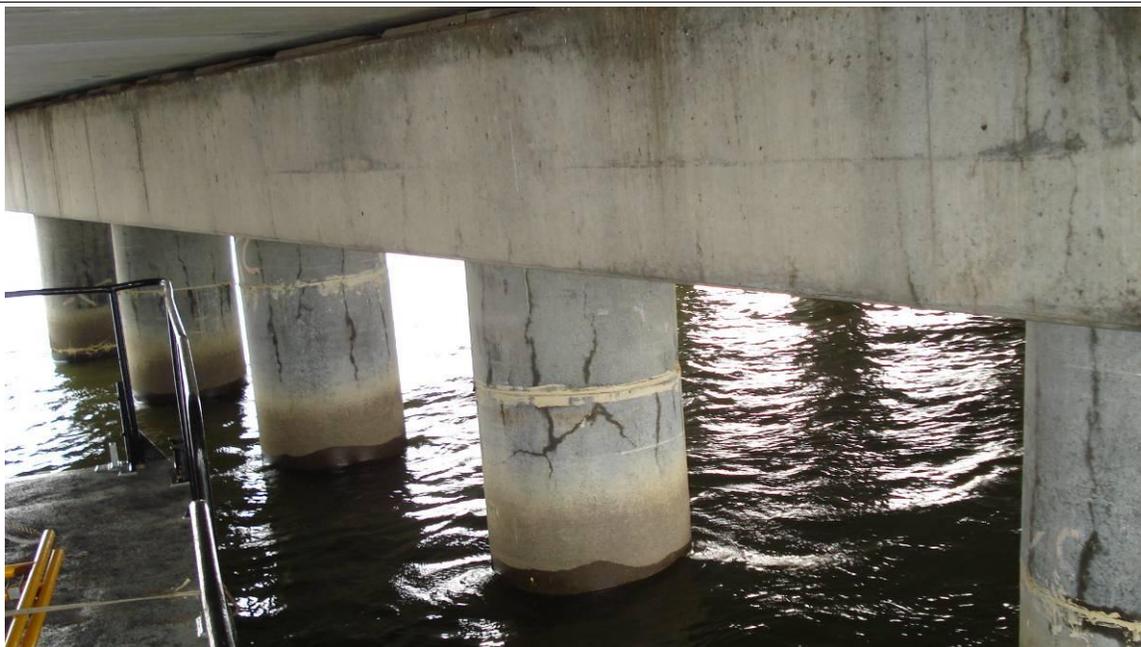
Photo No.: MC87

Location: Pier 5.

Description: Note construction joints where piers were extended. Typical. Joints are grouted tight with no evidence of deterioration.

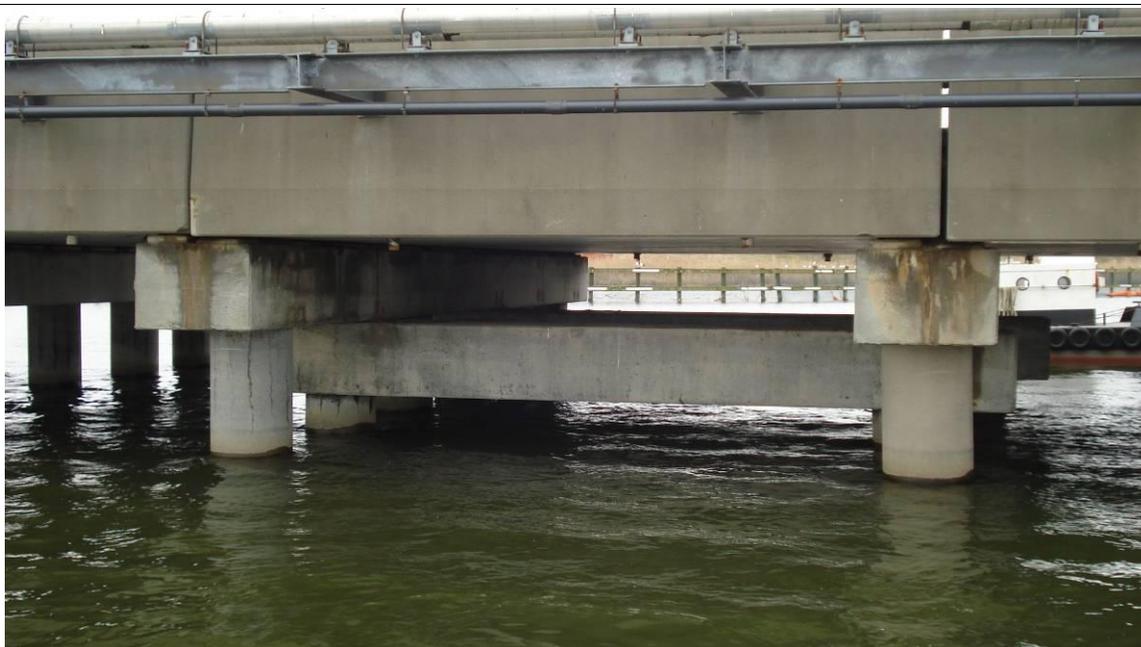
Photo No.: MC88

Location: Span 10, north elevation.

Description: Note sub-cap beams introduced during construction because two piles for Pier 9 were driven too far out-of-plumb to mate with the Pier 9 cap beam.

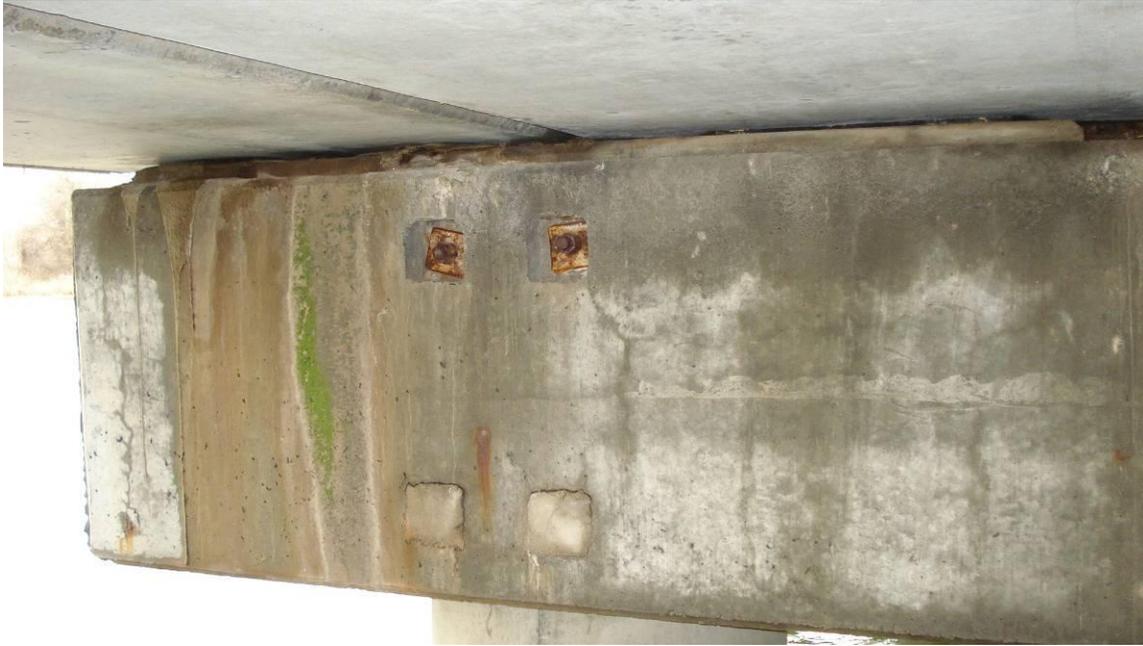
Photo No.: MC89

Location: Pier 9 cap beam, north end, west face.

Description: Note reinforcing rods added through piles. Pockets not grouted at two rods. All other pockets grouted.

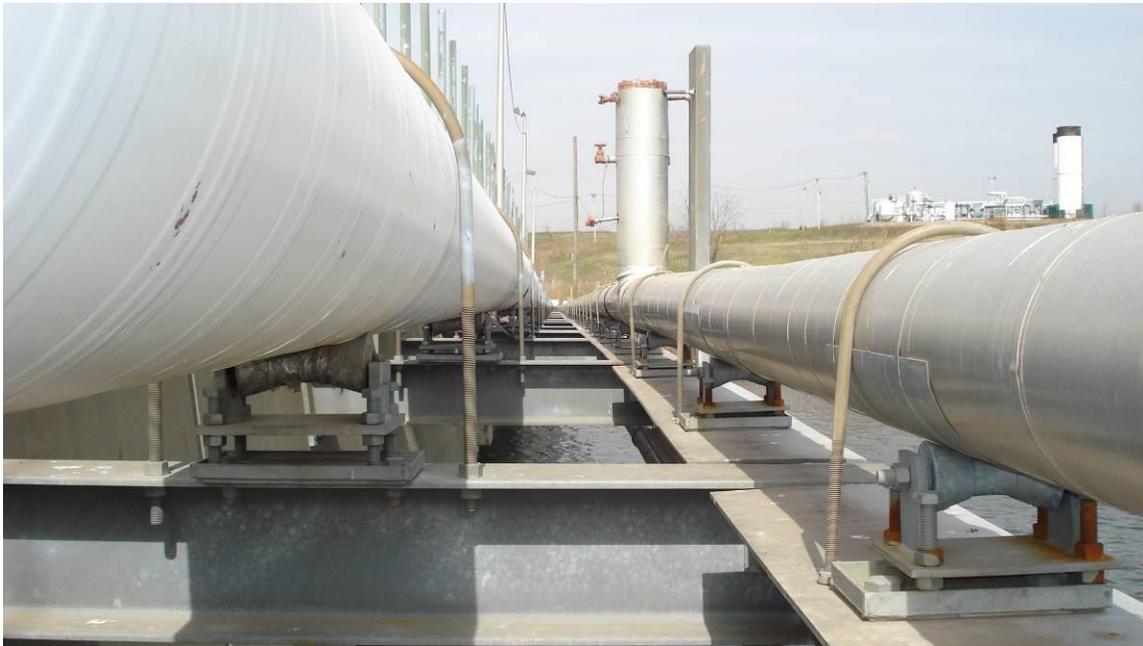
Photo No.: MC90

Location: North fascia, looking west.

Description: Two insulated utility lines supported on galvanized steel brackets cantilevering from the north parapet. The third utility line is below the outboard steel beam. Note the lighting standards.

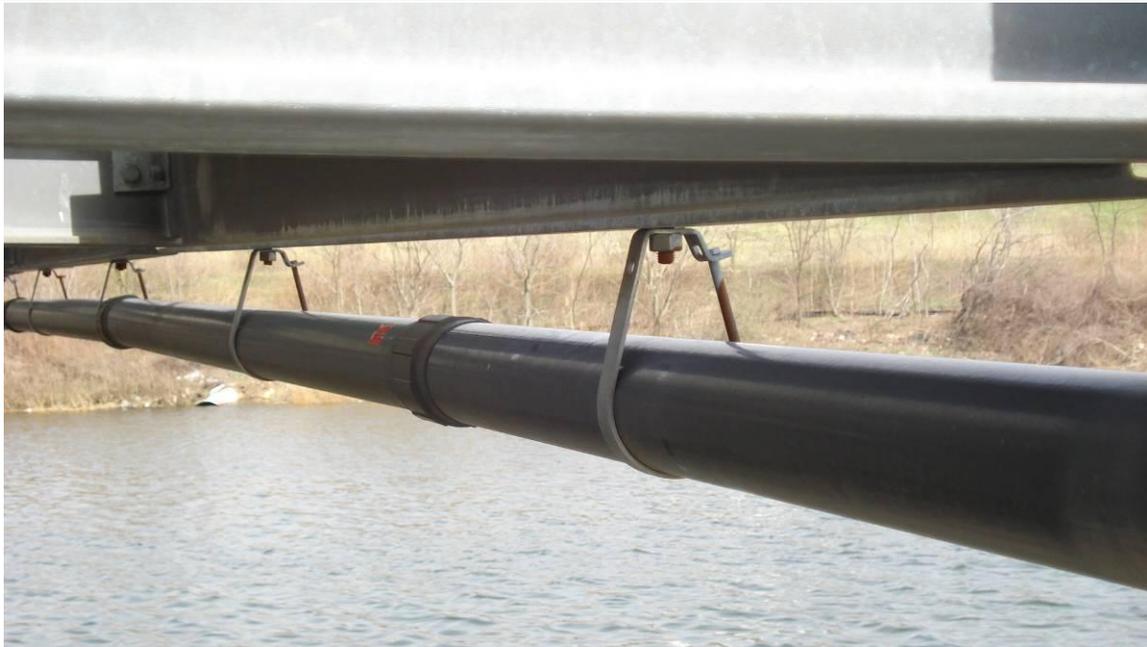
Photo No.: MC91

Location: North fascia, looking west.

Description: Third utility line is hung below the outboard steel beam.

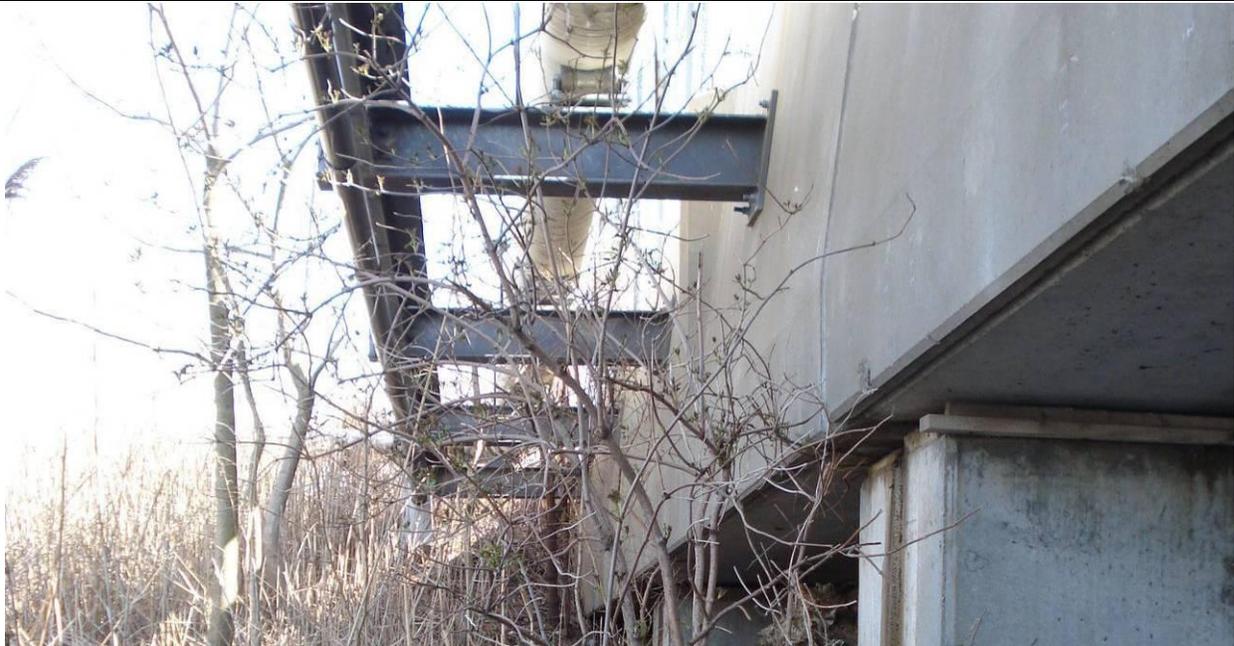
Photo No.: MC92

Location: North fascia, looking east.

Description: Steel supports framed into parapet.

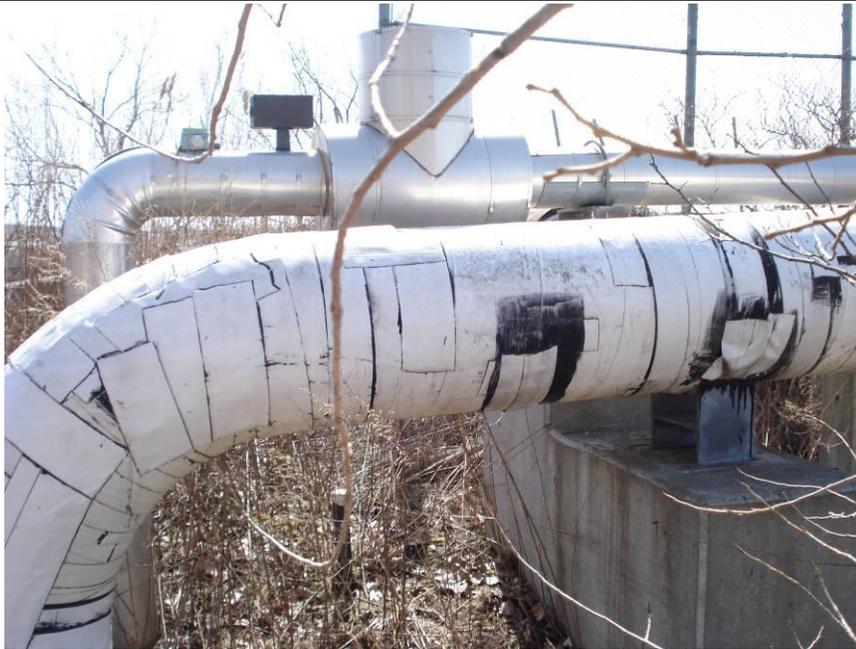
Photo No.: MC93

Location: East approach just north of the bridge, looking south.

Description: Two utility lines turn down and continue underground.

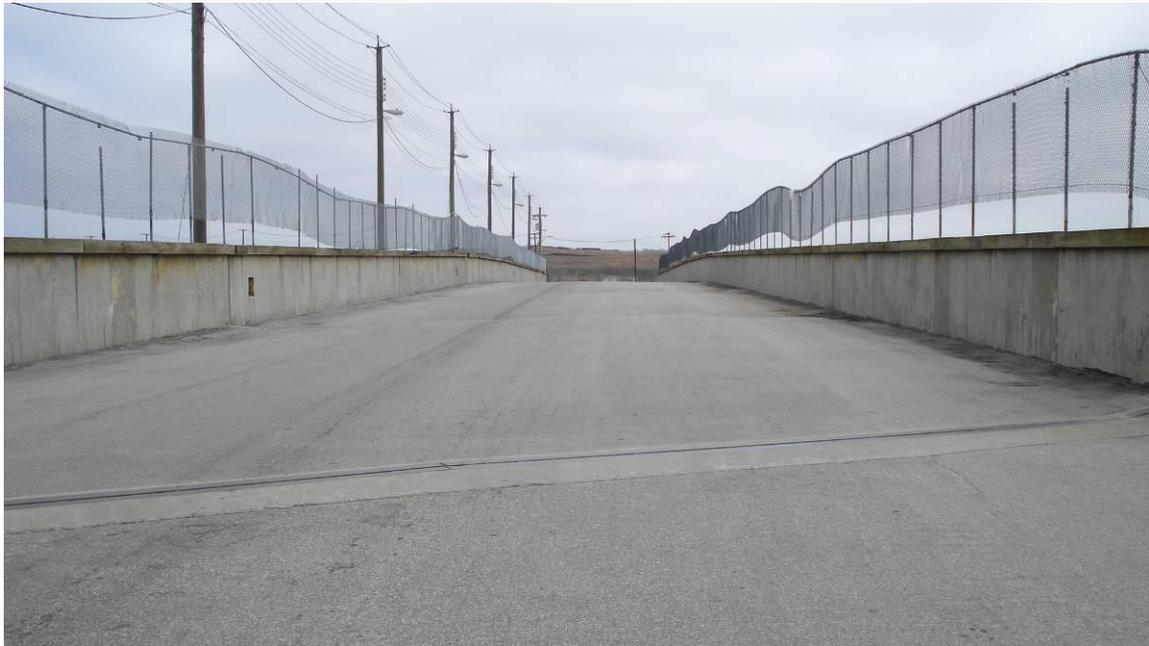
Photo No.: RC01

Location: Bridge roadway, looking east from the west approach.

Description: General configuration.

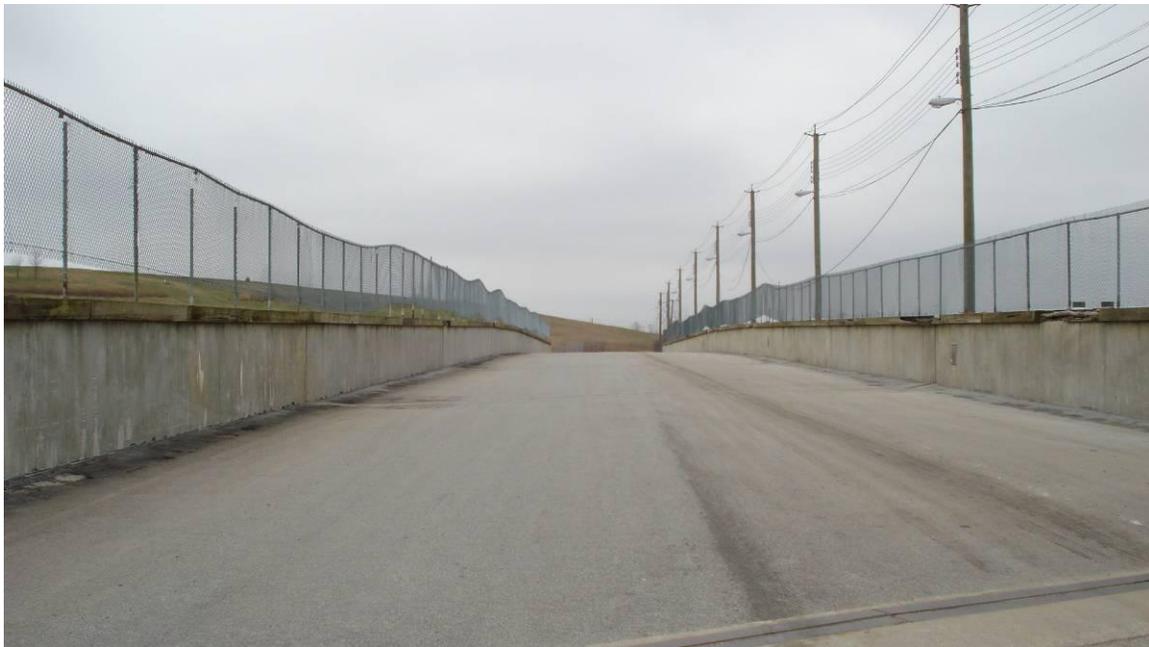
Photo No.: RC02

Location: Bridge roadway, looking west from the east approach.

Description: General configuration.

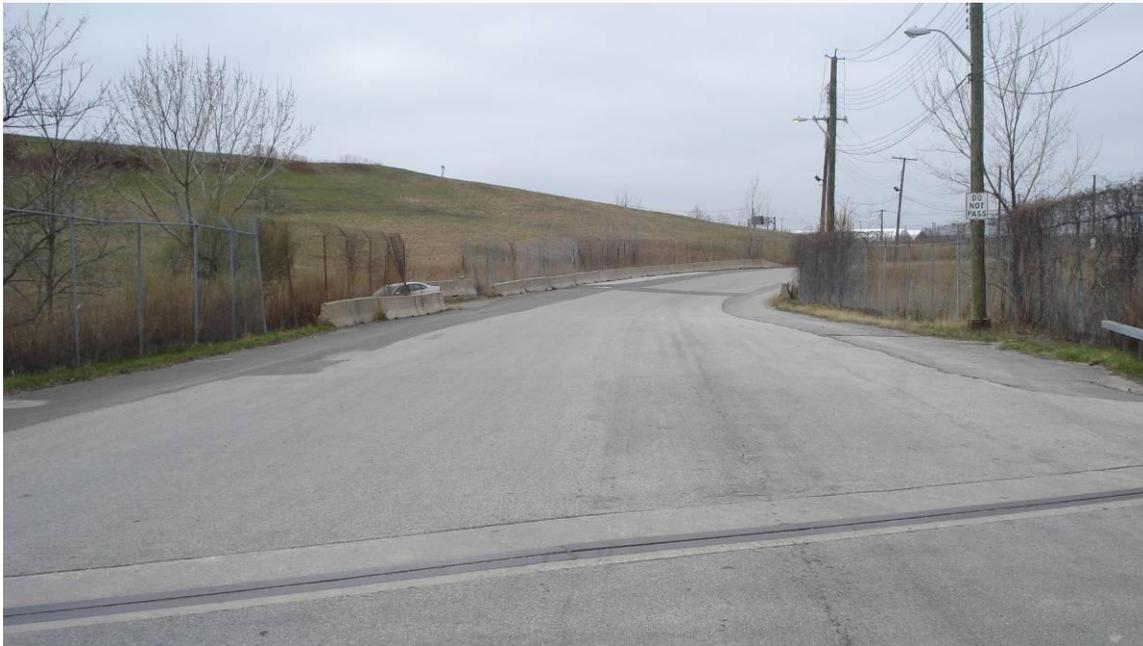
Photo No.: RC03

Location: West approach, looking west from the bridge.

Description: General configuration.

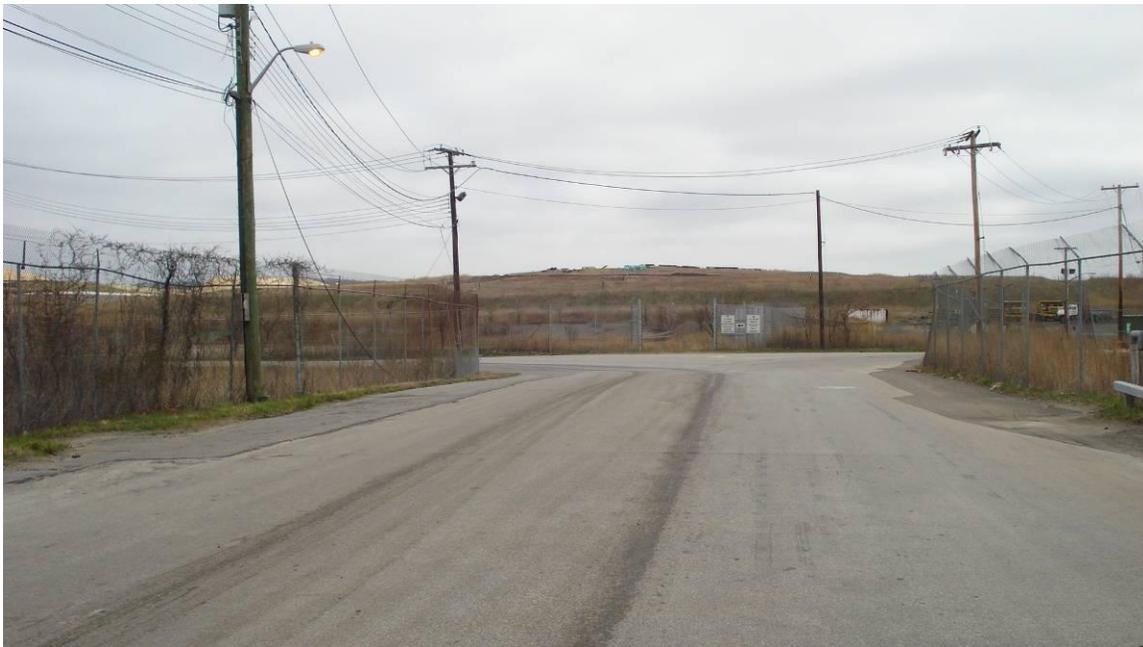
Photo No.: RC04

Location: East Approach, looking east from the bridge.

Description: General configuration.

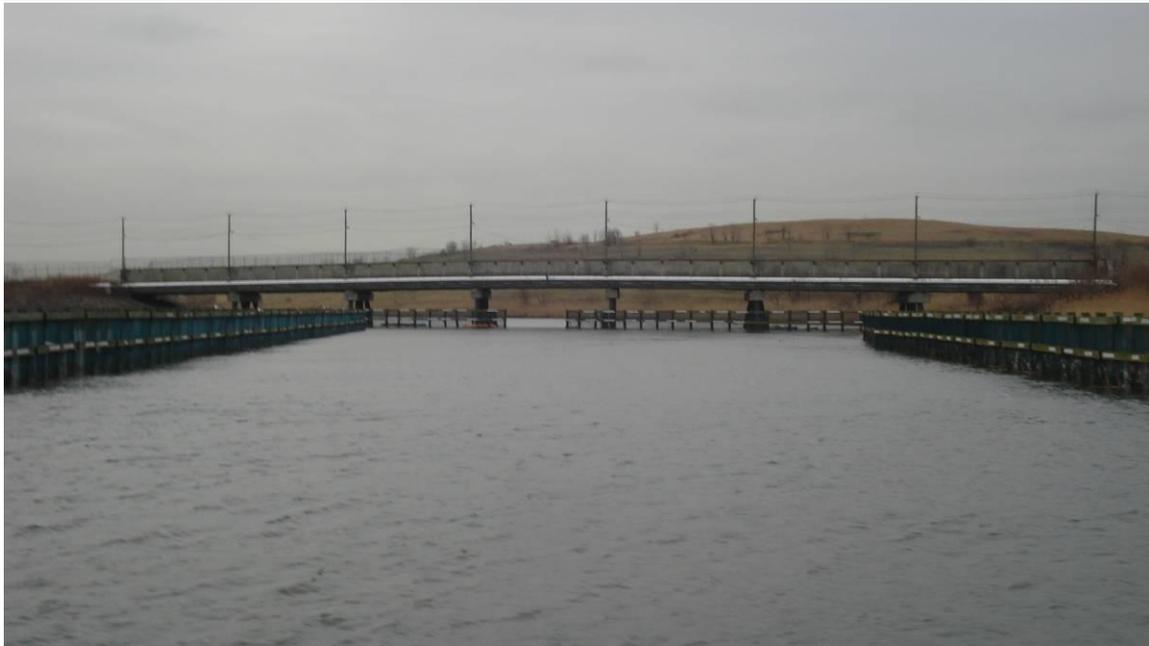
Photo No.: RC05

Location: North elevation.

Description: General configuration. Note debris fences.

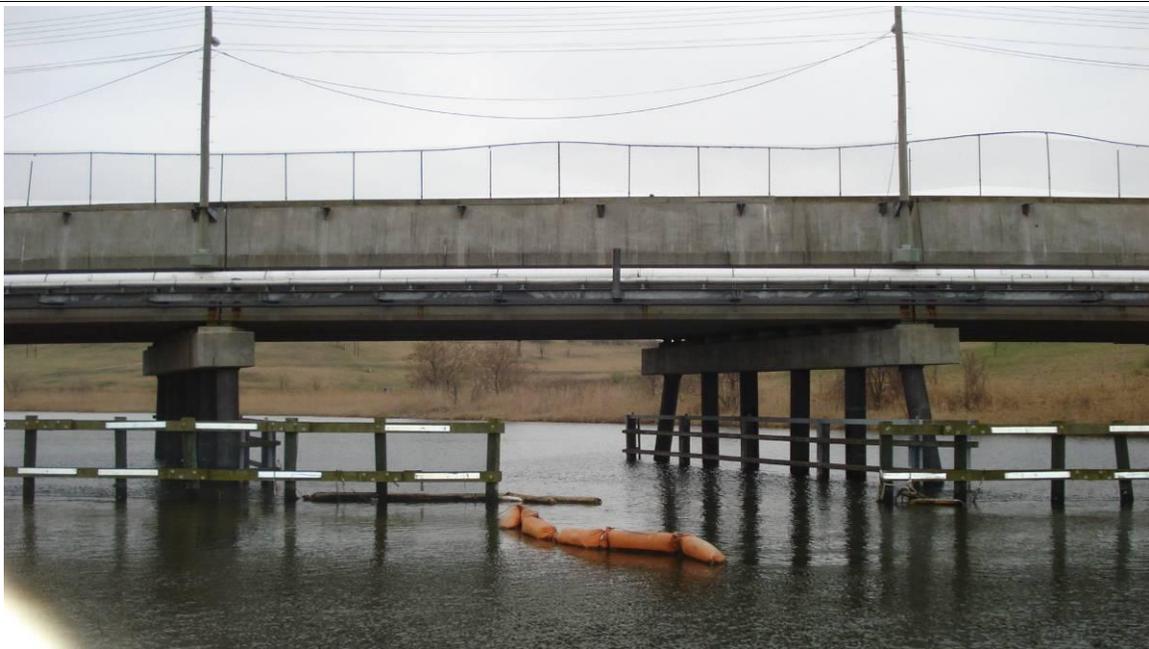
Photo No.: RC06

Location: North elevation, Span 4 and navigation channel below.

Description: General configuration. Note debris fences in good condition.

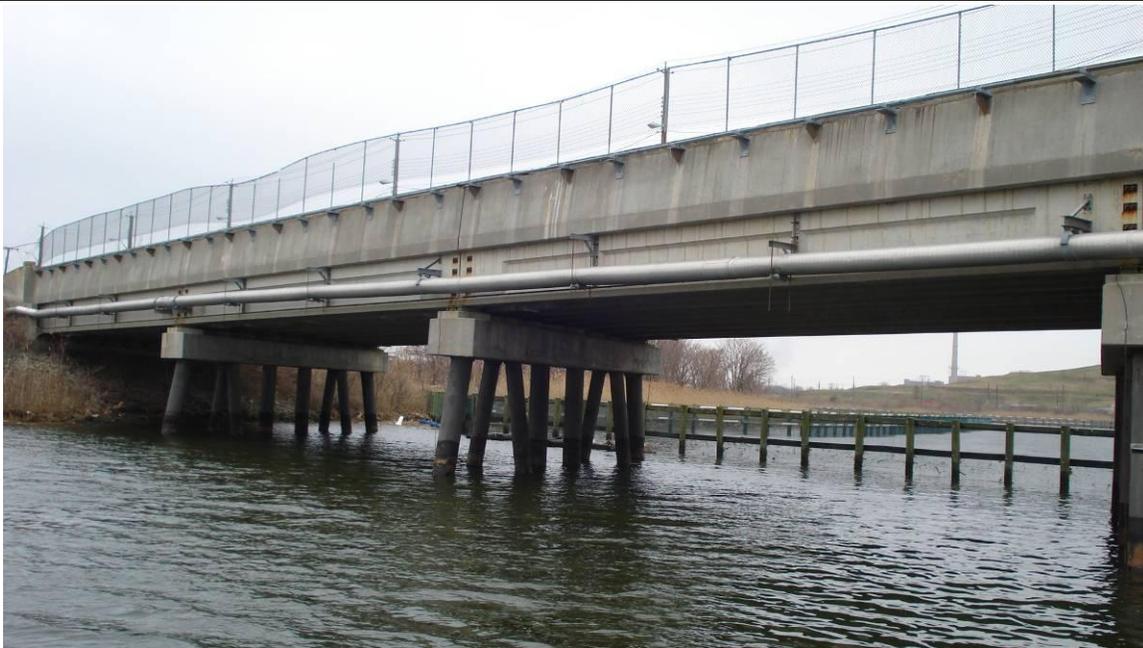
Photo No.: RC07

Location: South elevation looking northwest, Spans 1, 2 and 3.

Description: General configuration. Note debris fence in good condition.

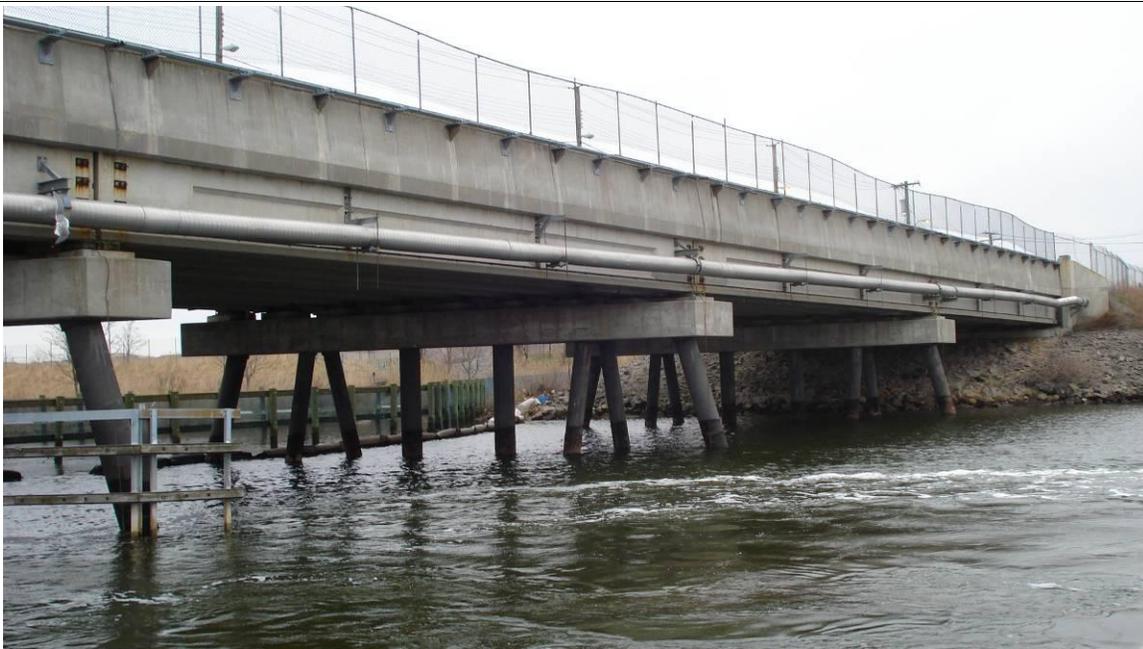
Photo No.: RC08

Location: South elevation, looking northeast, Spans 5, 6 and 7.

Description: General configuration. Note debris fence in good condition.

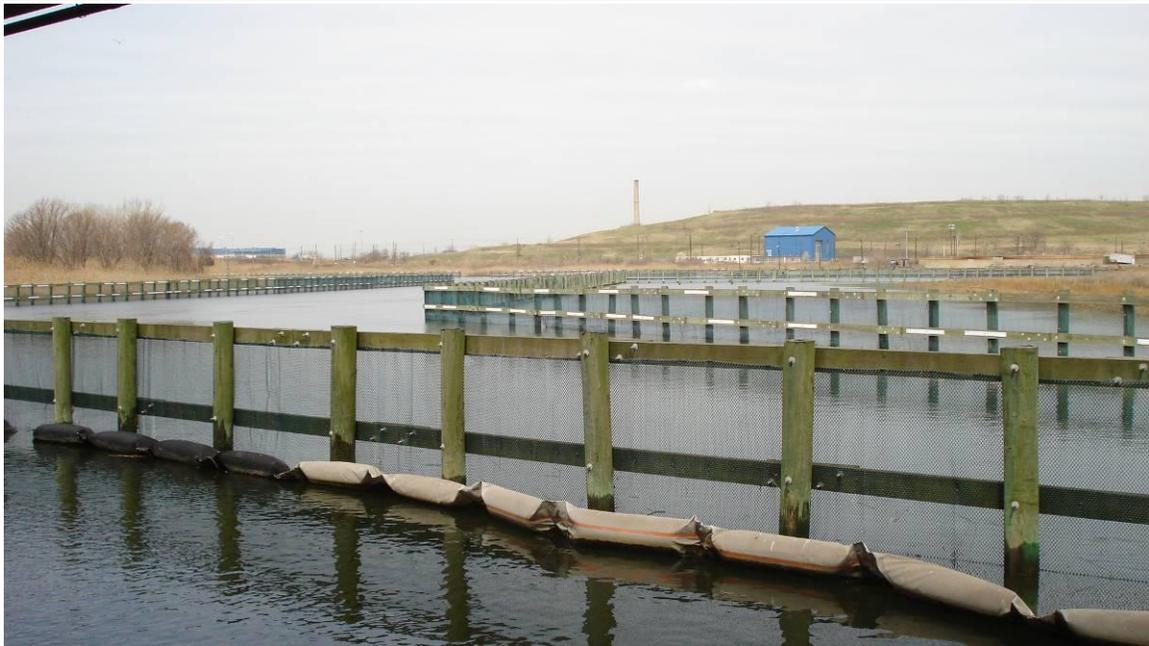
Photo No.: RC09

Location: Looking north at Richmond Creek from below Span 6.

Description: General configuration. Note debris fencing and boom in good condition.

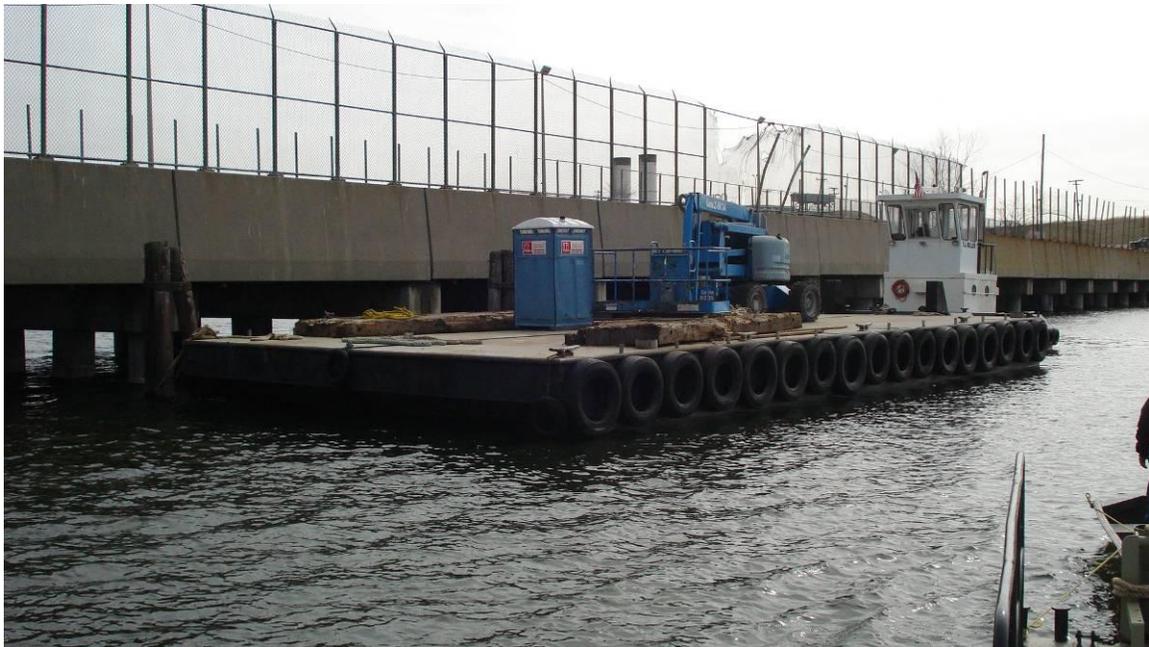
Photo No.: RC10

Location: Tied-up at Main Creek Bridge

Description: Deck barge, aerial lift and tugboat used for inspection of Richmond Creek Bridge.

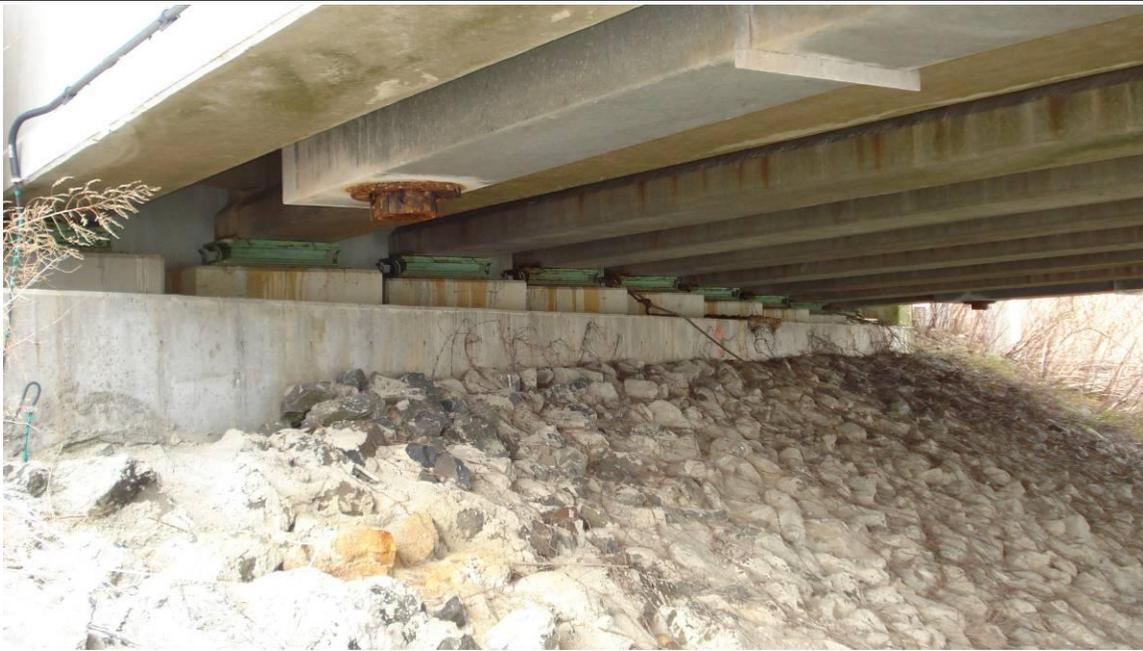
Photo No.: RC11

Location: West Abutment.

Description: General configuration. Abutment stem, seat, pedestals and bearings in good condition. Grouted rip-rap slope protection also in good condition. Note drainage trough and outfall on both sides.

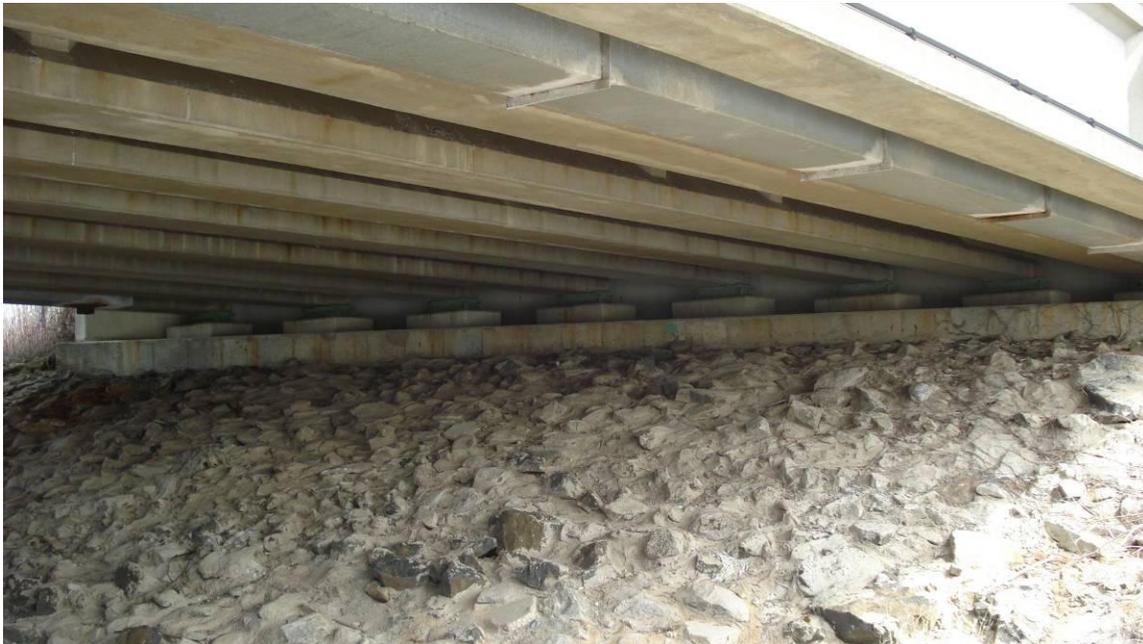
Photo No.: RC12

Location: East Abutment.

Description: General configuration. Abutment stem, seat, pedestals and bearings in good condition. Grouted rip-rap slope protection also in good condition.

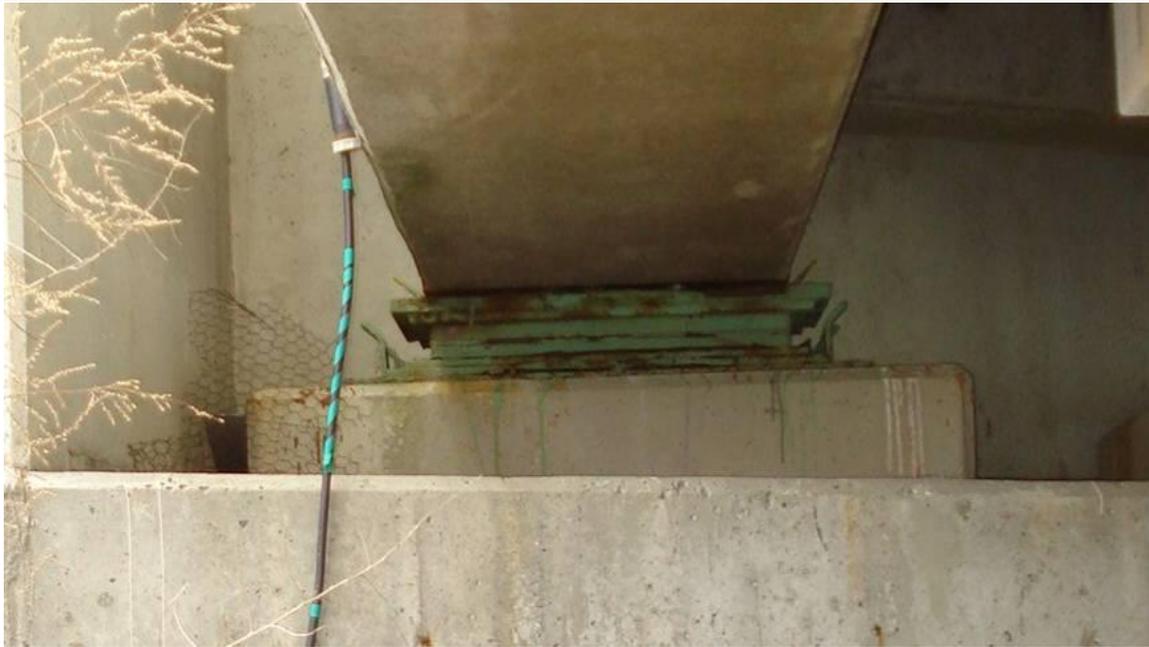
Photo No.: RC13

Location: West Abutment, Girder 1.

Description: 25% paint loss on fixed bearing with surface corrosion. Pedestal in good condition.

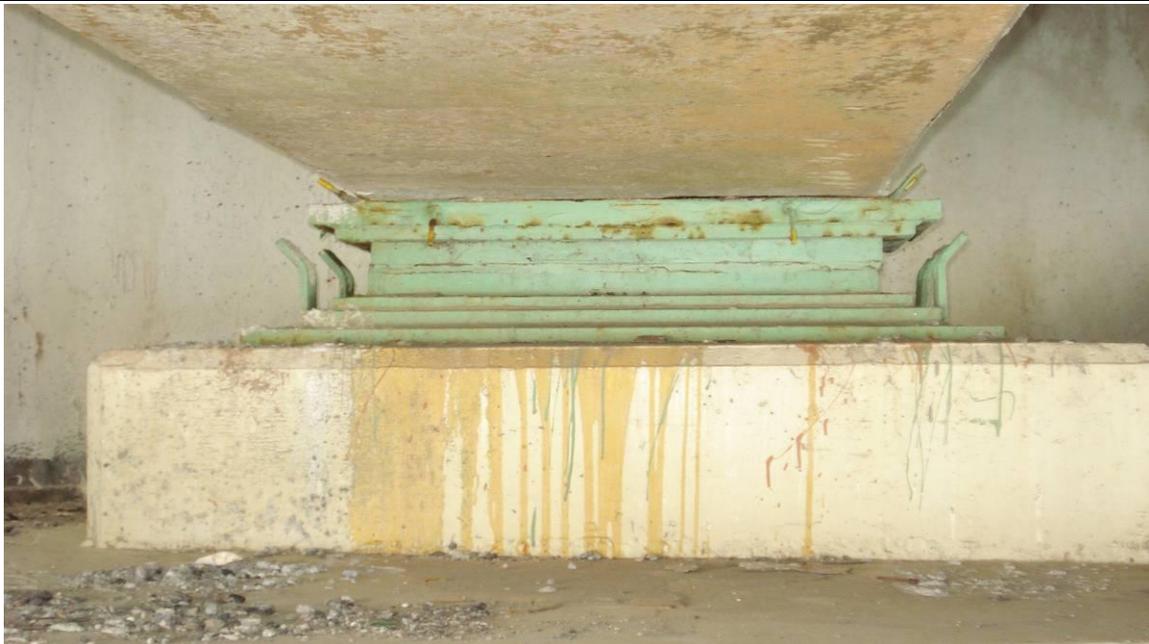
Photo No.: RC14

Location: West Abutment, Girder 2.

Description: Fixed Bearing in good condition with only minor paint loss. Typical.

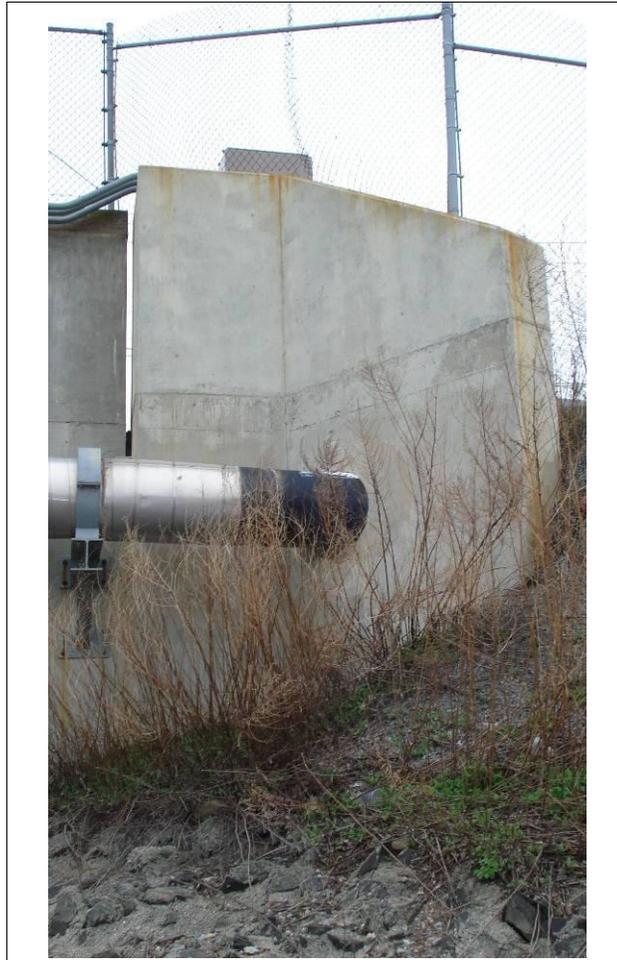
Photo No.: RC17

Location: East Abutment, south wingwall.

Description: Wingwall in good condition.

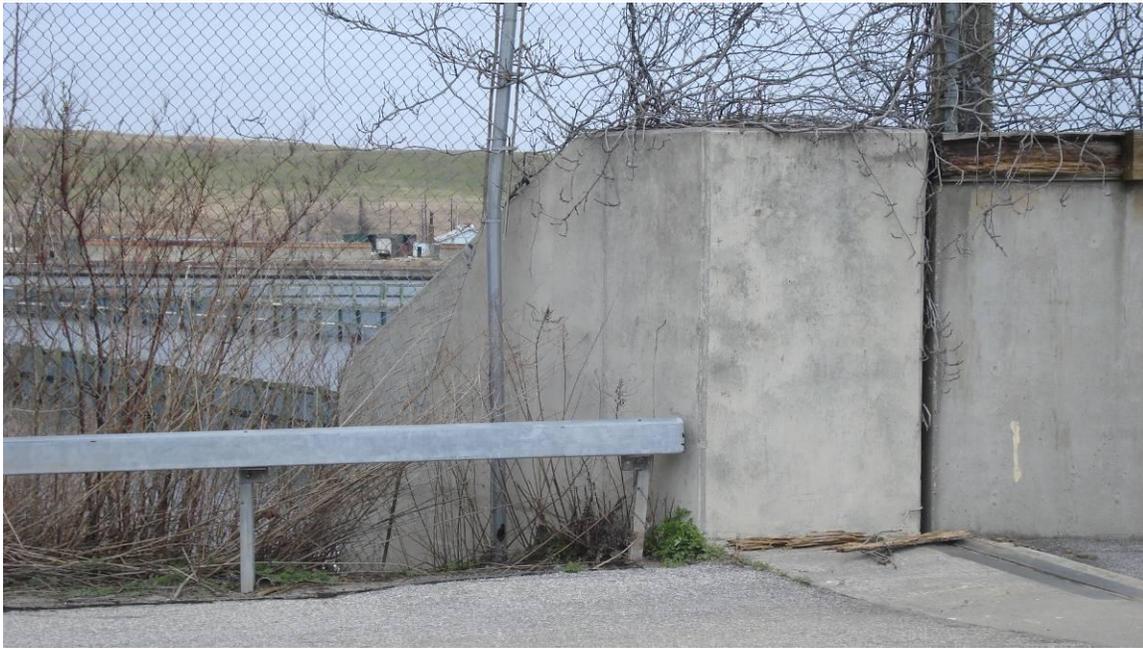
Photo No.: RC18

Location: West Abutment, north wingwall seen from the west approach.

Description: Wingwall in good condition.

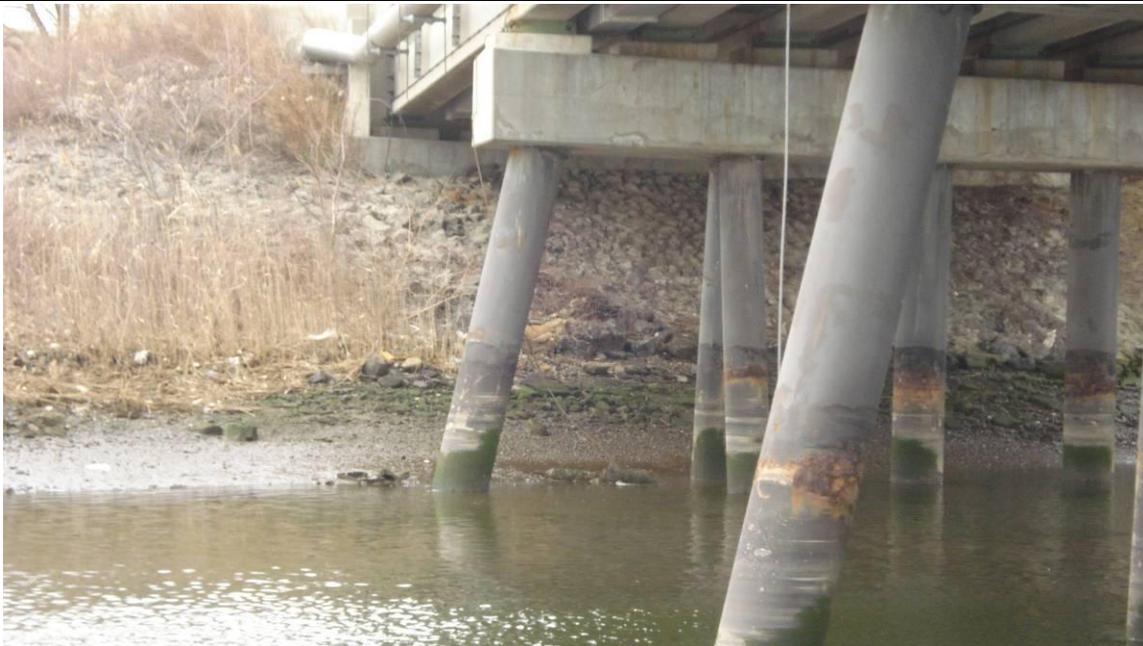
Photo No.: RC19

Location: West Abutment, looking from south fascia.

Description: Abutment and wingwall slopes are stabilized with large grouted rip-rap in good condition.

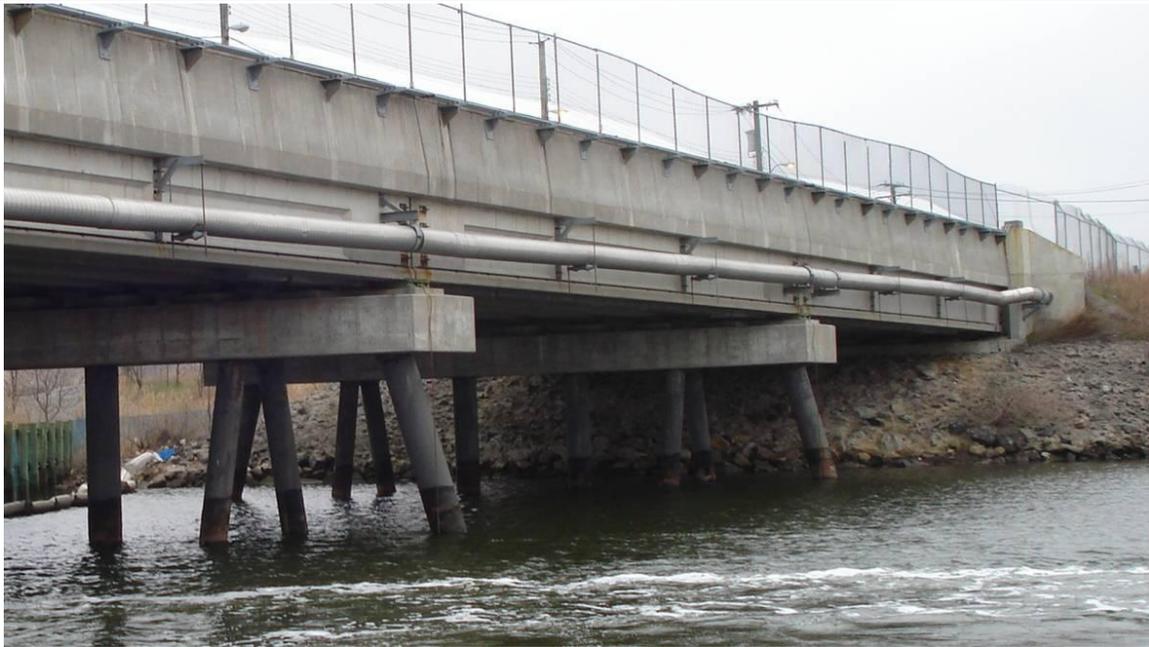
Photo No.: RC20

Location: East Abutment.

Description: Abutment and wingwall slopes stabilized by large grouted rip-rap in good condition.

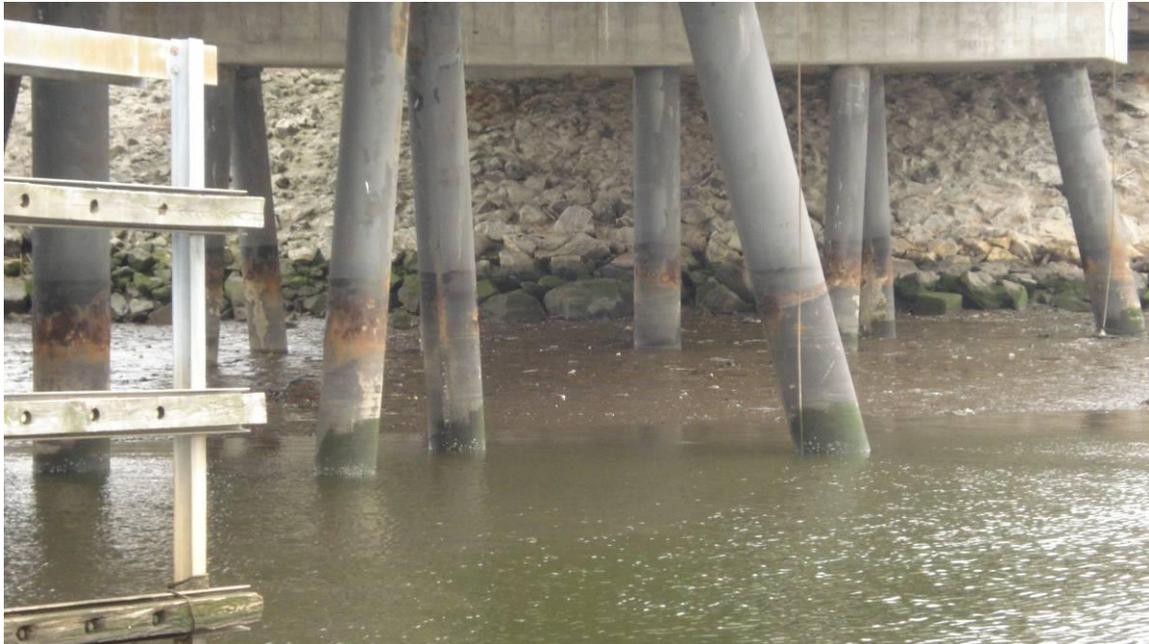
Photo No.: RC21

Location: East Abutment.

Description: Same as RC20, closer view of rip-rap in good condition.

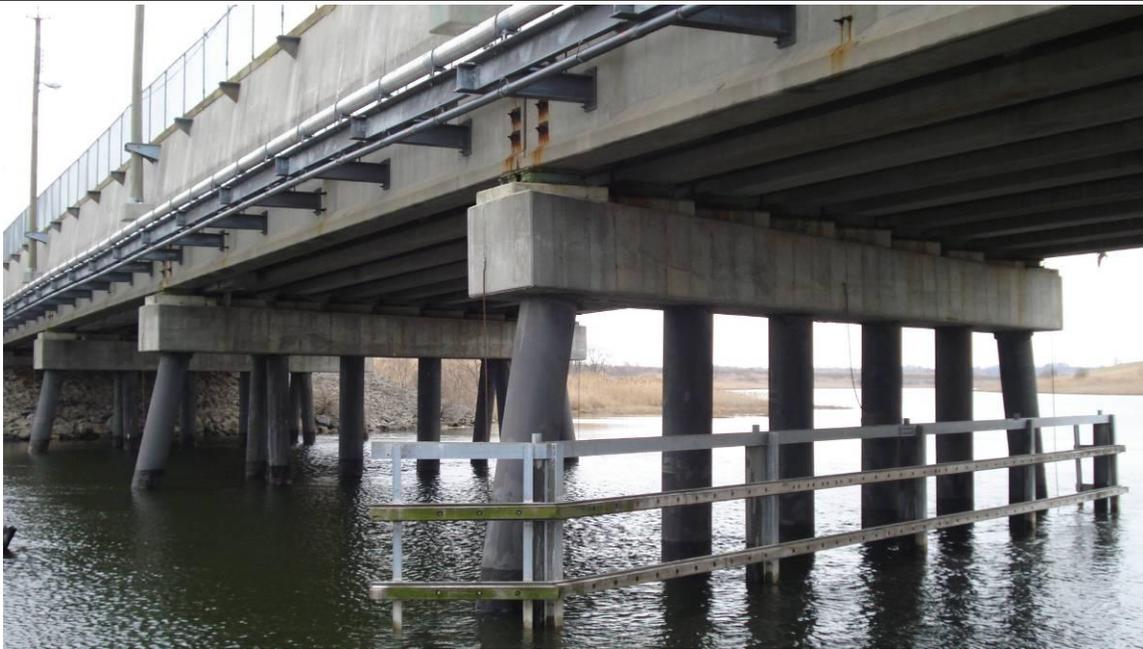
Photo No.: RC22

Location: West face (channel face) of Pier 4.

Description: Fender in good condition with some weathering of timber rub rails. Note concrete cap beams in good condition.

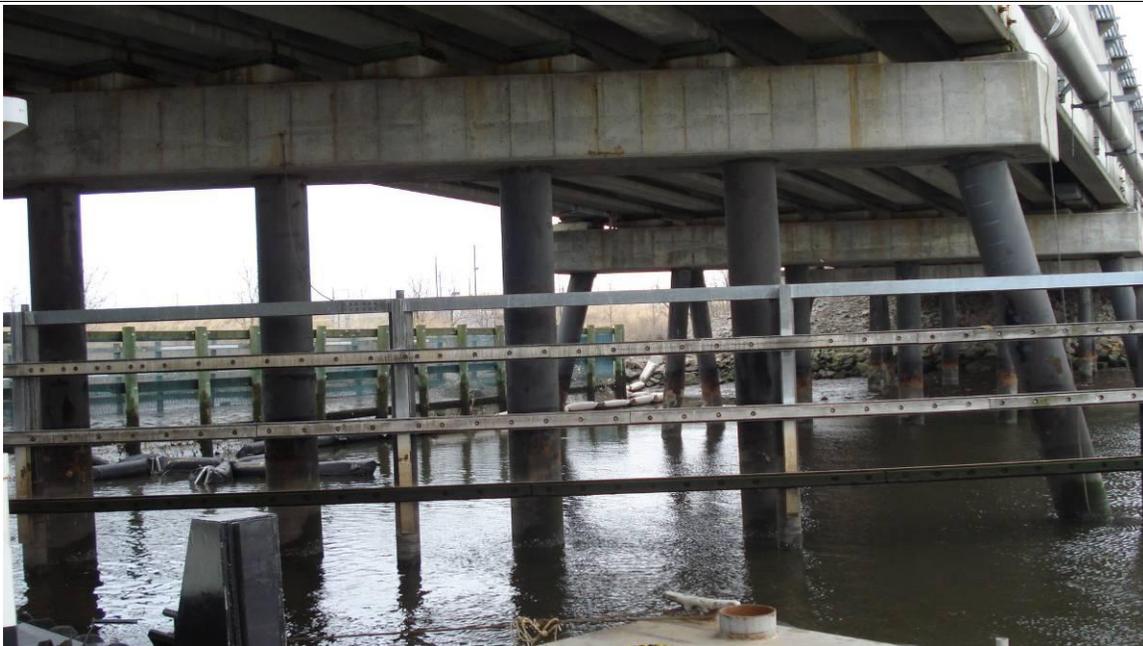
Photo No.: RC23

Location: East face of Pier 3.

Description: Fender in good condition with some weathering of timber rub rails. Note concrete cap beam in good condition.

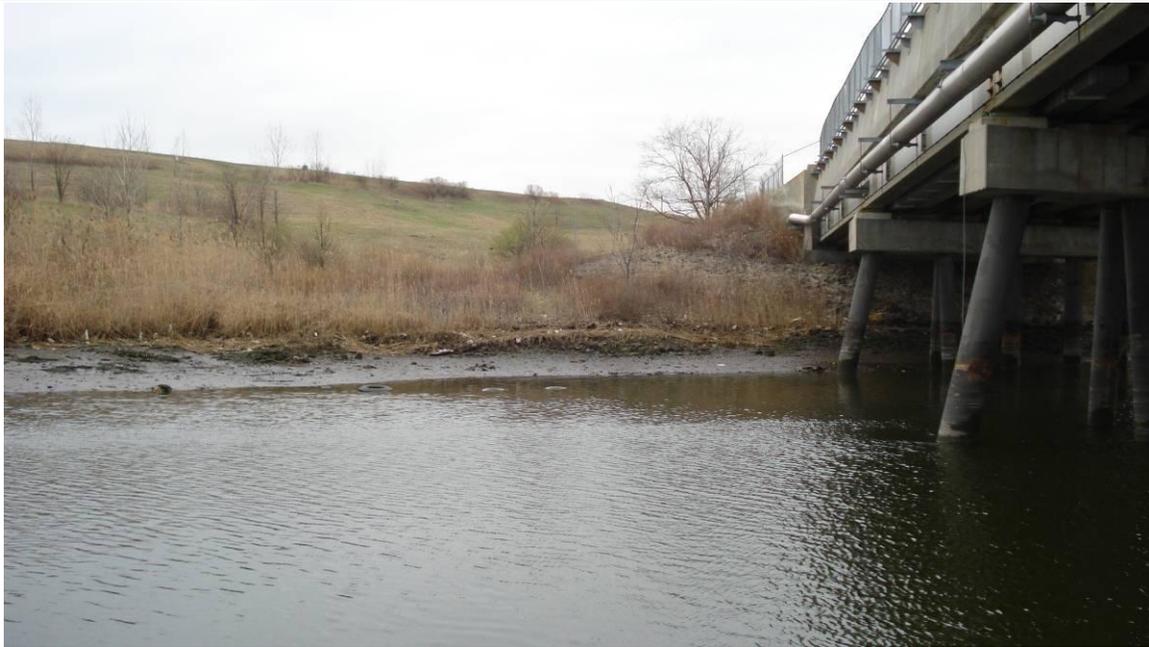
Photo No.: RC24

Location: West shore, south of the bridge.

Description: Shoreline is vegetated and stable. Typical on both shores.
