Fresh Kills Park

Phase 3A
Task 8.4.3
**Bridge Inspection
Report**

Final Report

August 2008

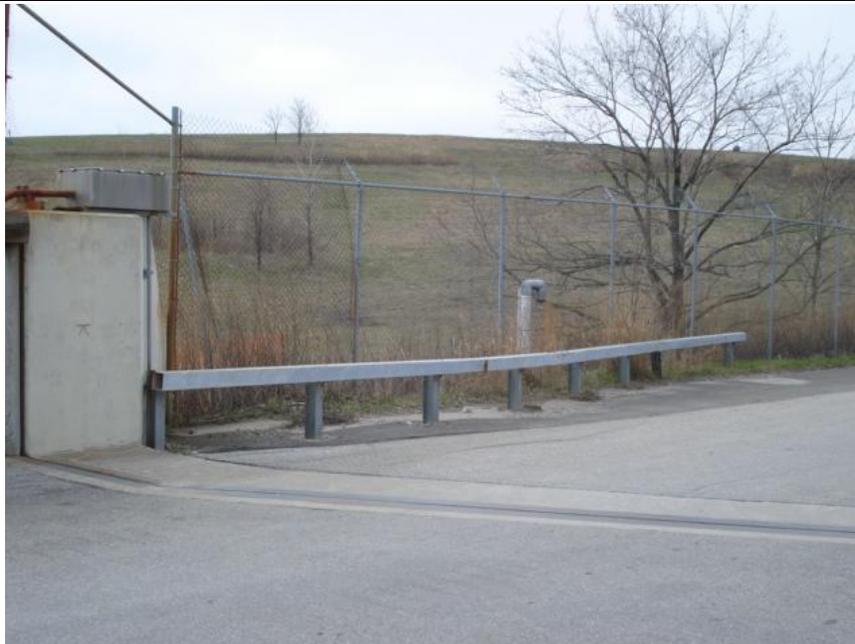
Photo No.: RC25

Location: West approach, south side.

Description: Box beam guide rail in good condition with some minor loss of galvanizing. No transition between guiderail and parapet has been provided. Typical.

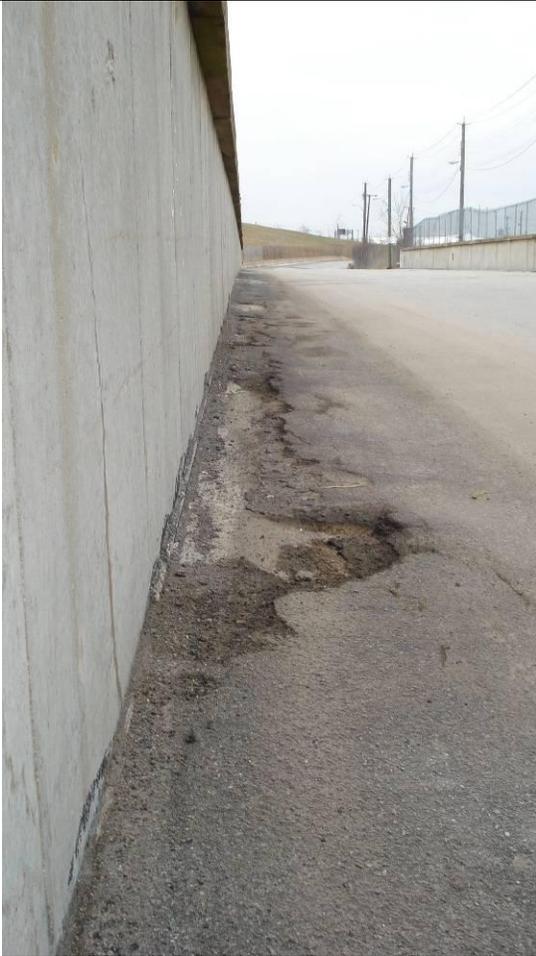
Photo No.: RC26
Location: Span 4, south side of roadway.
Description: Extensive pavement break-up and delamination is typical.

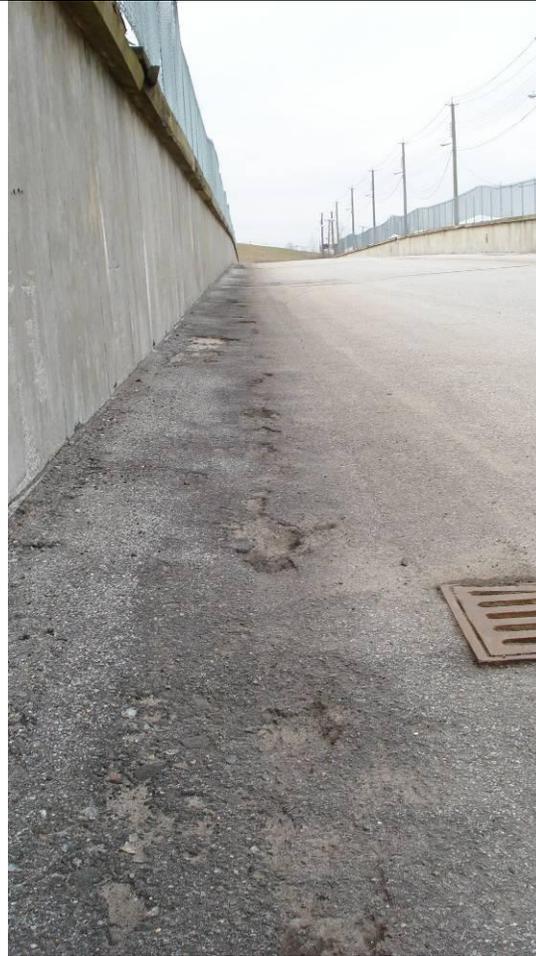
Photo No.: RC27
Location: Span 7, south side of roadway.
Description: Small potholes, pavement break-up and delamination is typical.

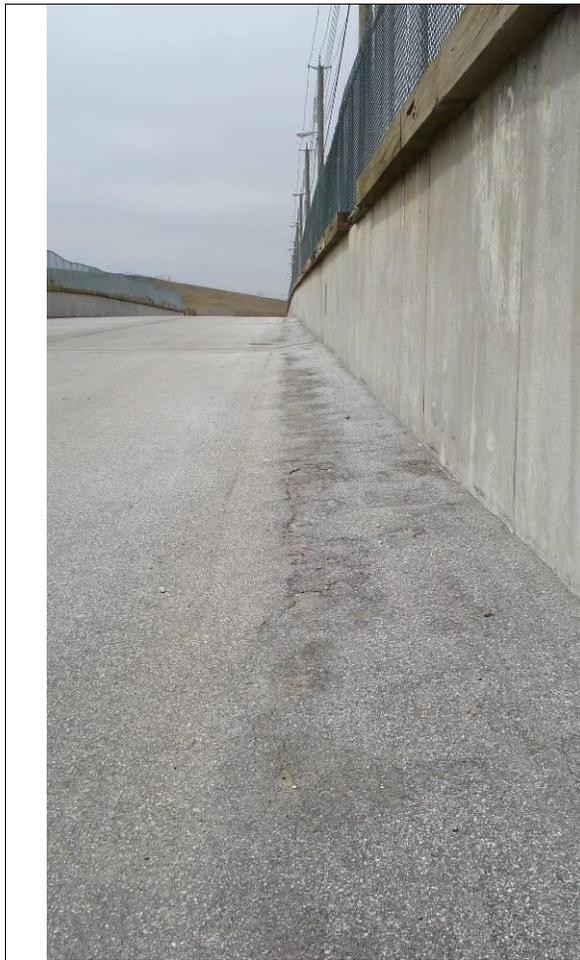
Photo No.: RC28
Location: Span 7, north side of roadway.
Description: Less extensive pavement break-up and delamination is typical.

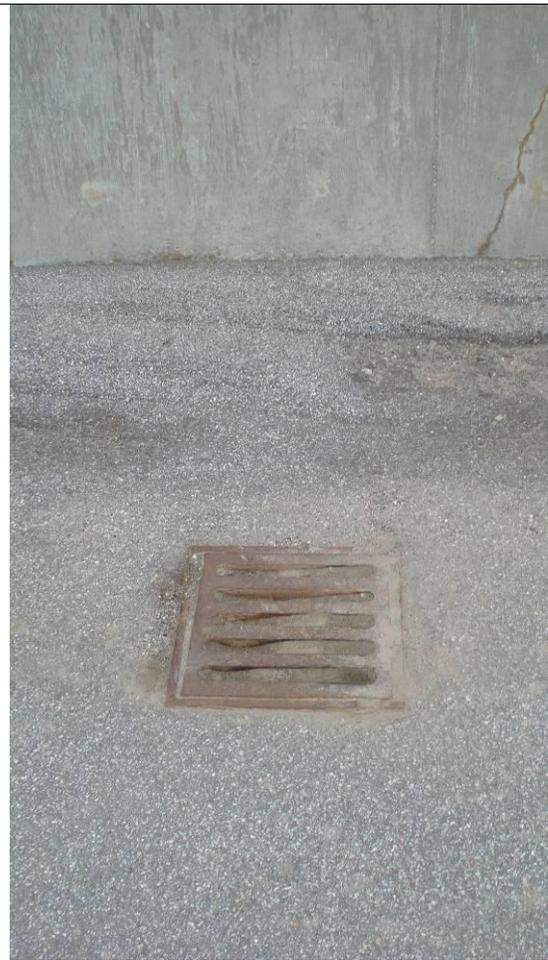
Photo No.: RC29
Location: Span 7, north side of roadway near east abutment.
Description: Scupper is completely clogged. Typical.

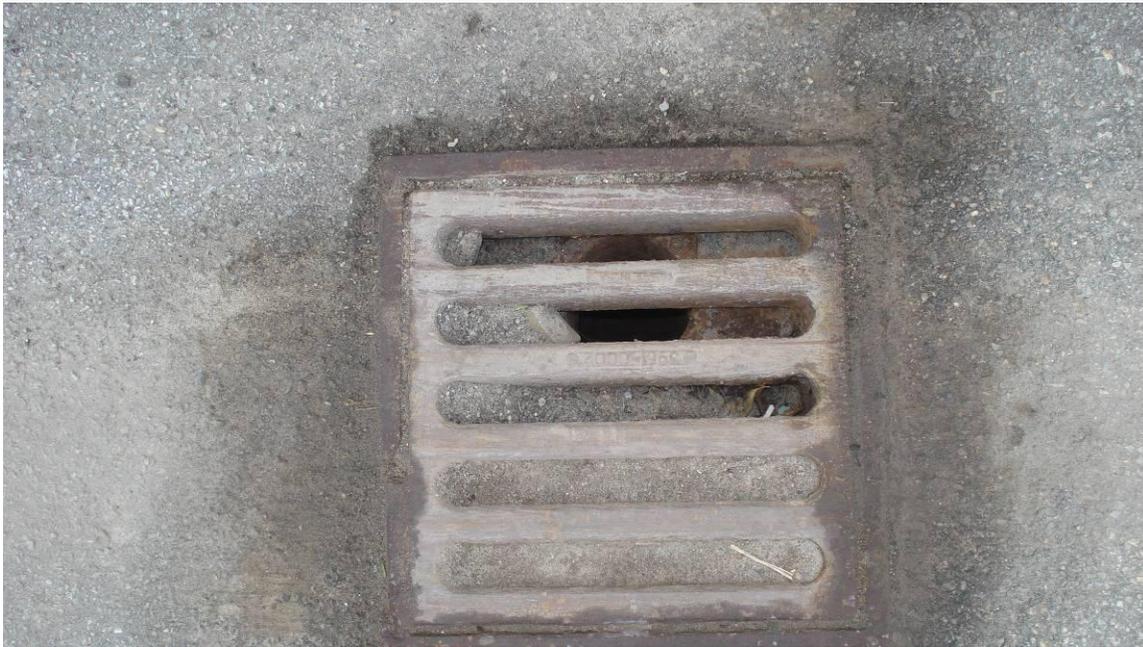
Photo No.: RC30

Location: Span 5, south side of roadway, near Pier 5.

Description: Scupper is partially clogged.

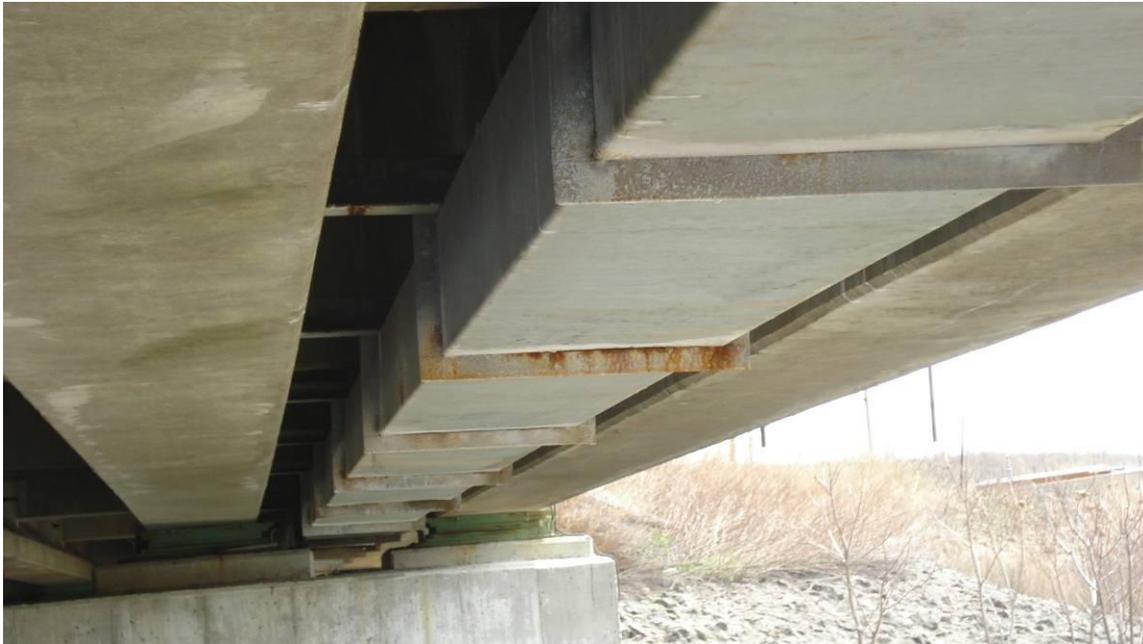
Photo No.: RC31

Location: Span 6 between Girders 8 and 9, south side, looking east.

Description: Typical drainage trough in good condition with only minor surface corrosion.

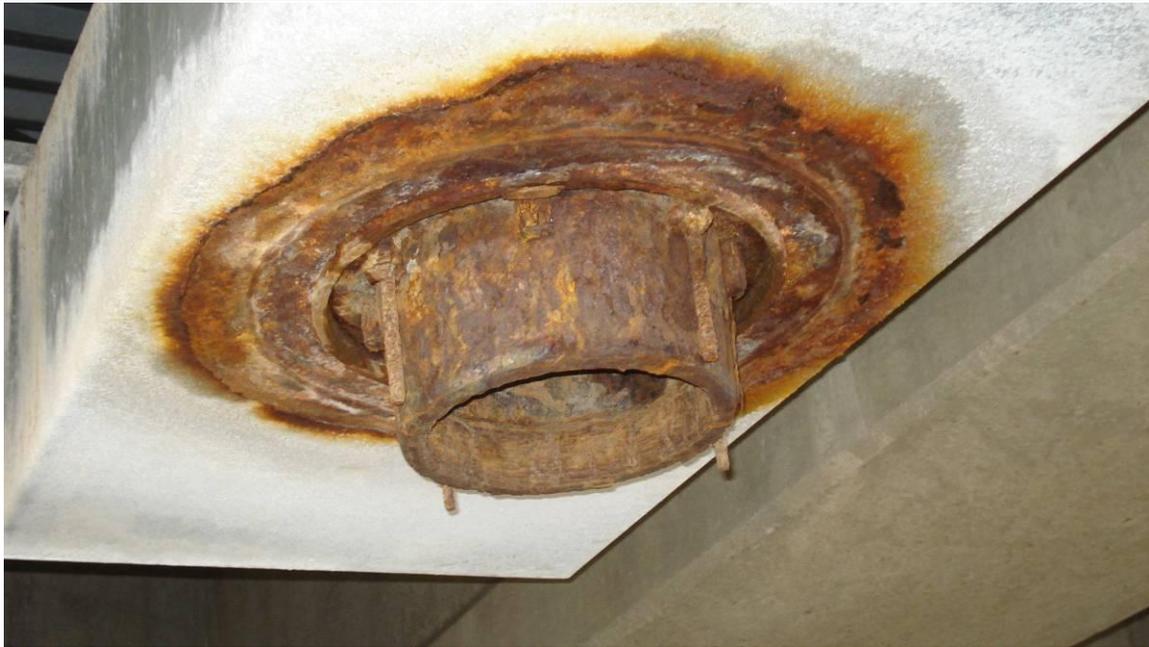
Photo No.: RC32

Location: Span 7, south scupper near east abutment.

Description: Outfall downspout is heavily corroded.

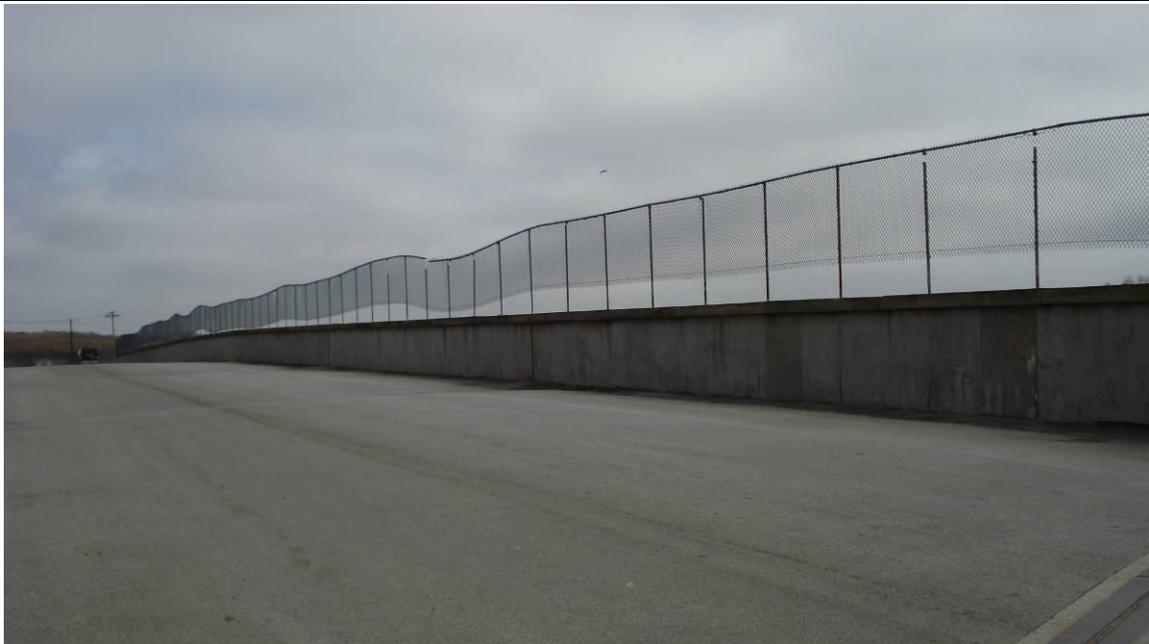
Photo No.: RC33

Location: North parapet, looking northwest from the east approach.

Description: General view of parapet, rub rail and fence. Fence in poor condition.

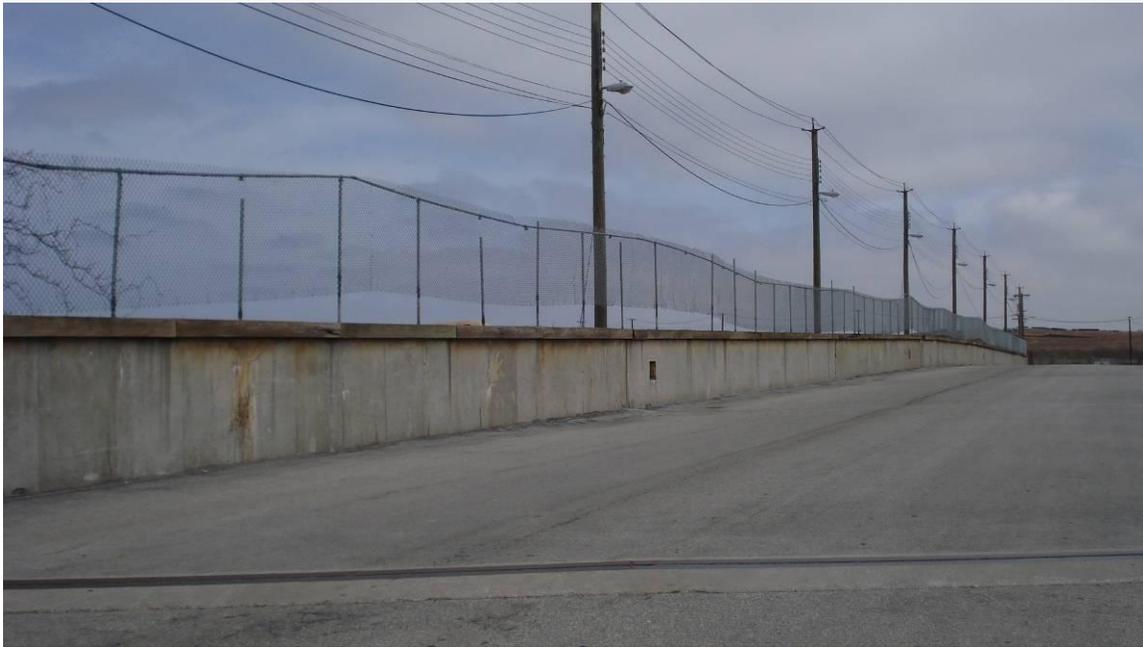
Photo No.: RC34

Location: South parapet, looking southwest from the east approach.

Description: General view of parapet, rub rail and fence. Rub rail in fair condition. Fence in poor condition. Note timber utility poles with utility lines and luminaires.

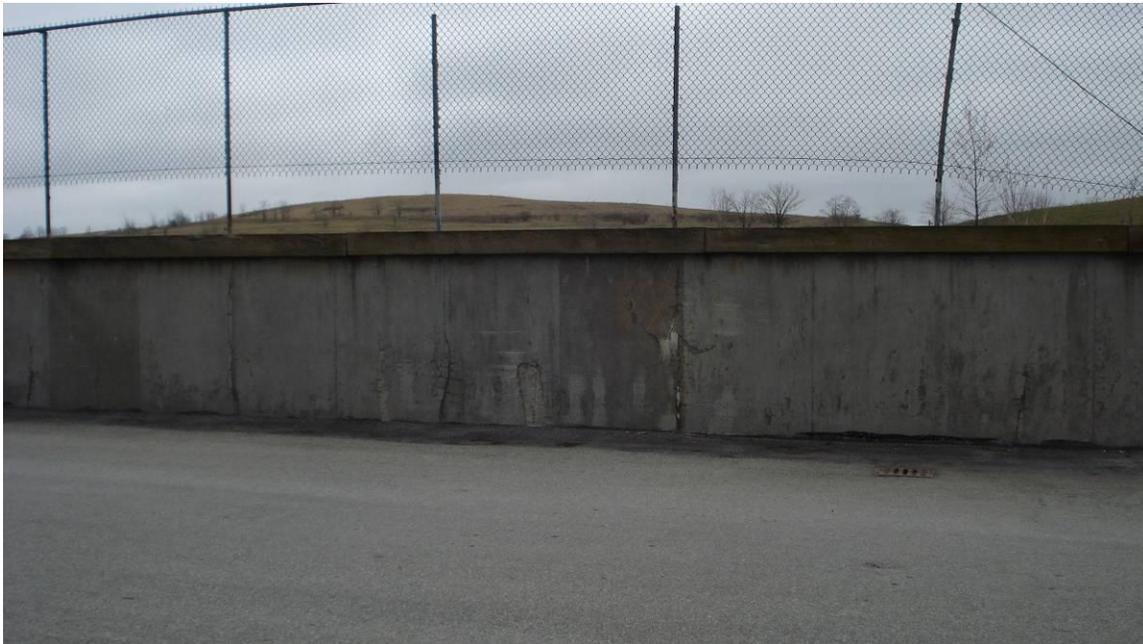
Photo No.: RC35

Location: Span 1 south parapet near west abutment.

Description: Delamination, cracks with efflorescence, map cracking on inside face of parapet. Fence in poor condition.

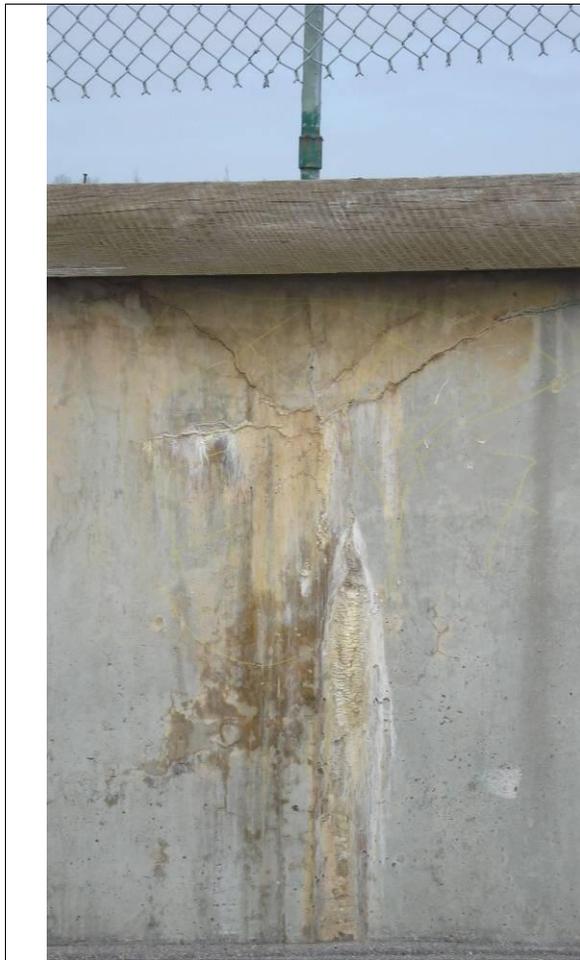
Photo No.: RC36
Location: Span 1, north parapet 30 ft. from west abutment.
Description: Delamination and cracking with efflorescence.

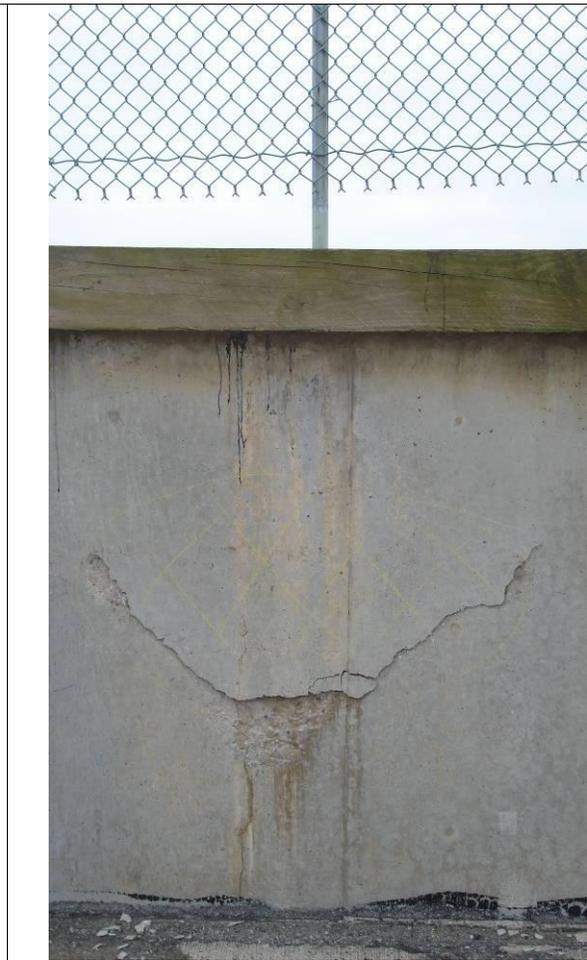
Photo No.: RC37
Location: Span 3, south parapet at mid-span.
Description: Delamination.

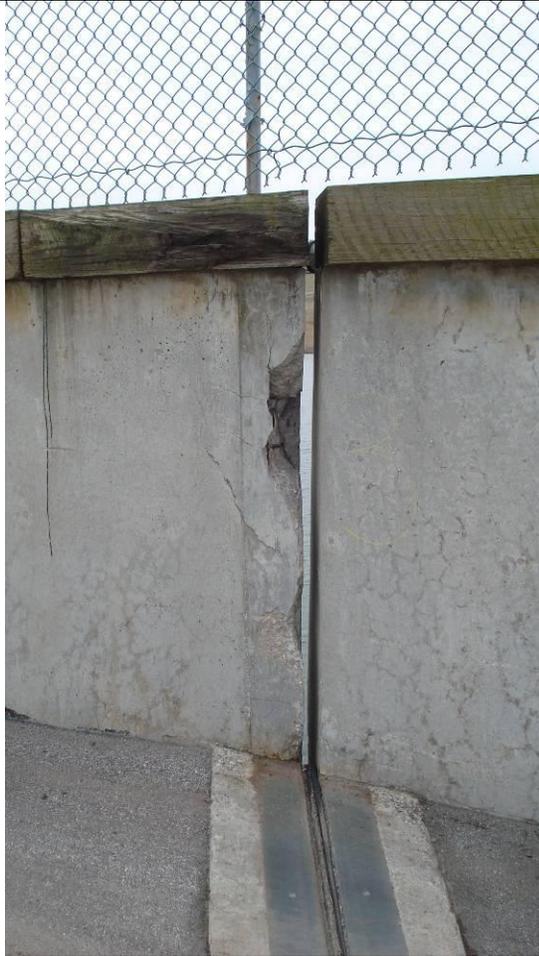
Photo No.: RC38
Location: Pier 4, south parapet.
Description: Spall, cracks and delamination.

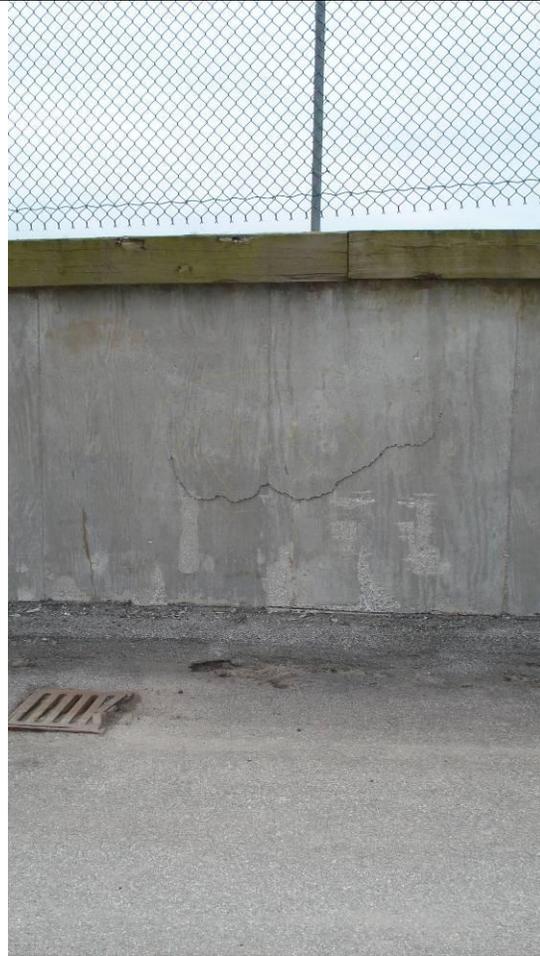
Photo No.: RC39
Location: Span 7, south parapet 10 ft. from east abutment.
Description: Delamination. Note scupper is clogged. Note pavement break-up.

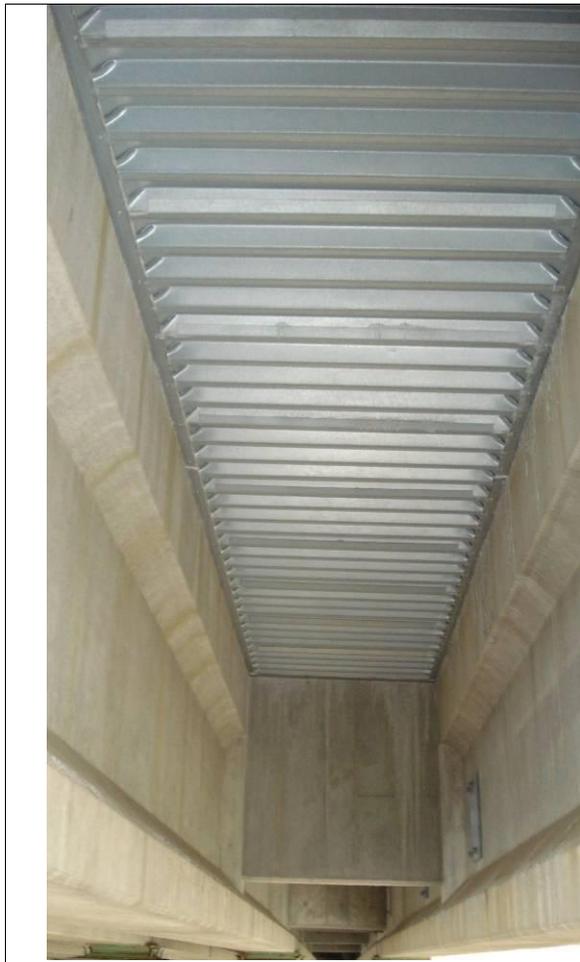
Photo No.: RC40
Location: Underside of Span 4 between Girders 8 and 9.
Description: Stay-in-place steel form in good condition. Typical. Note intermediate concrete diaphragm in good condition.

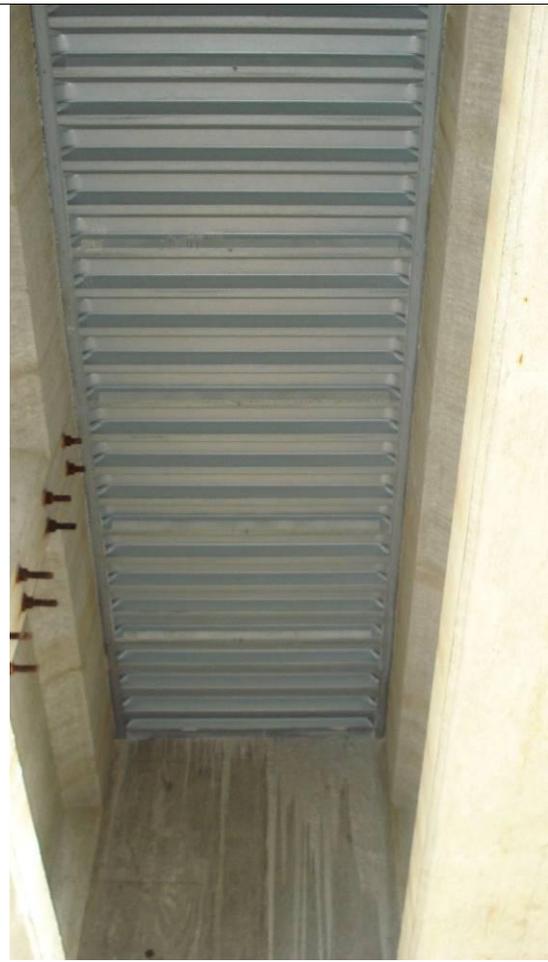
Photo No.: RC41
Location: Underside of Span 6 between Girders 3 and 4.
Description: Stay-in-place steel form in good condition. Typical. Note intermediate concrete diaphragm in good condition.

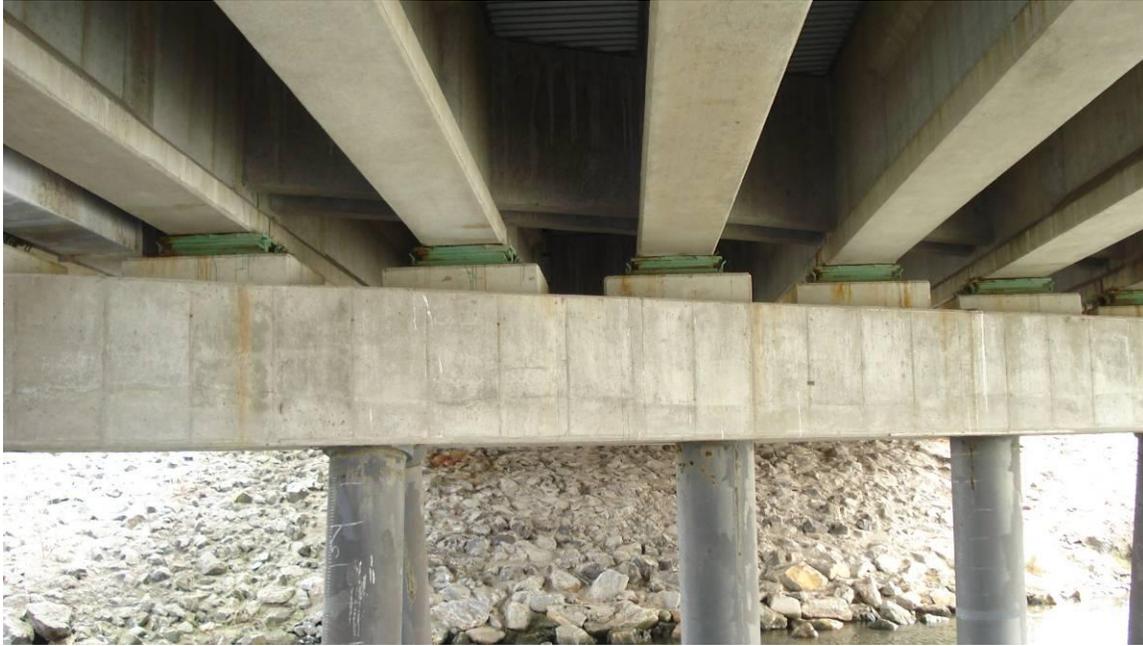
Photo No.: RC42

Location: Underside of Span 6, looking east towards Pier 6.

Description: General view of superstructure. Note concrete end diaphragms over pier. Pier cap beam in good condition.

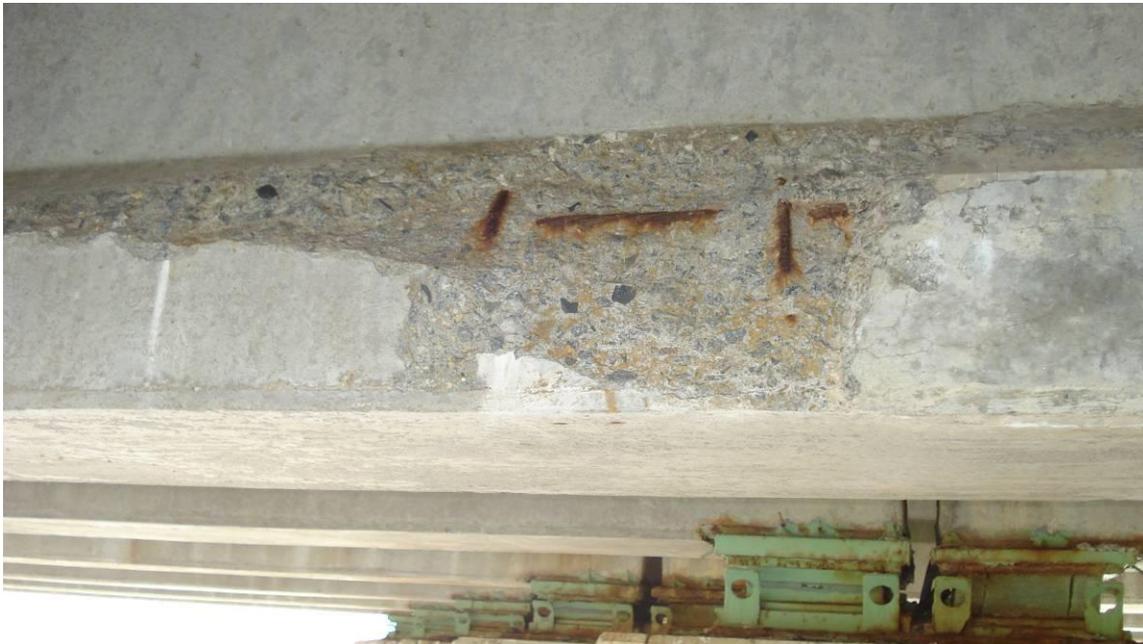
Photo No.: RC43

Location: Span 4, Girder 4, north face, 4 ft. from Pier 3 bearing.

Description: Spall in bottom flange of girder with exposed rebar.

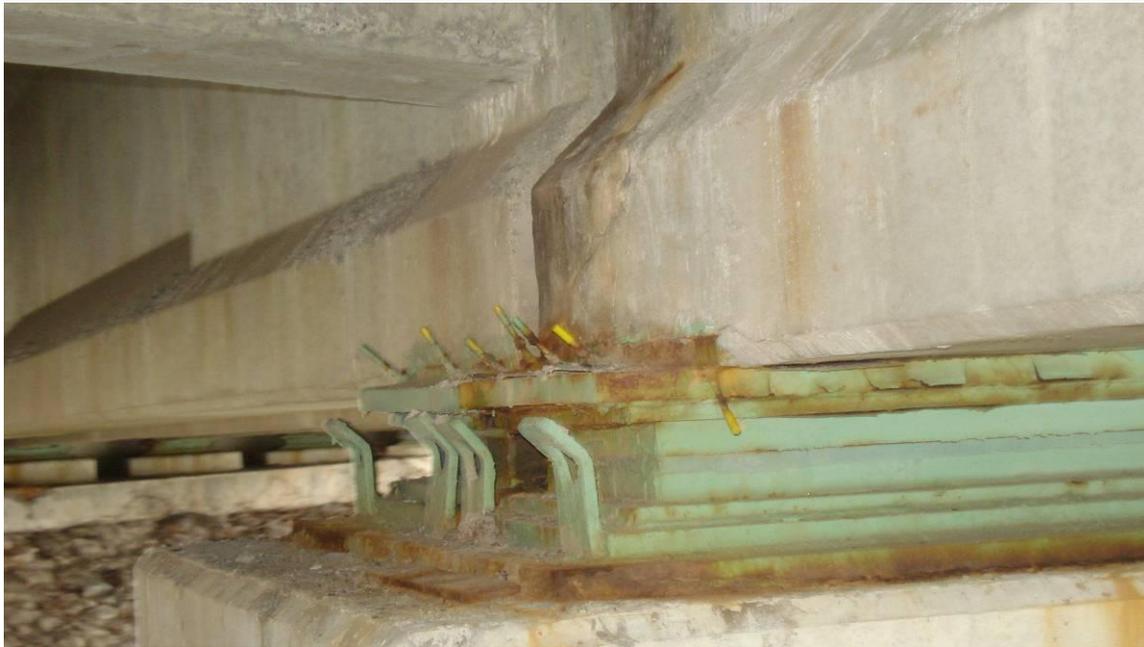
Photo No.: RC44

Location: Span 2, Girder 5, south face at Pier 1 bearing.

Description: Crack in end of girder.

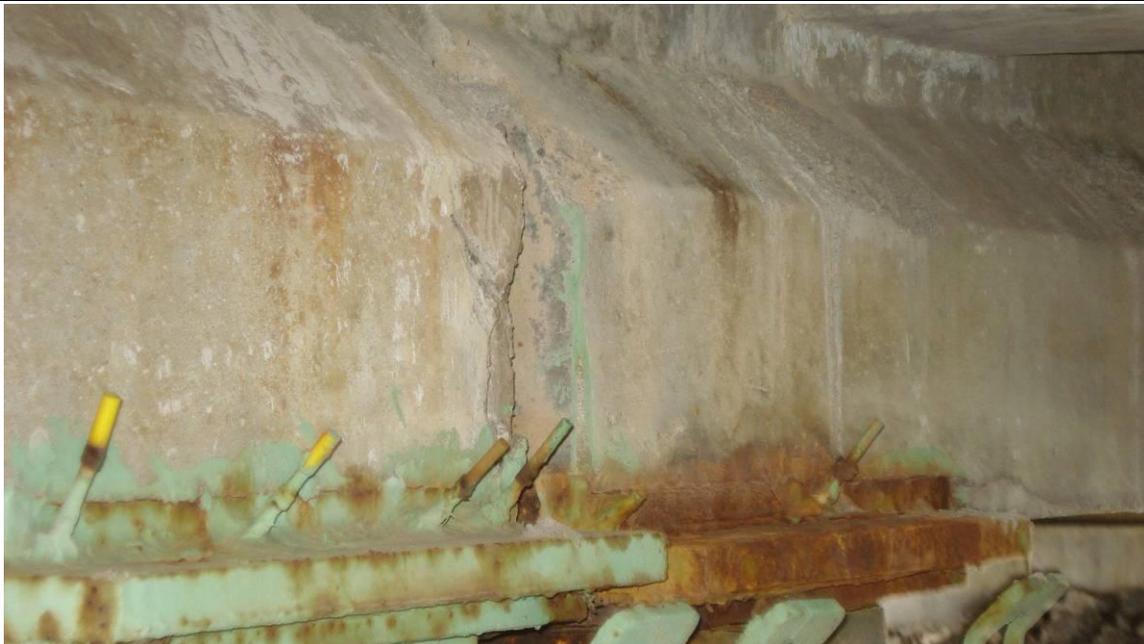
Photo No.: RC45

Location: Span 2, Girder 4, north face, at Pier 1 bearing.

Description: Crack in end of girder.

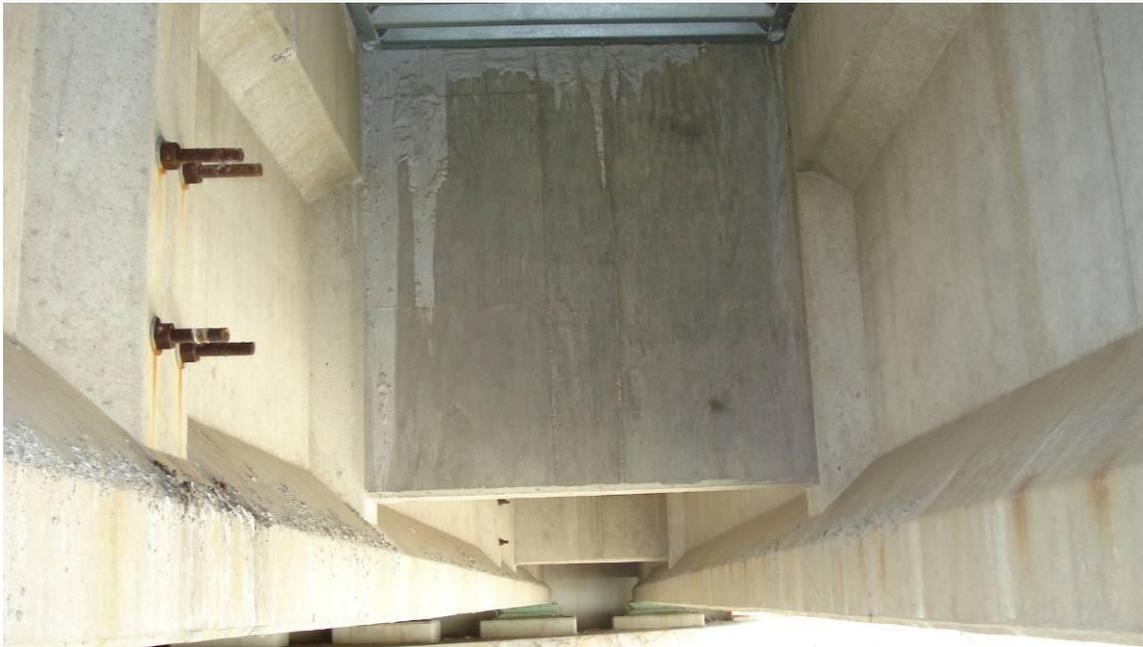
Photo No.: RC46

Location: Span 7, intermediate diaphragm between Girders 7 and 8, west face.

Description: Typical diaphragm in good condition. Note leakage of deck concrete around steel form during construction. Note threaded rebars for adjacent intermediate diaphragms.

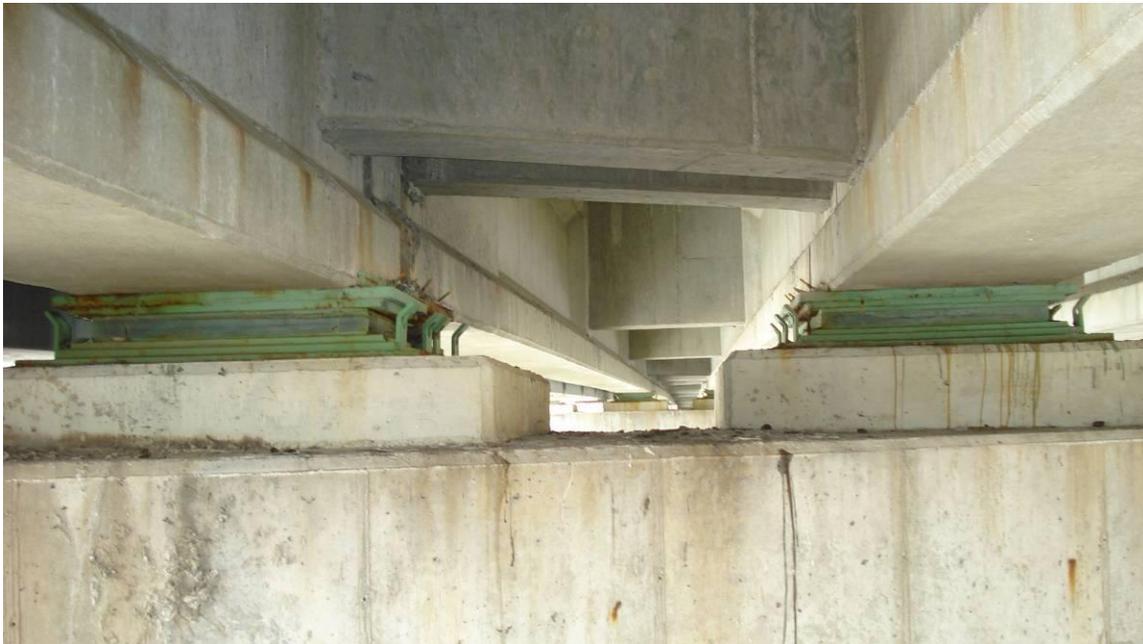
Photo No.: RC47

Location: Pier 6, east face between Girders 7 and 8.

Description: Typical end diaphragms at pier are in good condition. Intermediate diaphragms in the background are also in good condition. The fixed bearings are in good condition with little paint loss. Pedestals also in good condition.

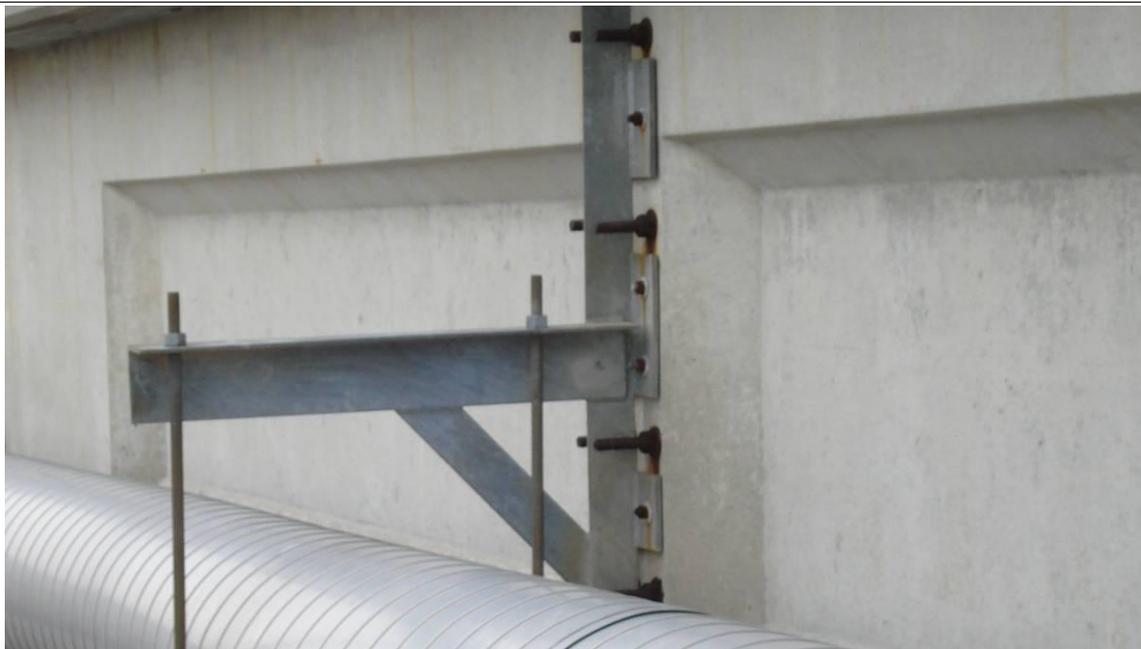
Photo No.: RC48

Location: South fascia.

Description: Typical threaded rebar for intermediate diaphragm, with utility bracket cut to clear. Bars, nuts and washers are corroding.

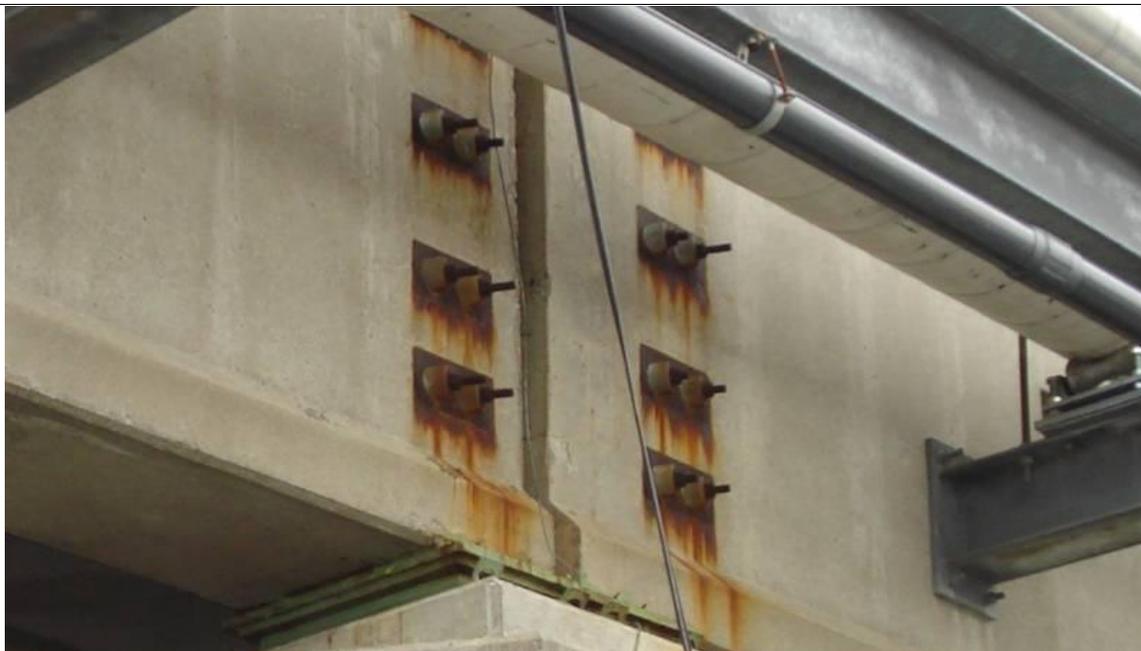
Photo No.: RC49

Location: Pier 3, north fascia.

Description: Typical threaded rebar, beveled washers and plates for end diaphragms. Bars, and hardware are corroding.

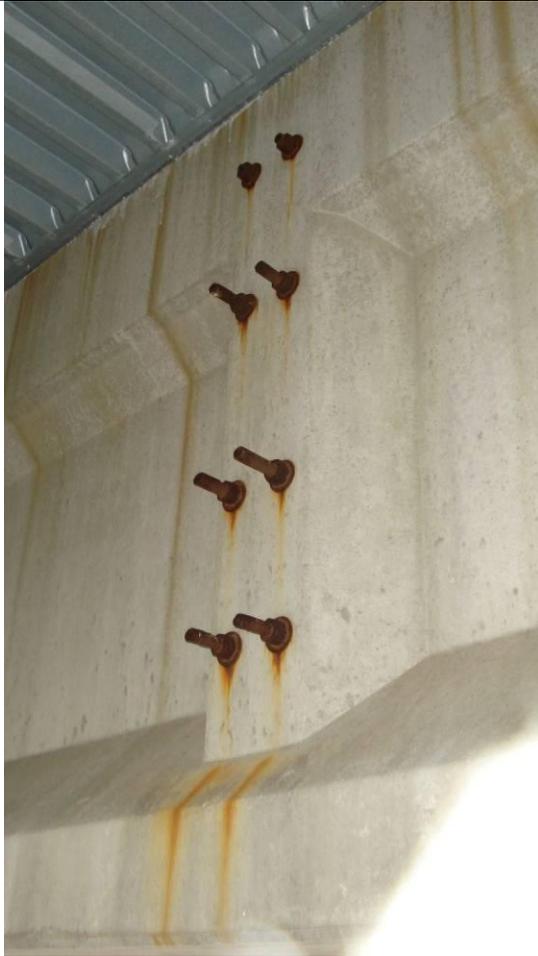
Photo No.: RC50
Location: Span 4, Girder 6, south face.
Description: Typical threaded rebar. Nuts are tight. Rebars and hardware are corroding.

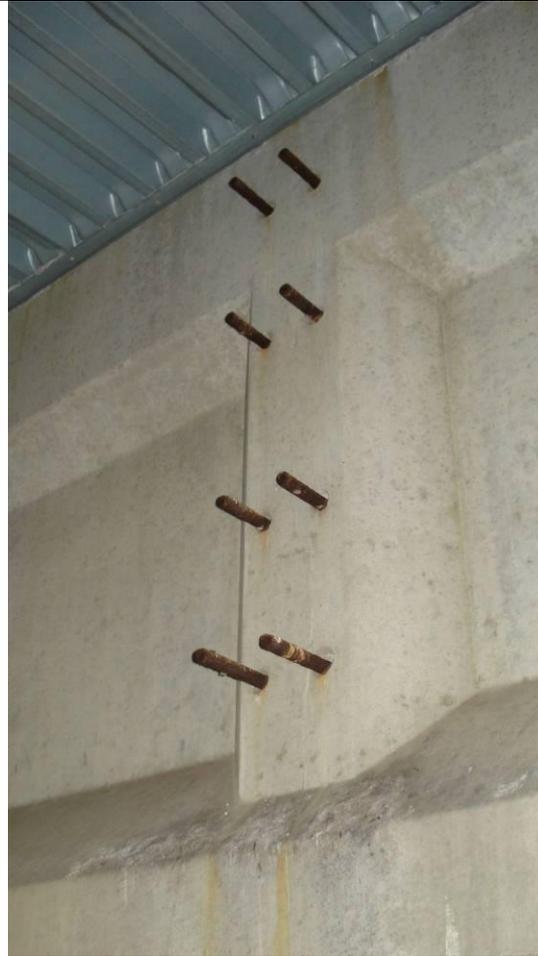
Photo No.: RC51
Location: Span 4, Girder 7, south face.
Description: Nuts have walked off of threaded rebar, or were never installed.

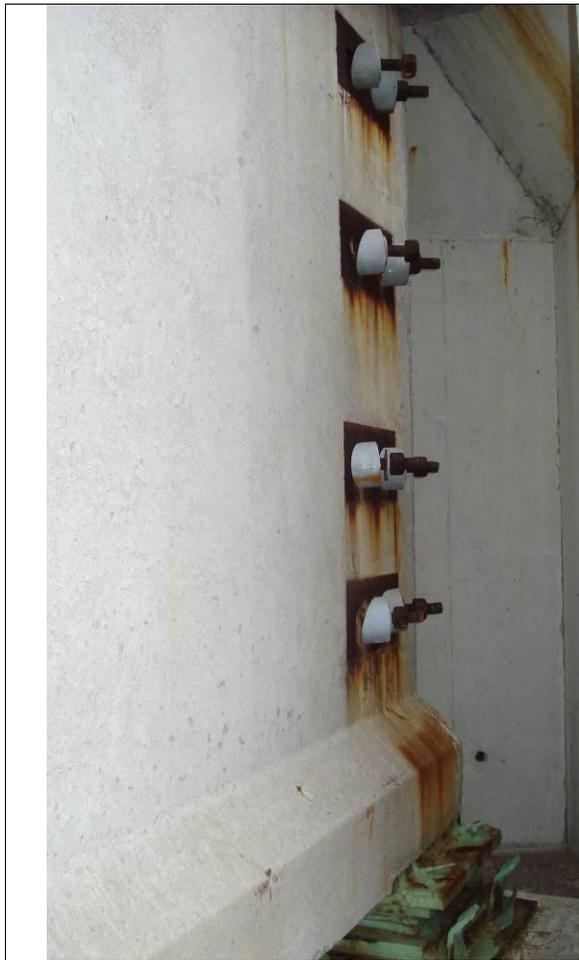
Photo No.: RC52
Location: East Abutment, Girder 1, south face.
Description: Nuts on threaded rebar have loosened.

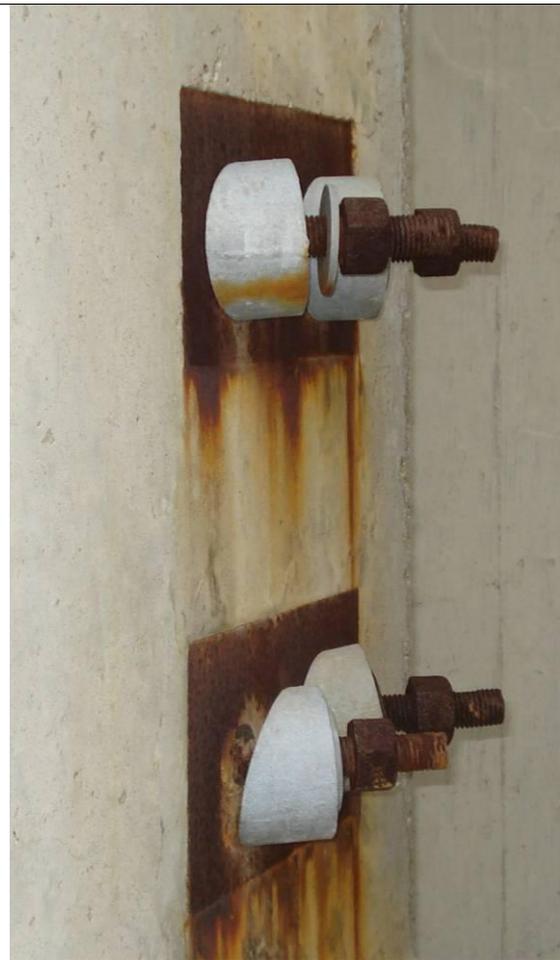
Photo No.: RC53
Location: Same as RC52.
Description: Closer view of connections.

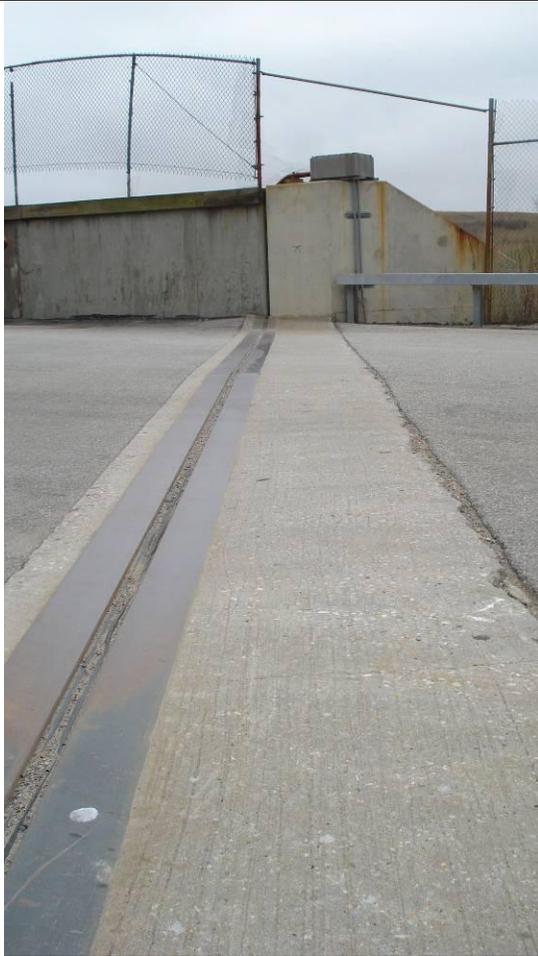
Photo No.: RC54
Location: Roadway at west abutment, looking south.
Description: Armored compression joint in good condition. Minor deterioration along approach edge of concrete header.

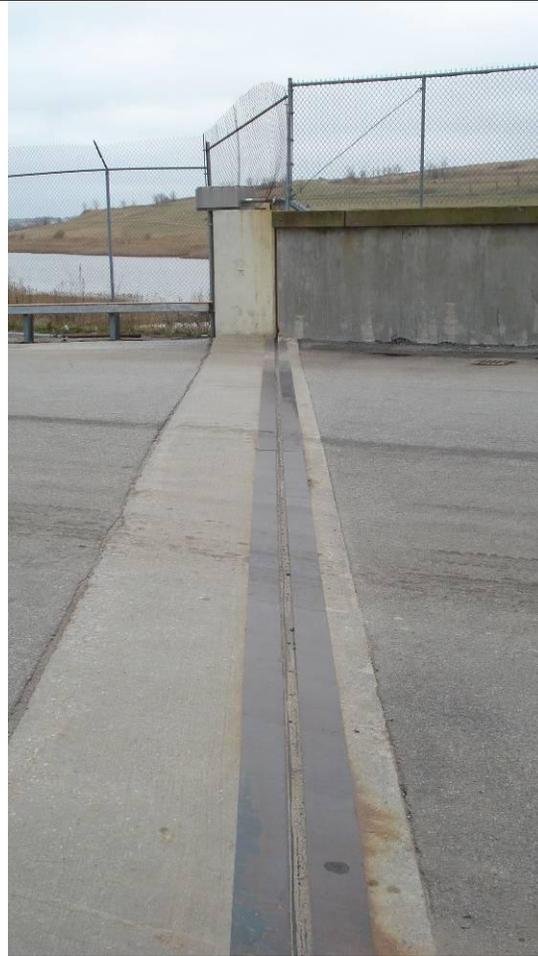
Photo No.: RC55
Location: Roadway at east abutment, looking south.
Description: Armored compression joint in good condition. Minor deterioration along approach edge of concrete header.

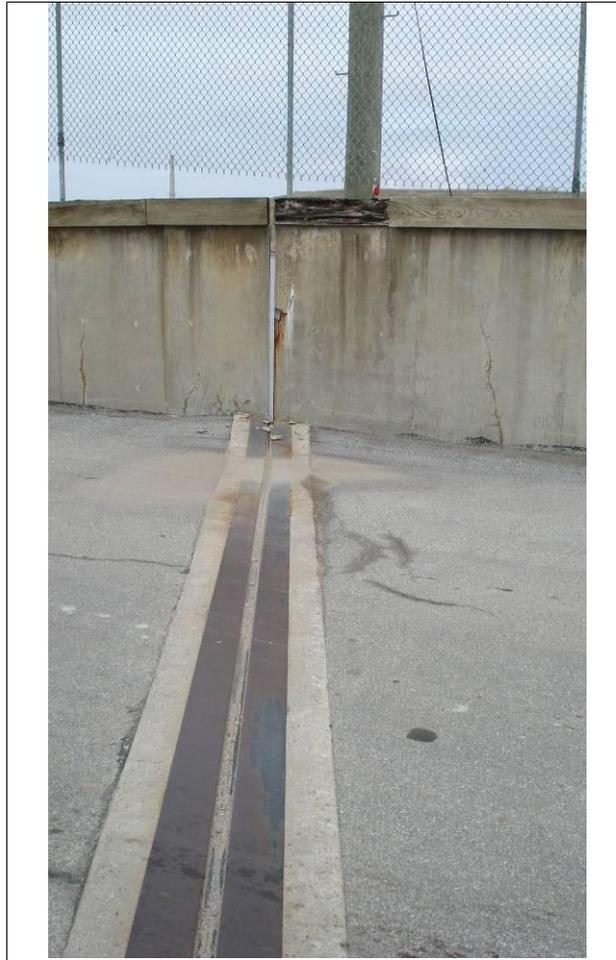
Photo No.: RC56

Location: Roadway at Pier 3, looking north.

Description: Armored compression joint in good condition. Minor asphalt deterioration along edges of concrete header.

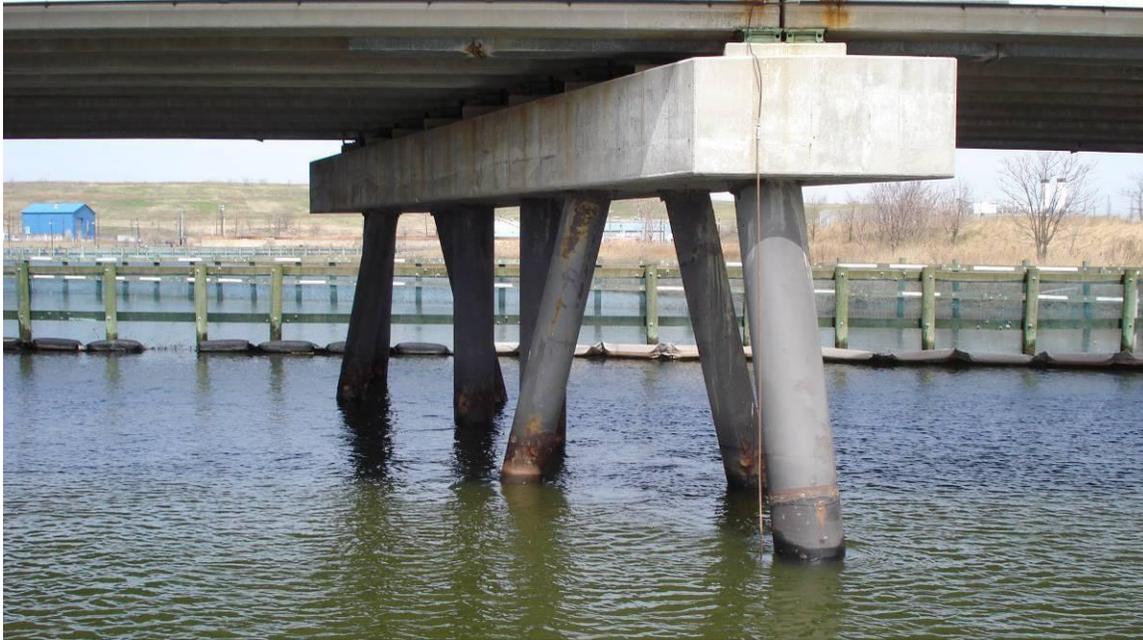
Photo No.: RC57

Location: Pier 5, South fascia looking north.

Description: General configuration of pier. Typical for Piers 1, 2, 5 and 6. Note end piles battered transversely, and two sets of intermediate piles battered longitudinally. Cap beam and piles in good condition. Note $\frac{3}{4}$ " galvanized steel wire for cathodic protection system.

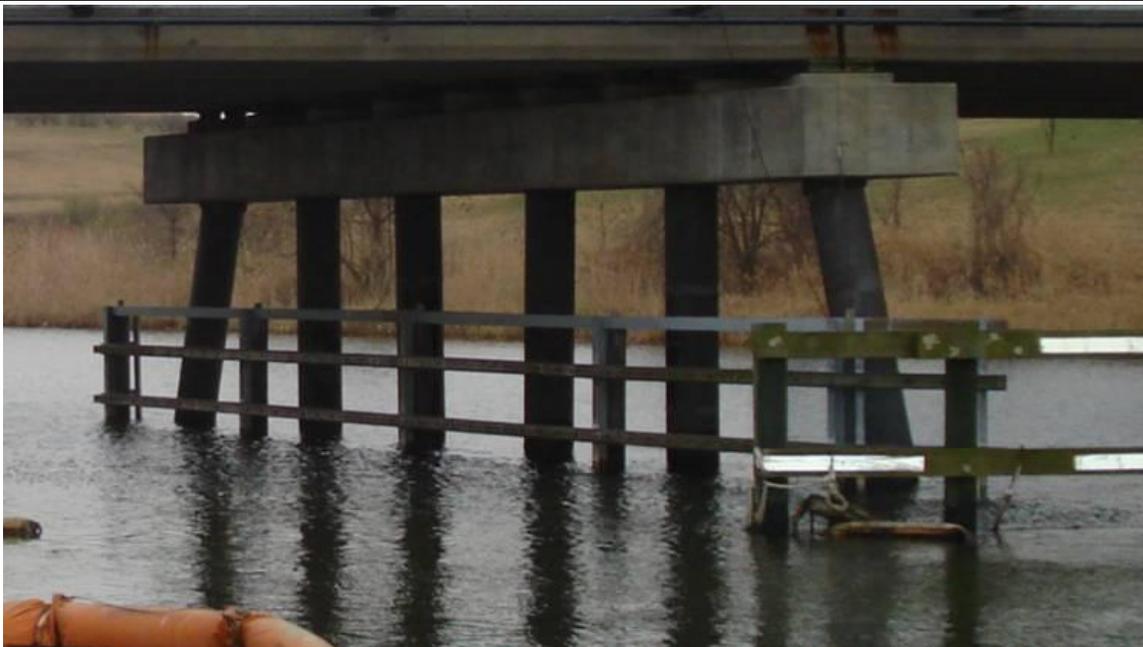
Photo No.: RC58

Location: Pier 3, north fascia looking southwest.

Description: Typical configuration of Piers 3 and 4. End piles are battered transversely. All intermediate piles are vertical.
