Fresh Kills Park

Phase 3A
Task 8.4.3
**Bridge Inspection
Report**

Final Report

August 2008

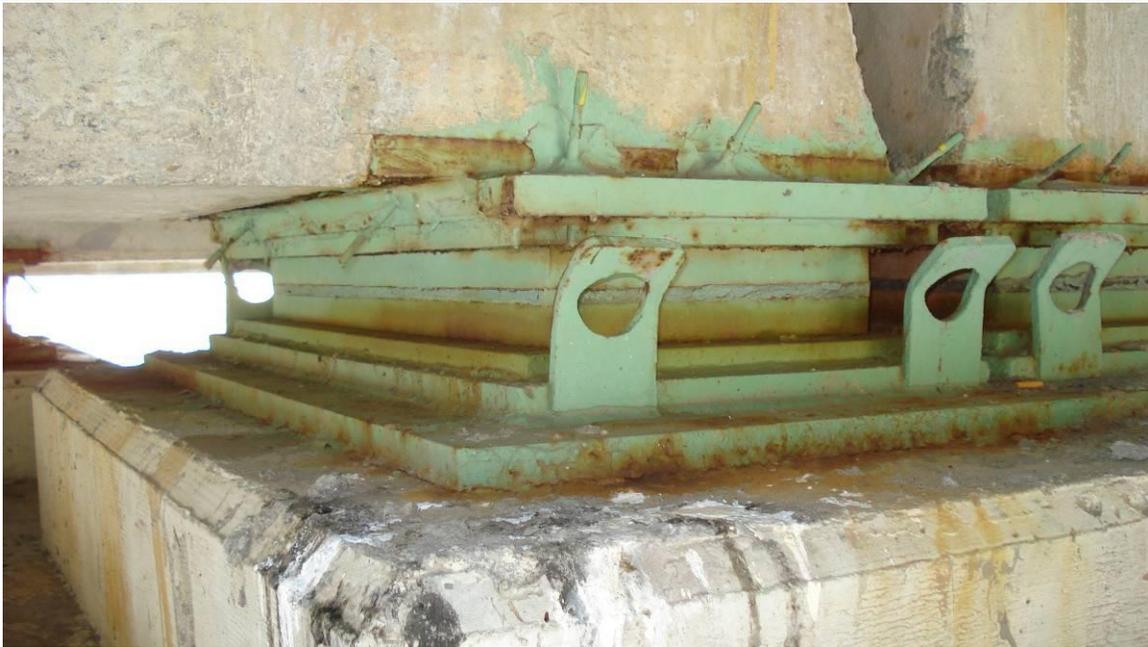
Photo No.: RC59

Location: Pier 3, Span 3, Girder 3.

Description: Typical fixed bearings in good condition with some paint loss and surface corrosion.

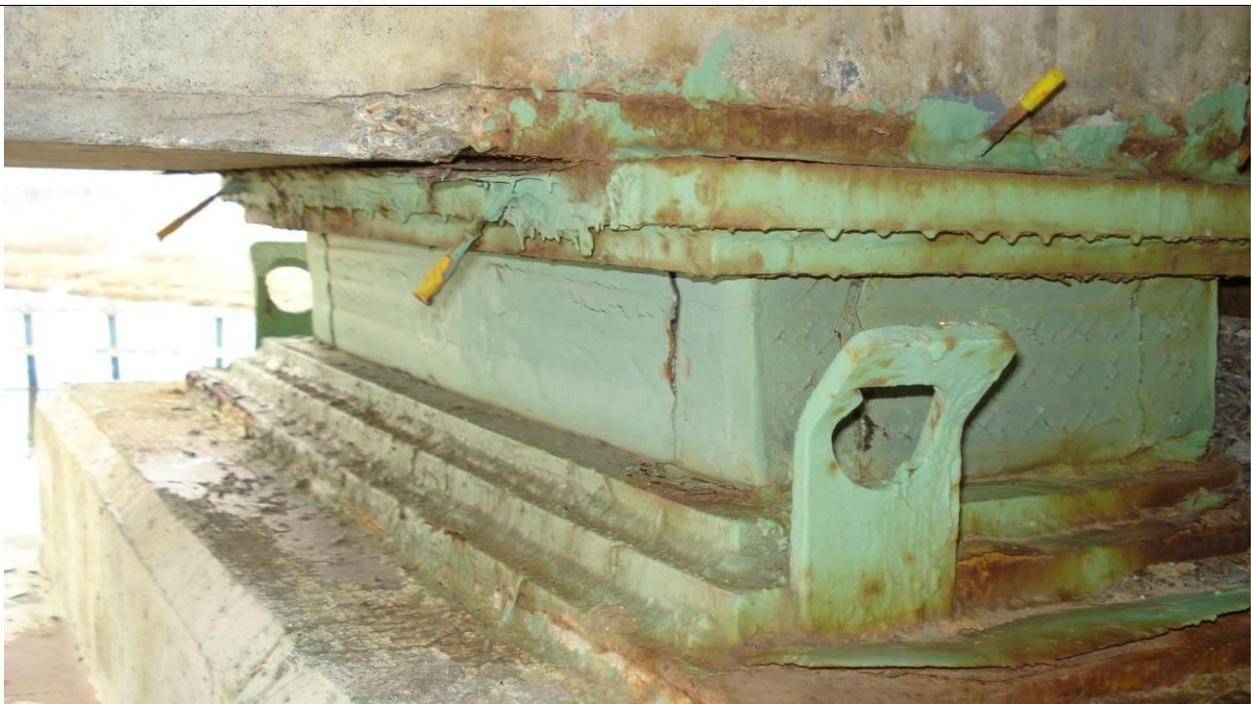
Photo No.: RC60

Location: Pier 4, Span 4, Girder 9.

Description: Typical expansion bearing in good condition with some paint loss and surface corrosion.

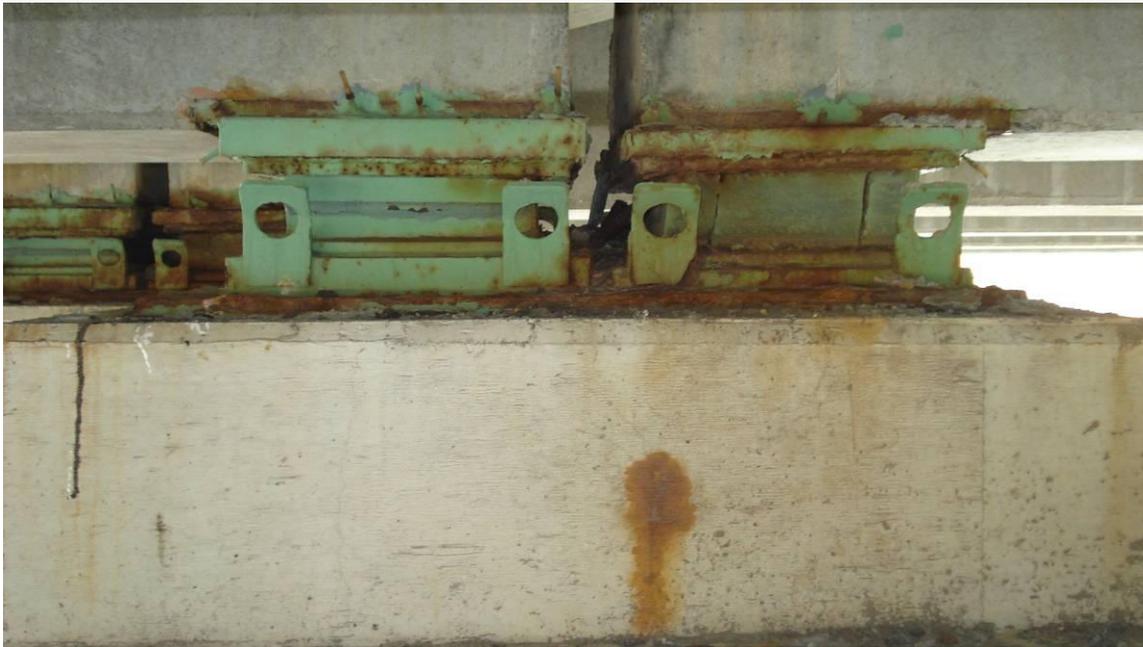
Photo No.: RC61

Location: Pier 4, Girder 5.

Description: Typical moderate paint loss and corrosion on expansion bearing on the right. Note movement accommodated by expansion bearing, which is functioning as designed.

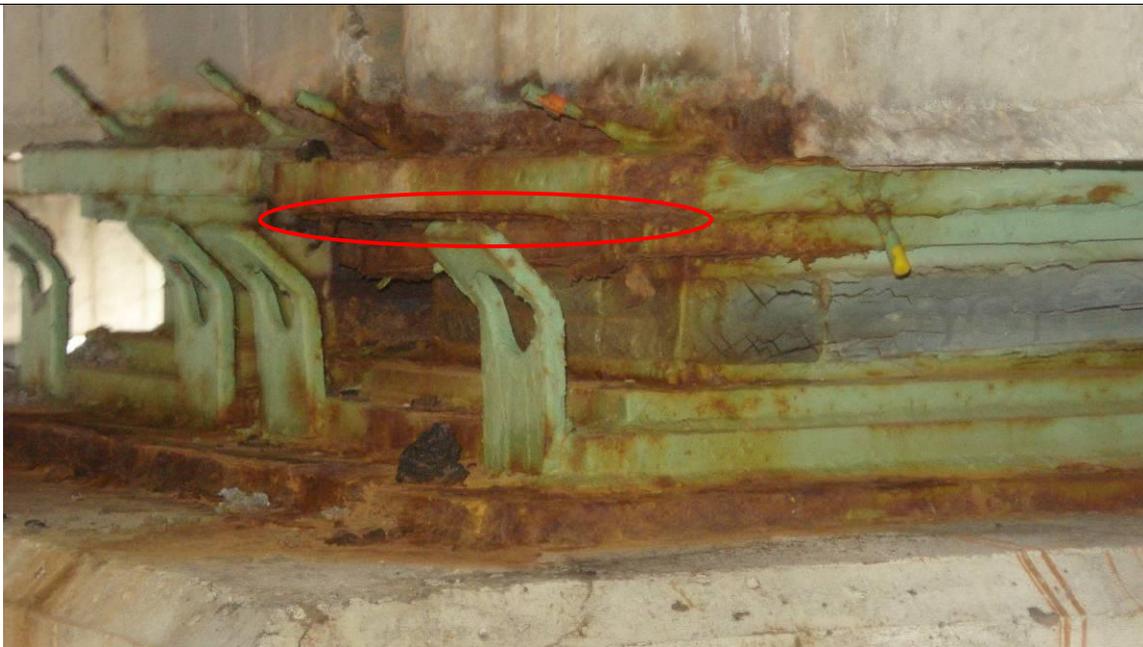
Photo No.: RC62

Location: Pier 1, Span 1, Girder 3 expansion bearing.

Description: Crevice corrosion has broken the weld between an upper guide bar and the upper bearing plate.

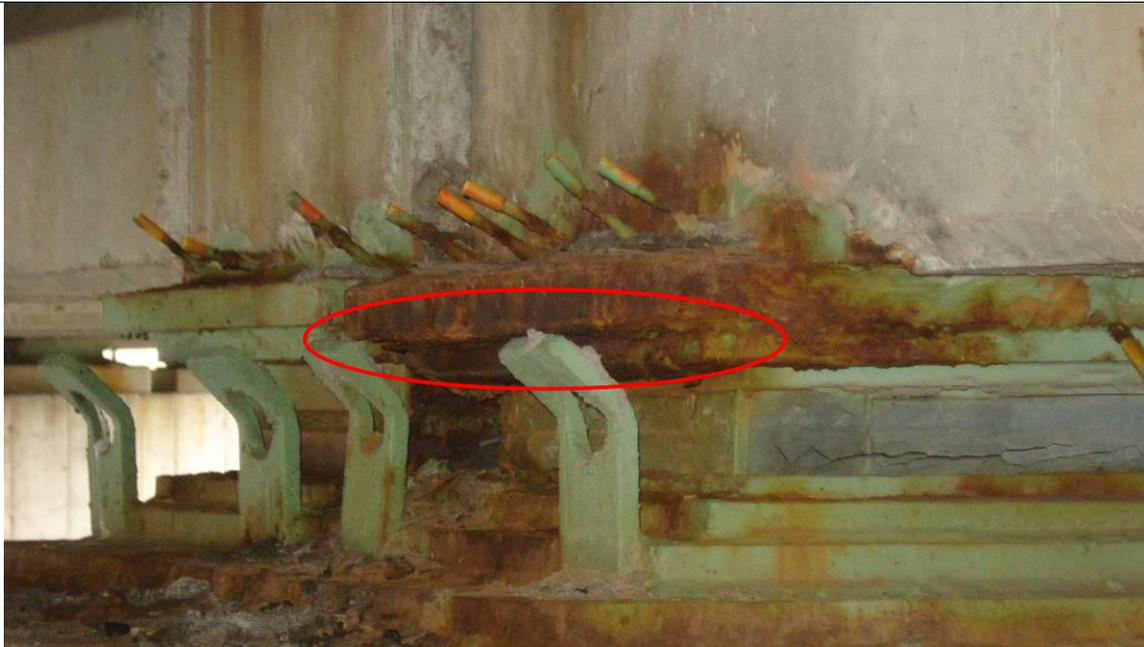
Photo No.: RC63

Location: Pier 1, Span 1, Girder 5 expansion bearing.

Description: Crevice corrosion has cracked the weld between an upper guide bar and the upper bearing plate, and the guide bar is distorted.

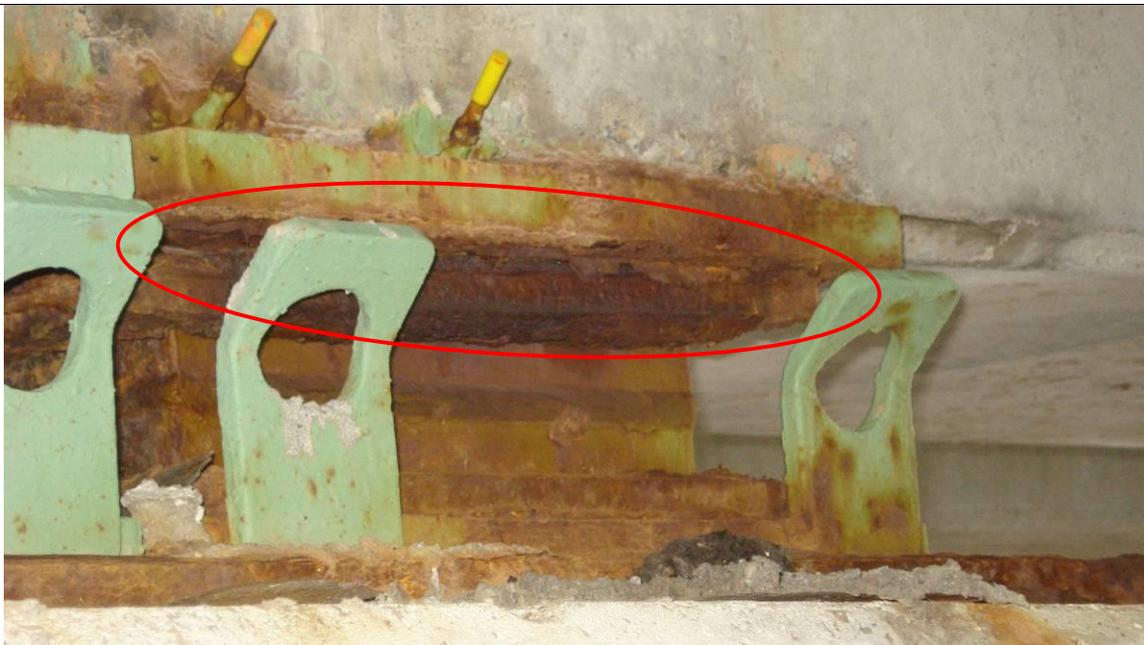
Photo No.: RC64

Location: Pier 1, Span 2, Girder 7 fixed bearing.

Description: Crevice corrosion has cracked the weld between an upper guide bar and the upper bearing plate. Guide bar has partially separated.

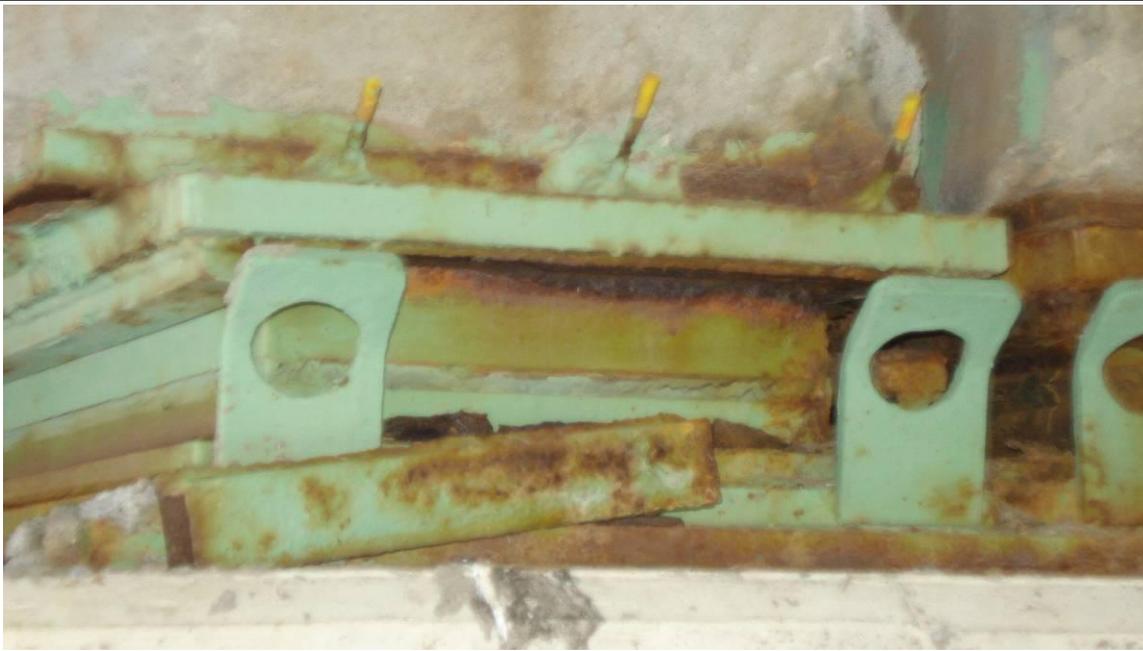
Photo No.: RC65

Location: Pier 2, Span 3, Girder 8 fixed bearing.

Description: Crevice corrosion has broken the weld between an upper guide bar and the upper bearing plate. Bar has detached entirely.

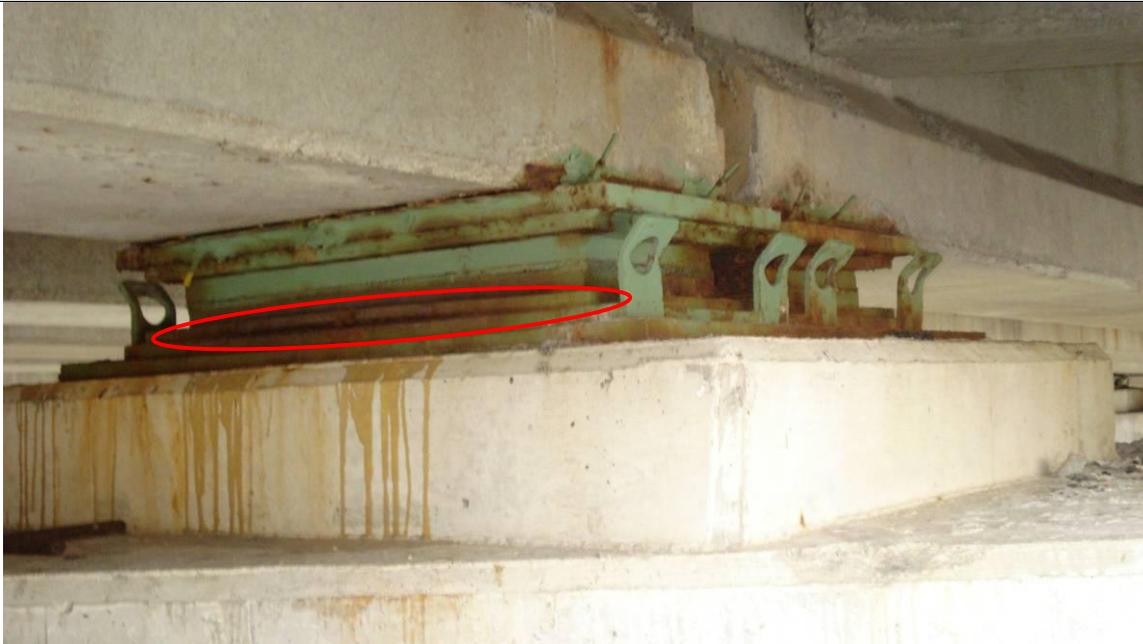
Photo No.: RC66

Location: Pier 3, Span 4, Girder 2, fixed bearing.

Description: Cracked weld between a lower guide bar and the lower bearing plate.

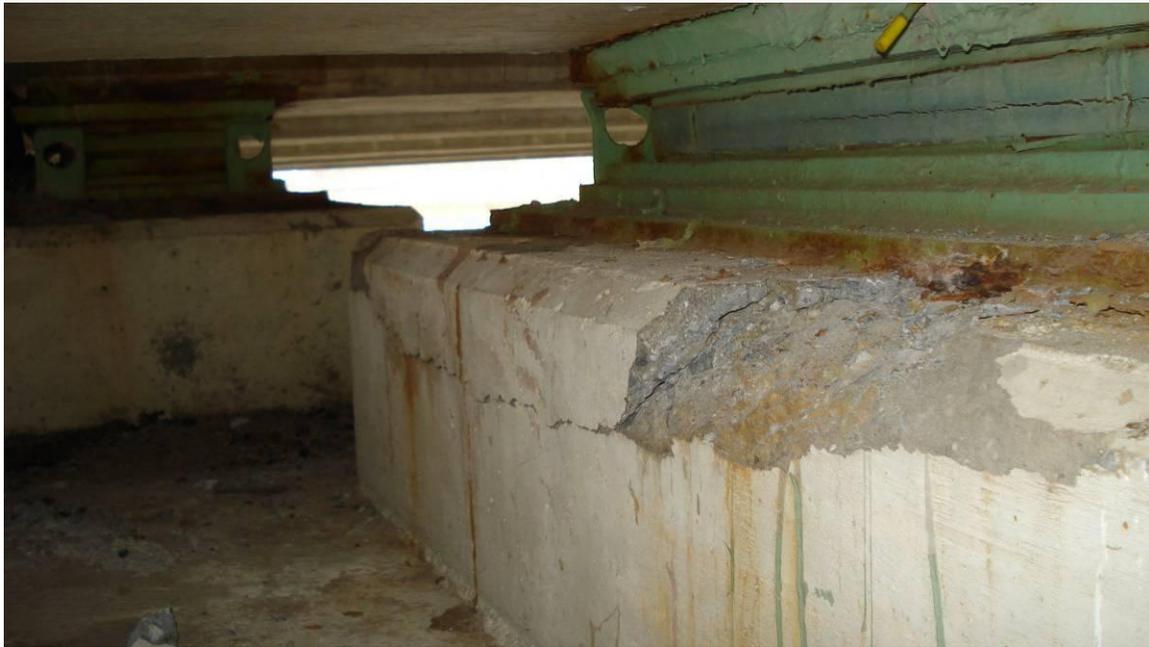
Photo No.: RC67

Location: Pier 2, Span 2, Girder 6.

Description: Delamination and spall on pedestal. The bearing is not undermined.

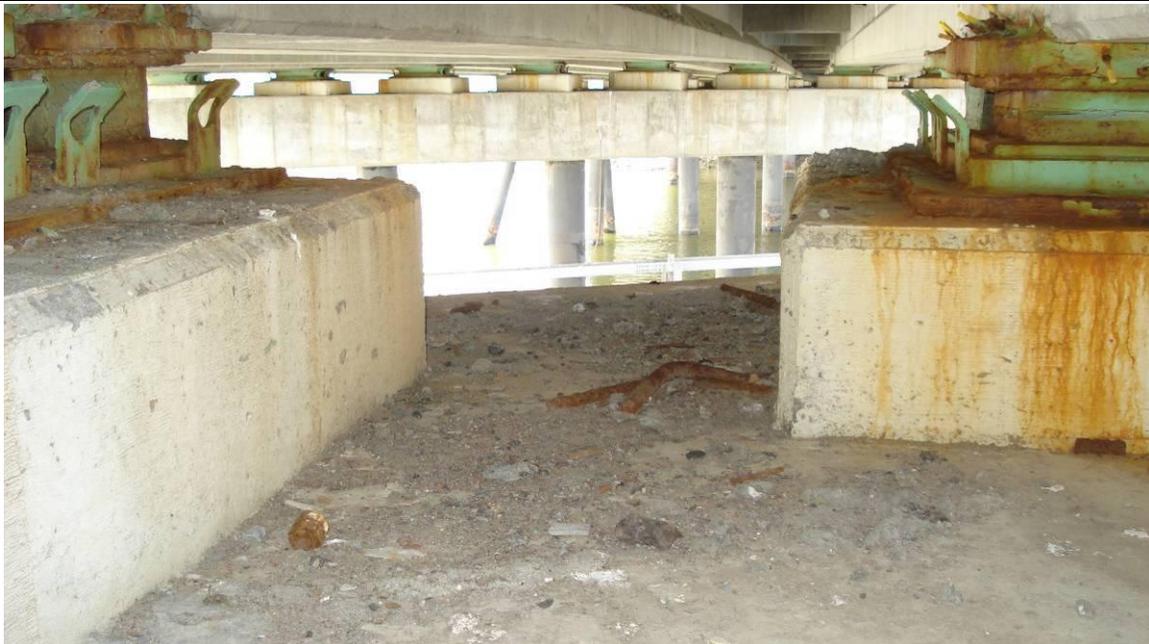
Photo No.: RC68

Location: Pier 4 top of cap beam between Girders 3 and 4.

Description: Typical debris on top of cap beam is minor.

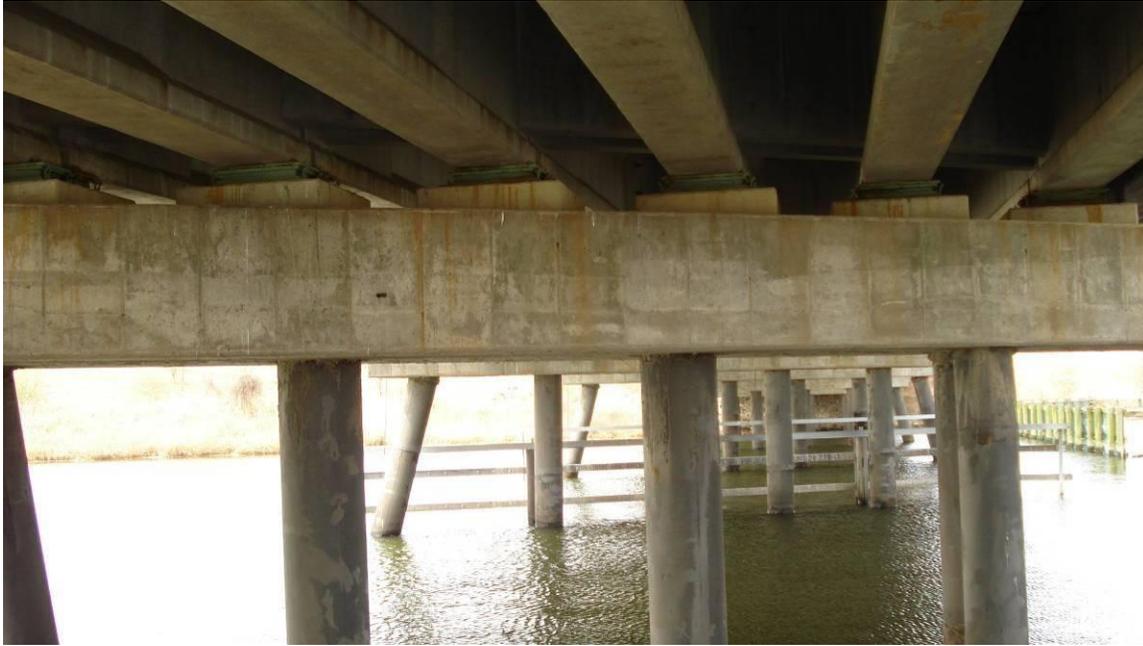
Photo No.: RC69
Location: Pier 5 cap beam, east elevation.
Description: Cap beam in good condition. Typical.

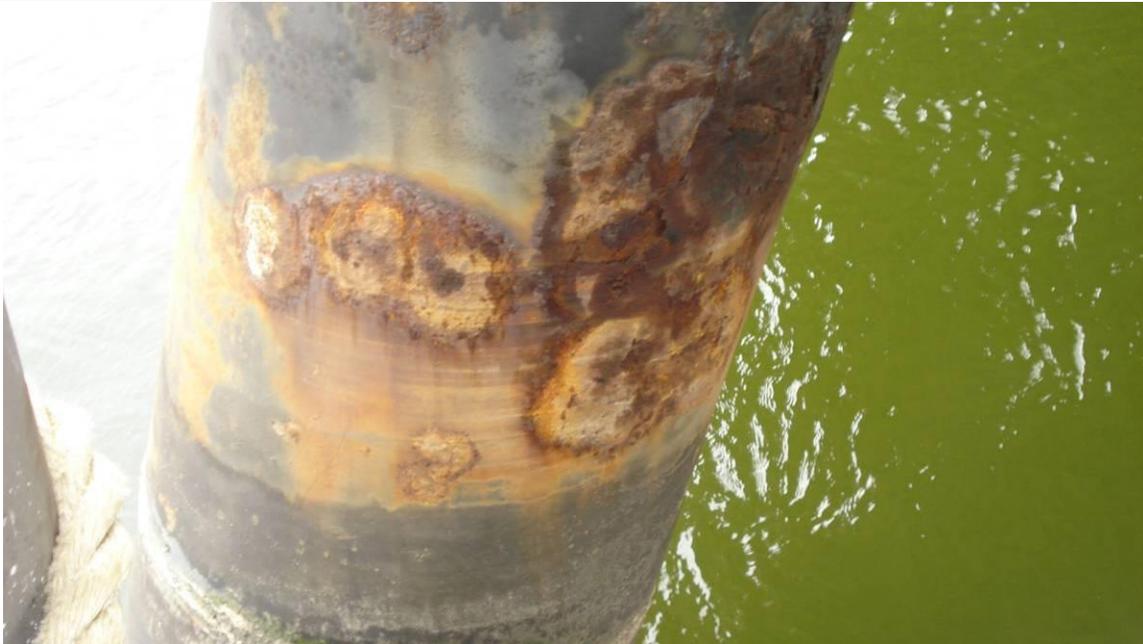
Photo No.: RC70
Location: Pier 3 southernmost pile.
Description: Typical paint loss and corrosion in the splash zone at and above high water.

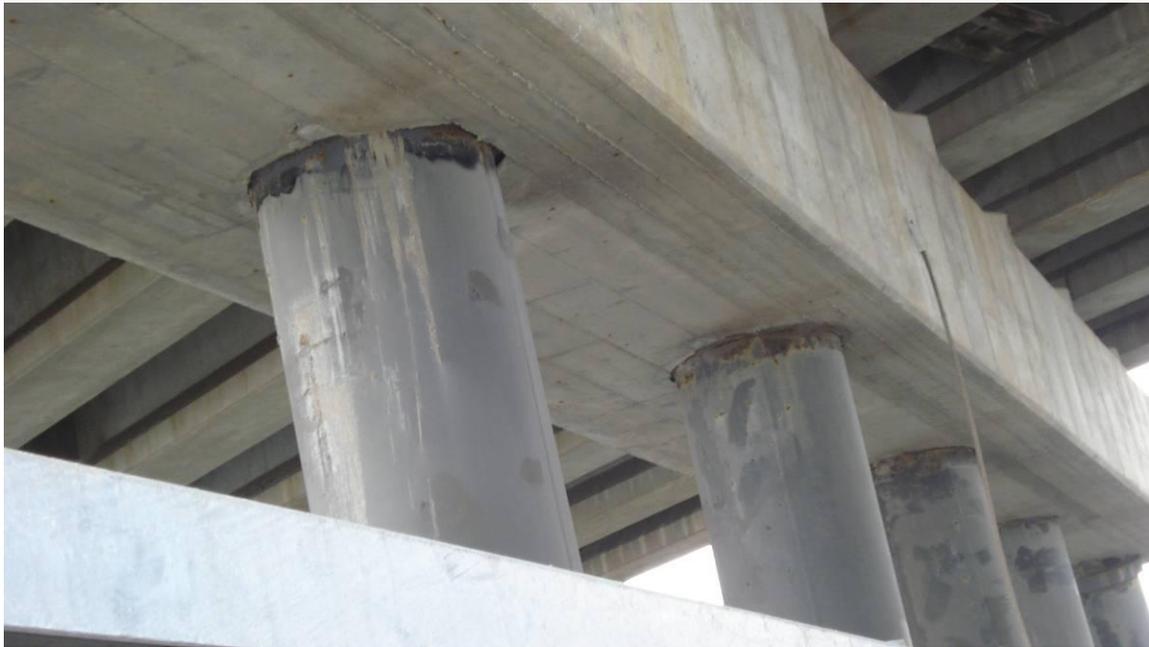
Photo No.: RC71

Location: Pier 3 underside of cap beam.

Description: Typical moderate corrosion at top of piles at interface with cap beam. Note $\frac{3}{4}$ " galvanized steel wire for cathodic protection system.

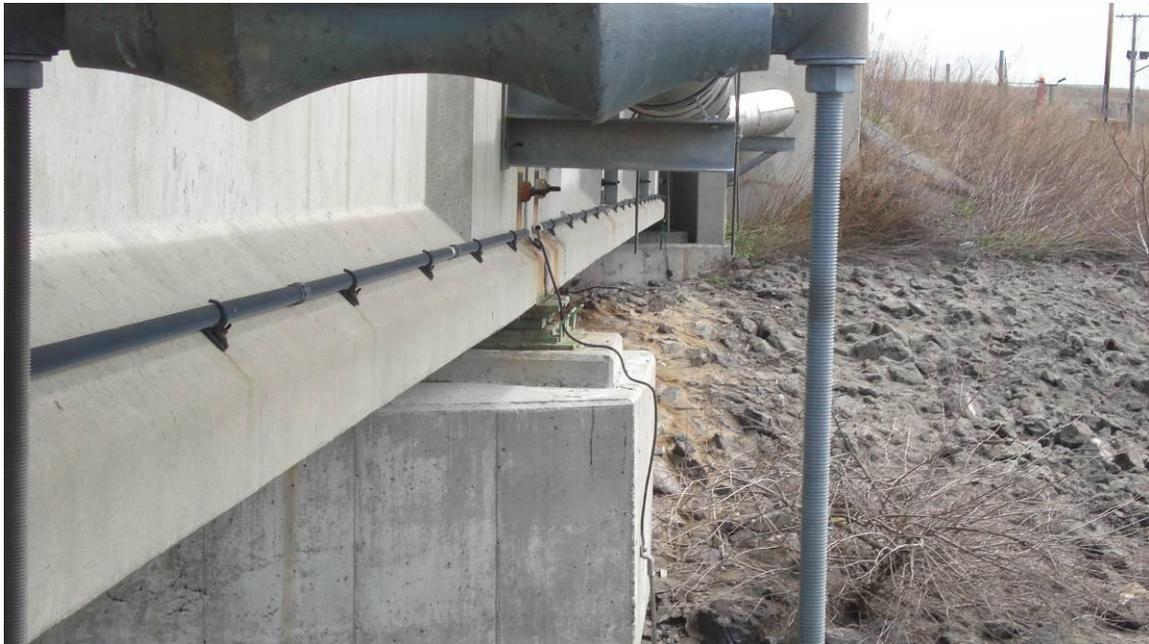
Photo No.: RC72

Location: South fascia at Pier 6.

Description: A PVC conduit carries current for an active cathodic protection system for the steel pipe piles. Wire grounds to a threaded insert welded to rebar in the end of the pier cap, and continues down to an Aluminum anode placed on the riverbed. Typical for all piers.

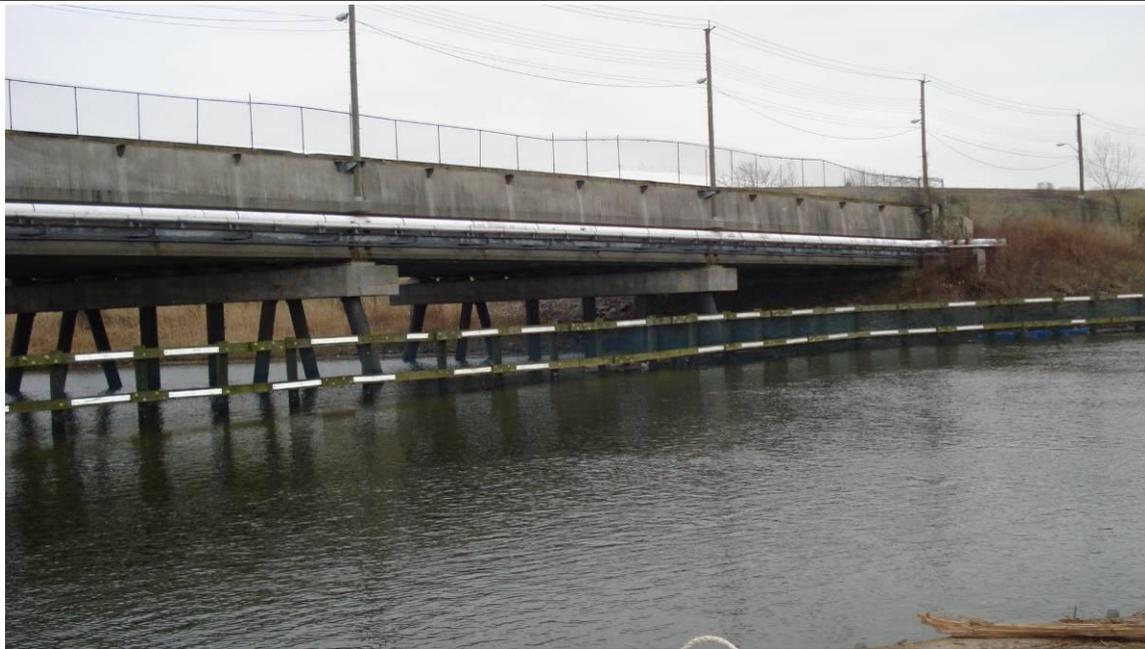
Photo No.: RC73

Location: North elevation of spans 3, 2 and 1.

Description: Timber lighting standards, luminaries and electric lines carried on the north side of the bridge. Note utilities as well carried just above the piers.

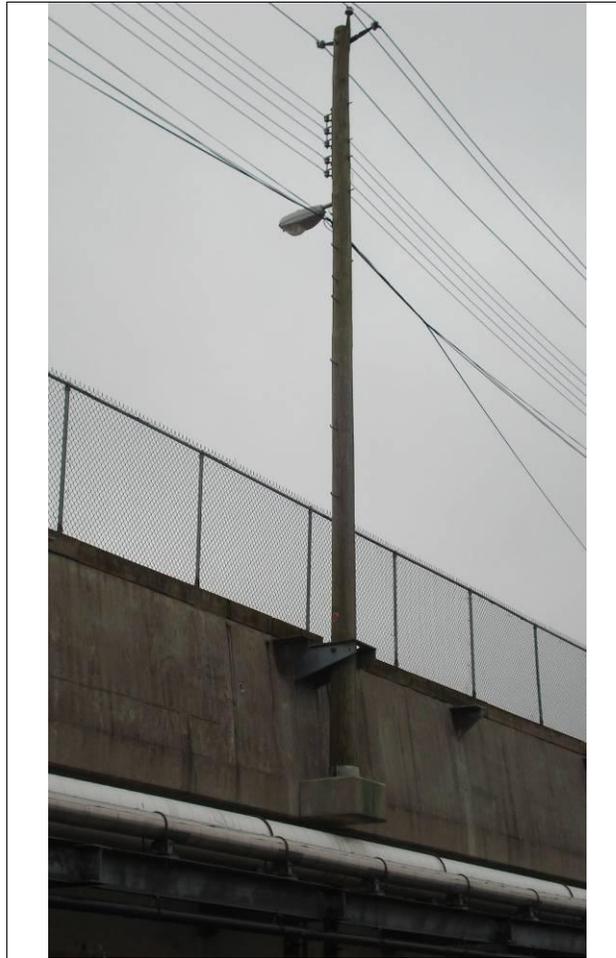
Photo No.: RC74

Location: North fascia at Pier 7.

Description: Typical timber lighting standard and luminaire in good condition.

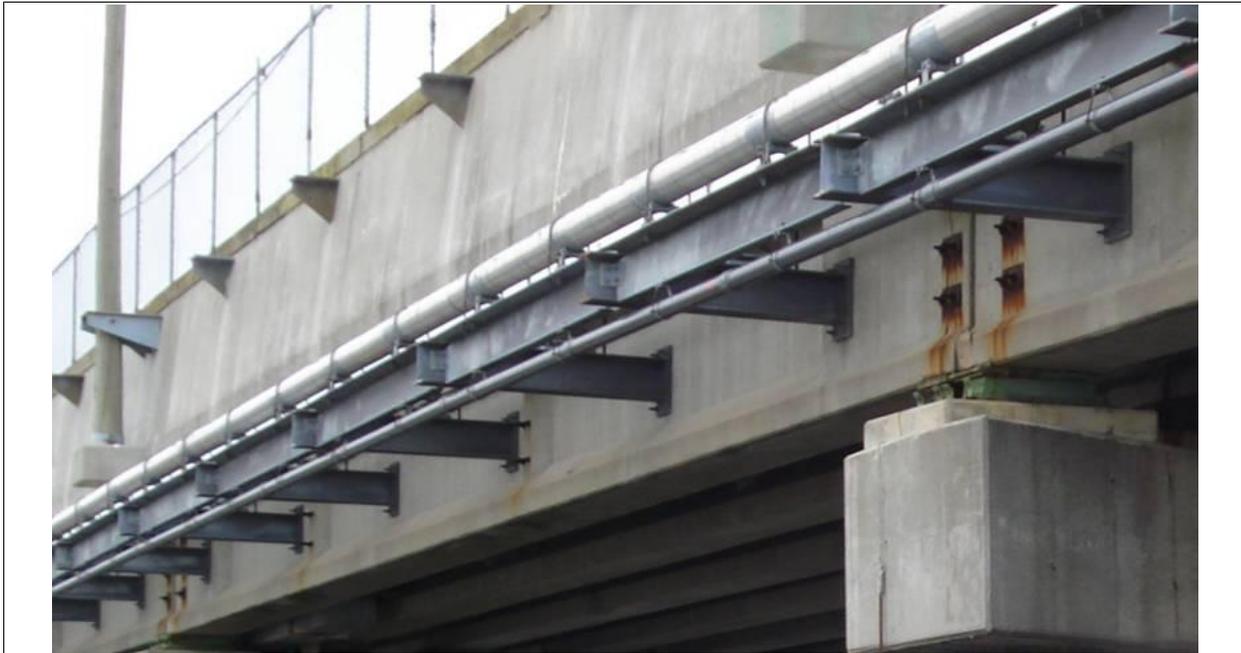
Photo No.: RC75

Location: North elevation of Span 4.

Description: Galvanized steel frame supporting north side utilities in good condition.

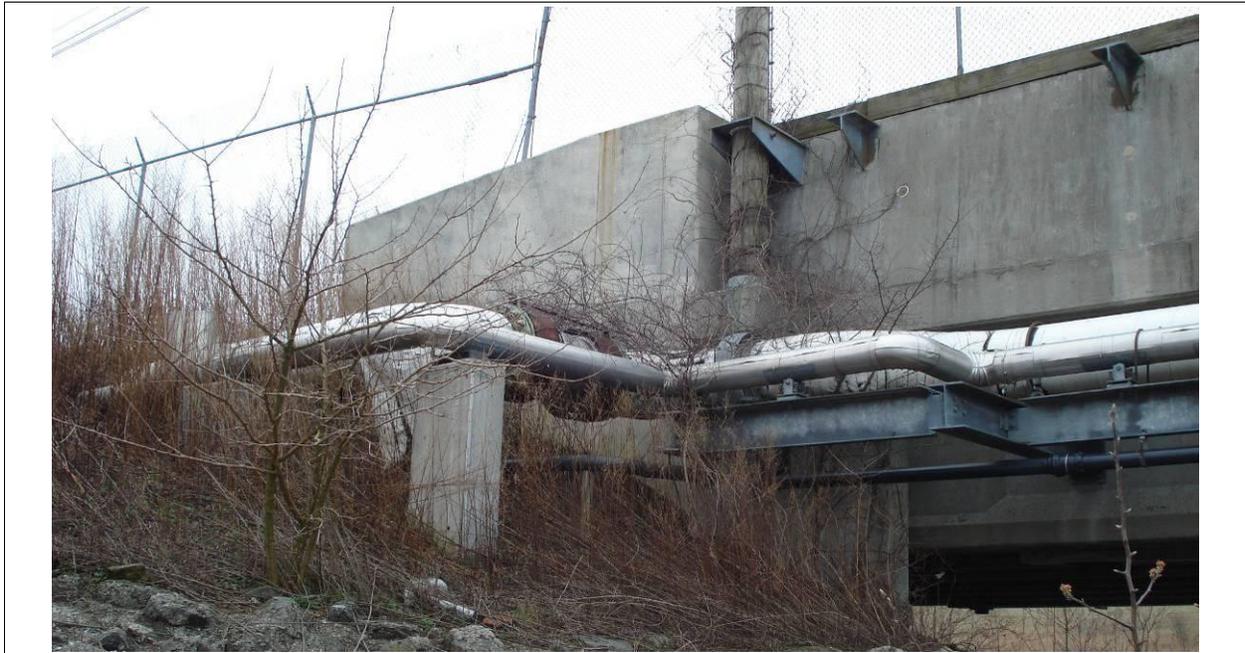
Photo No.: RC76

Location: Northeast wingwall.

Description: General configuration of utility terminations at end of bridge. Utilities and supports in good condition. Northwest termination similar.

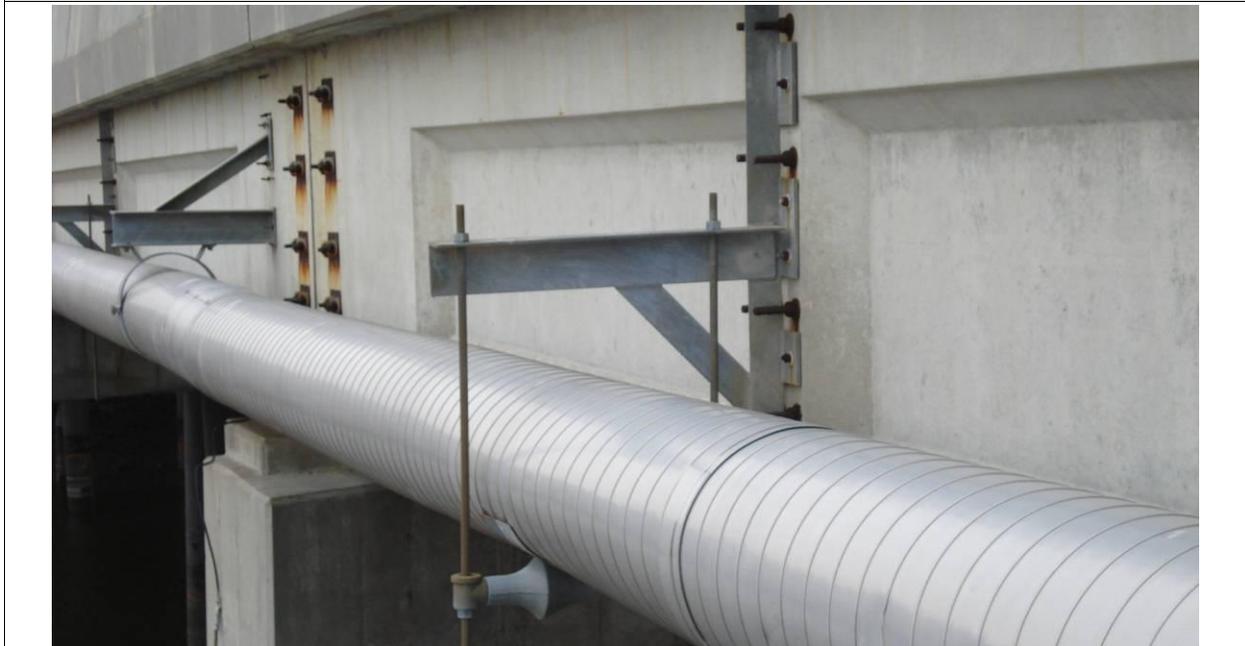
Photo No.: RC77

Location: South fascia.

Description: Galvanized steel supports for south side insulated utility line in good condition. Typical.

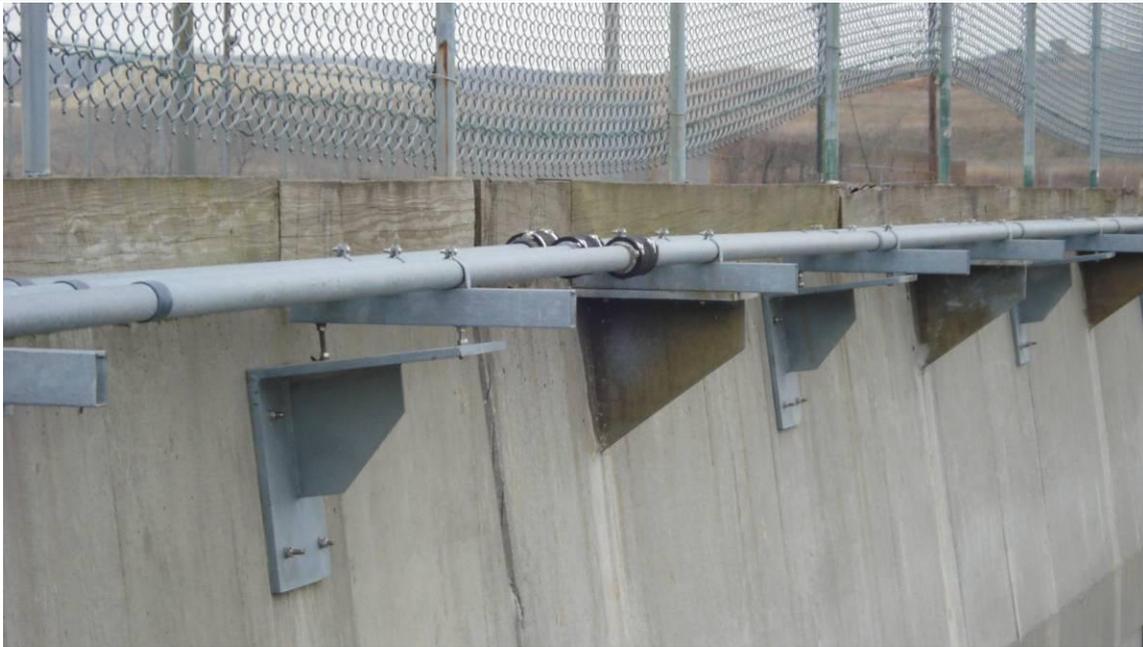
Photo No.: RC78

Location: South fascia.

Description: General configuration of three galvanized utility conduits in good condition. Conduits have been mounted on brackets originally intended for future fire control system never installed.

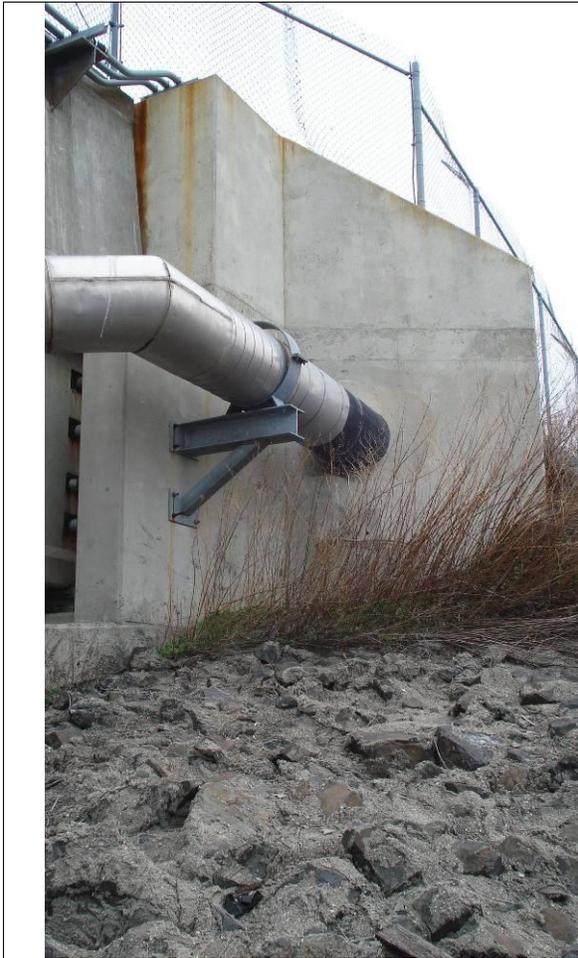
Photo No.: RC79
Location: Southeast wingwall.
Description: Landfill utility line penetrates through the wingwall, in good condition. Southwest termination similar.

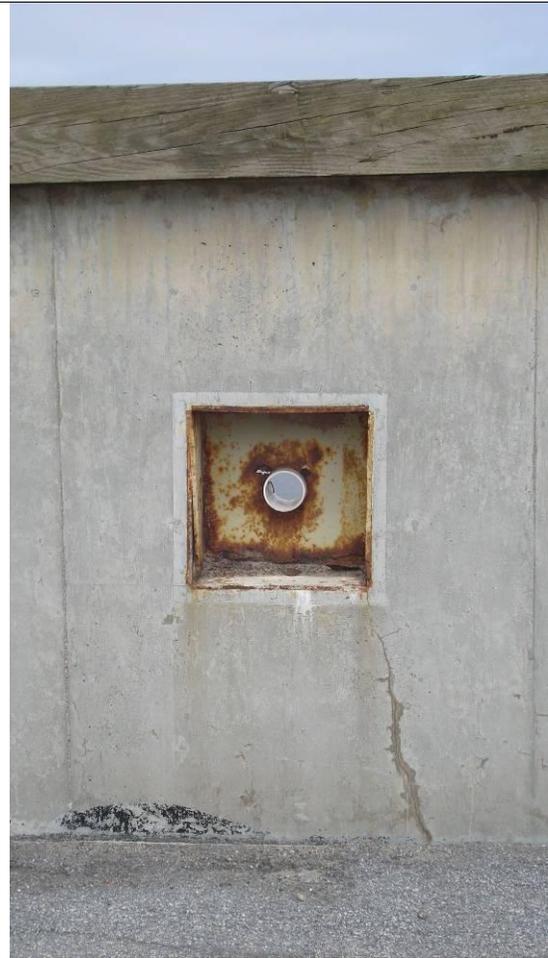
Photo No.: RC80
Location: Span 2, inside face of north parapet, 6 ft. from Pier 1.
Description: Junction box installed for future fire control system never installed. Stainless steel cover is missing. Typical.

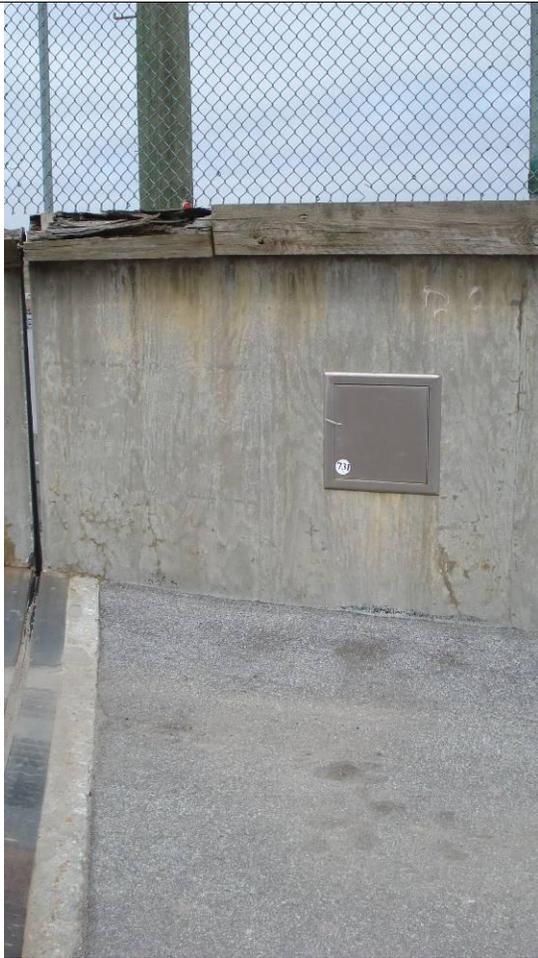
Photo No.: RC81
Location: Span 7 inside face of north parapet near Pier 6..
Description: Junction box installed for future fire control system with intact cover in good condition.

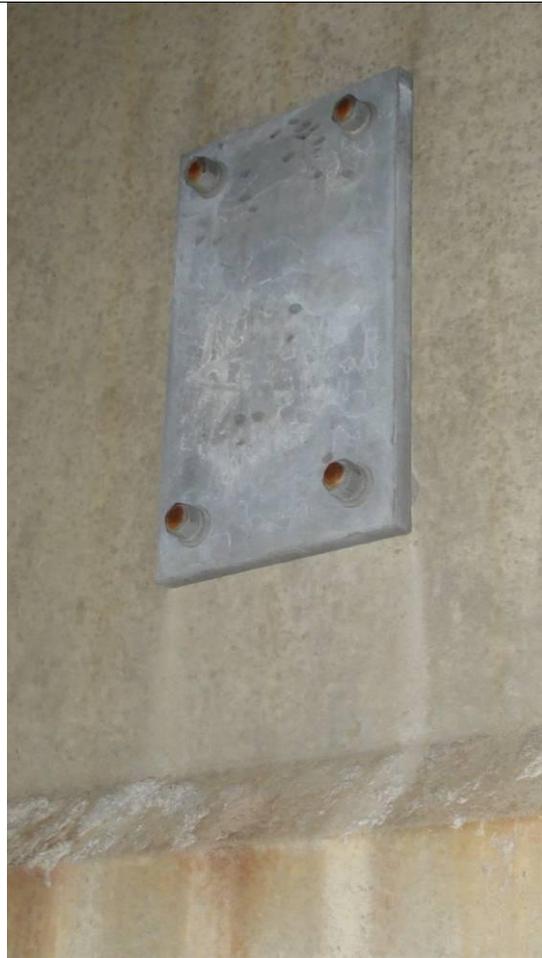
Photo No.: RC82
Location: Inside web face of north fascia girder.
Description: Typical back-up plate for utility support brackets in good condition.

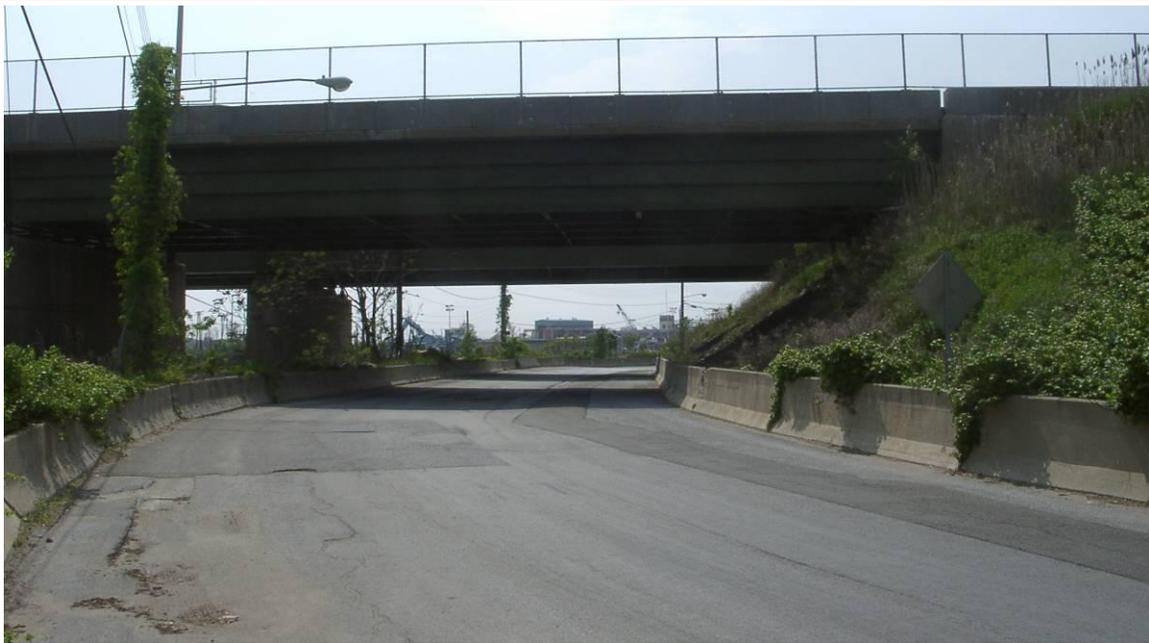
Photo No.: WSE01

Location: North shore underpass, looking west.

Description: General configuration. Note concrete Jersey barriers on both sides of roadway.

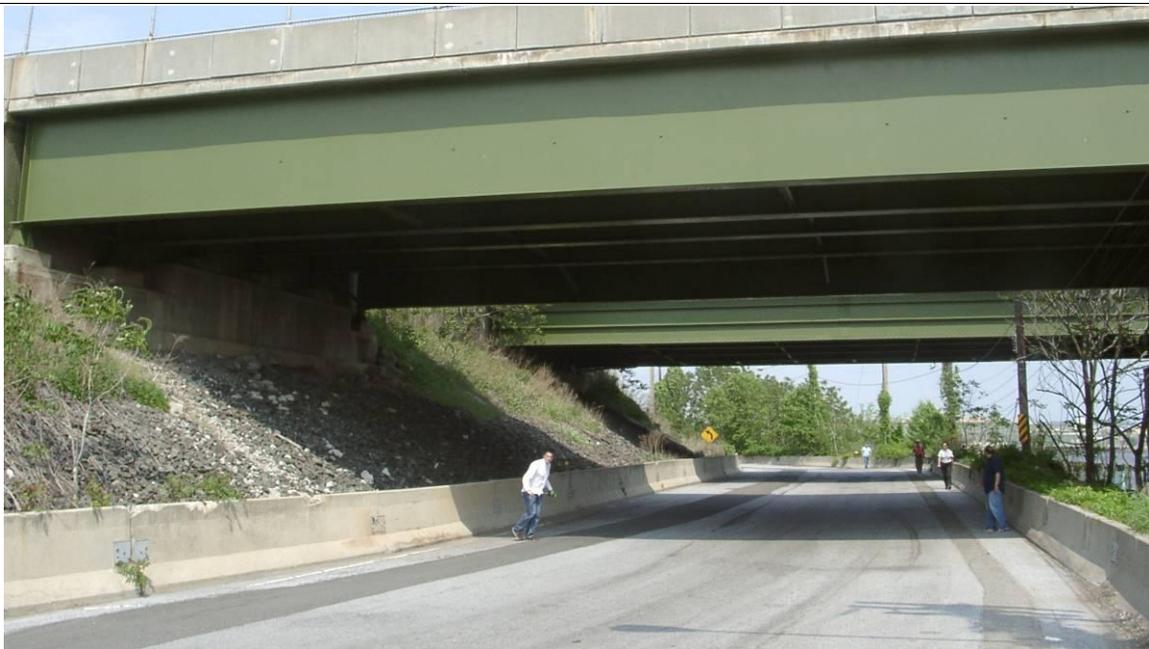
Photo No.: WSE02

Location: North shore underpass, looking east.

Description: General configuration. Note concrete Jersey barriers on both sides of roadway.

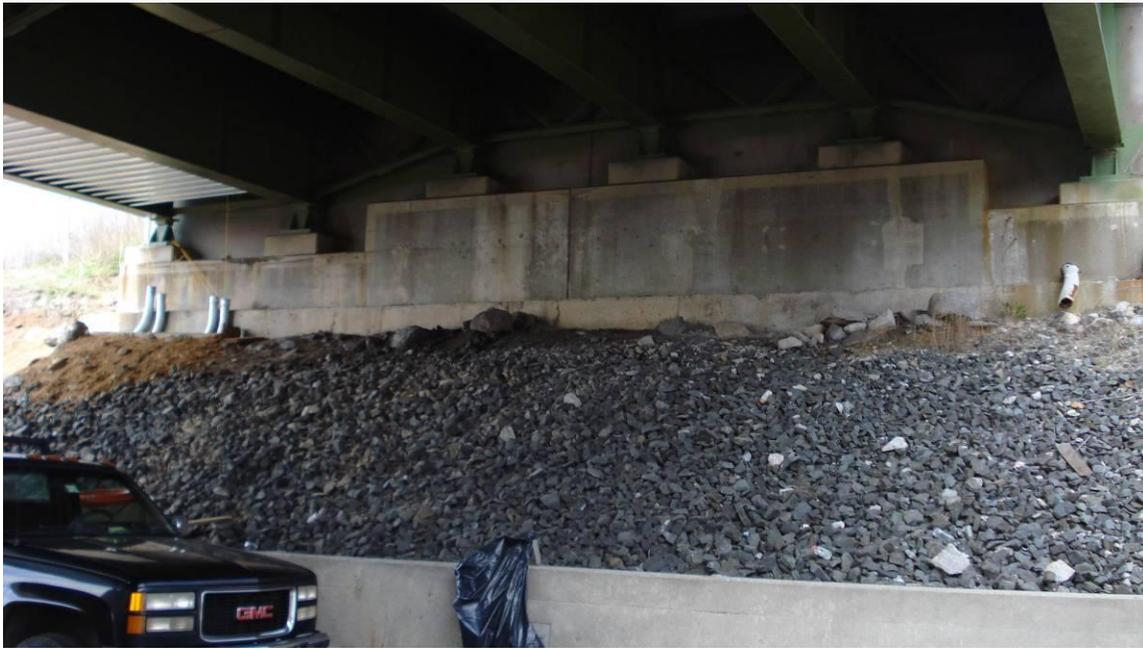
Photo No.: WSE03

Location: North shore under west bridge.

Description: Abutment slope stabilized with stone rip-rap.

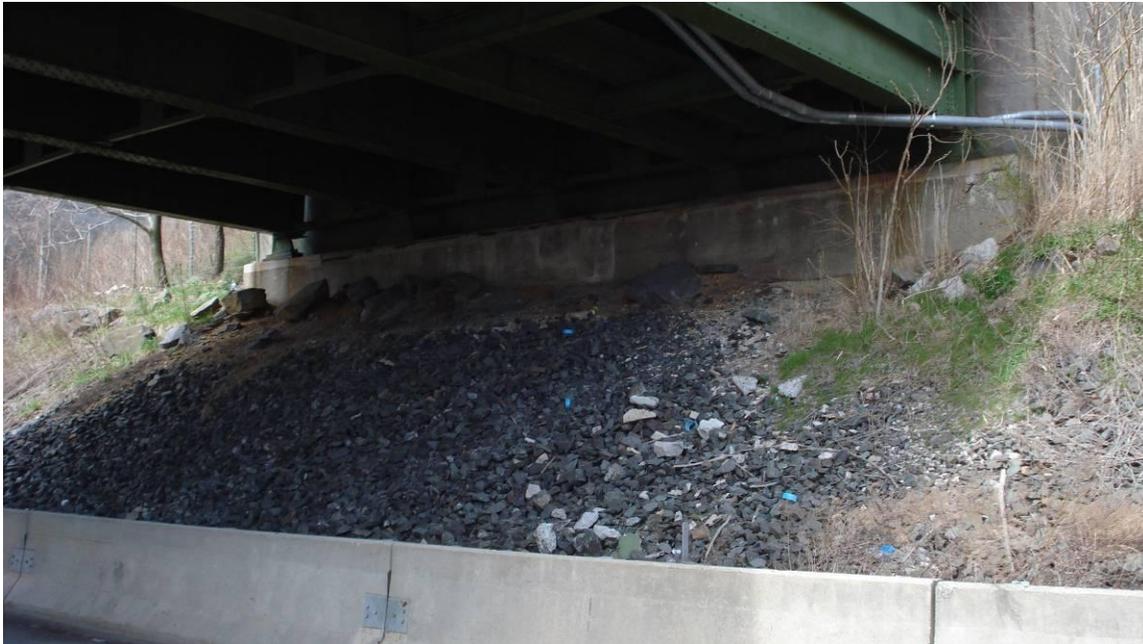
Photo No.: WSE04

Location: North shore below east bridge.

Description: Abutment slope stabilized with stone rip-rap.

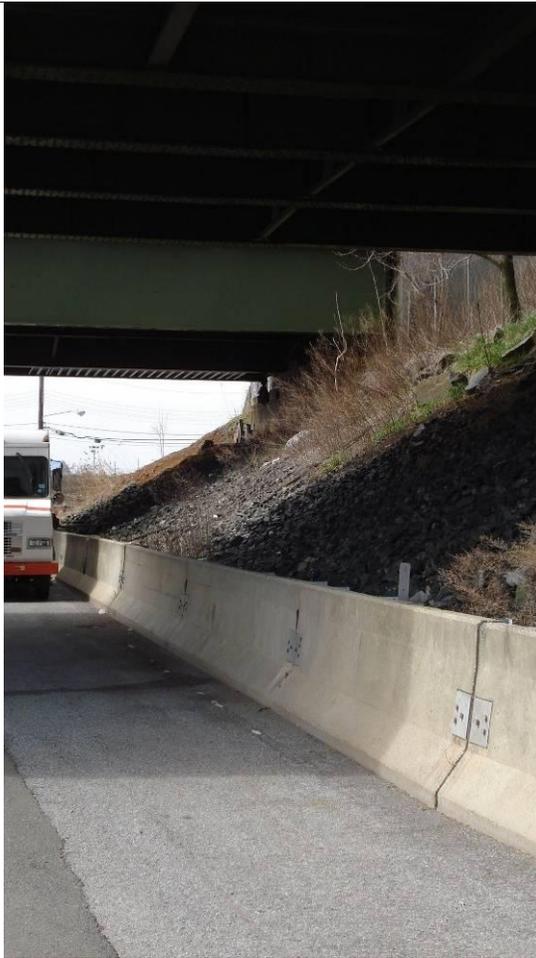
Photo No.: WSE05

Location: North shore underpass looking west.

Description: Concrete Jersey barriers at the toe of the abutment slope. Typical.

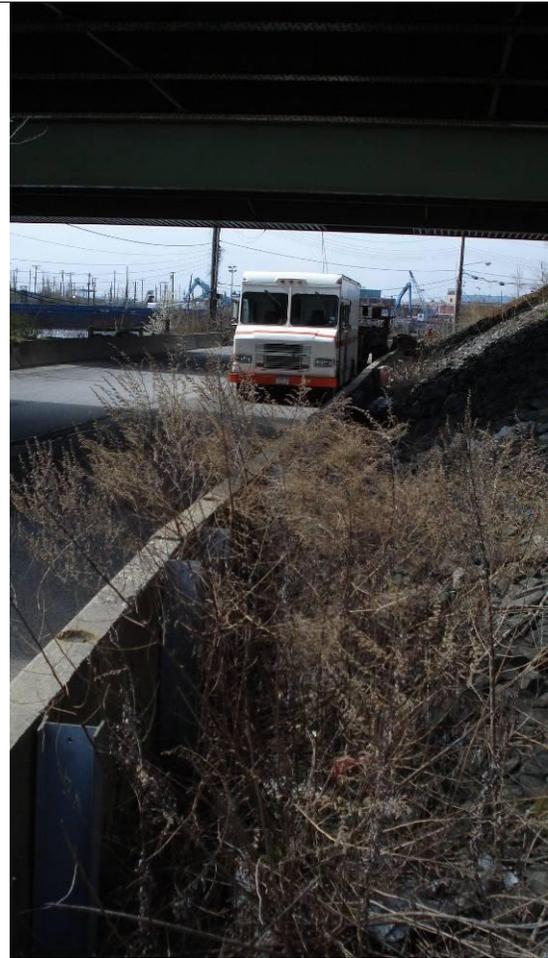
Photo No.: WSE06

Location: North shore underpass looking west.

Description: Barriers are backed-up with galvanized guiderail posts. Barriers act to retain the slope.
