Fresh Kills Park

Phase 3A
Task 8.4.3
**Bridge Inspection
Report**

Final Report

August 2008

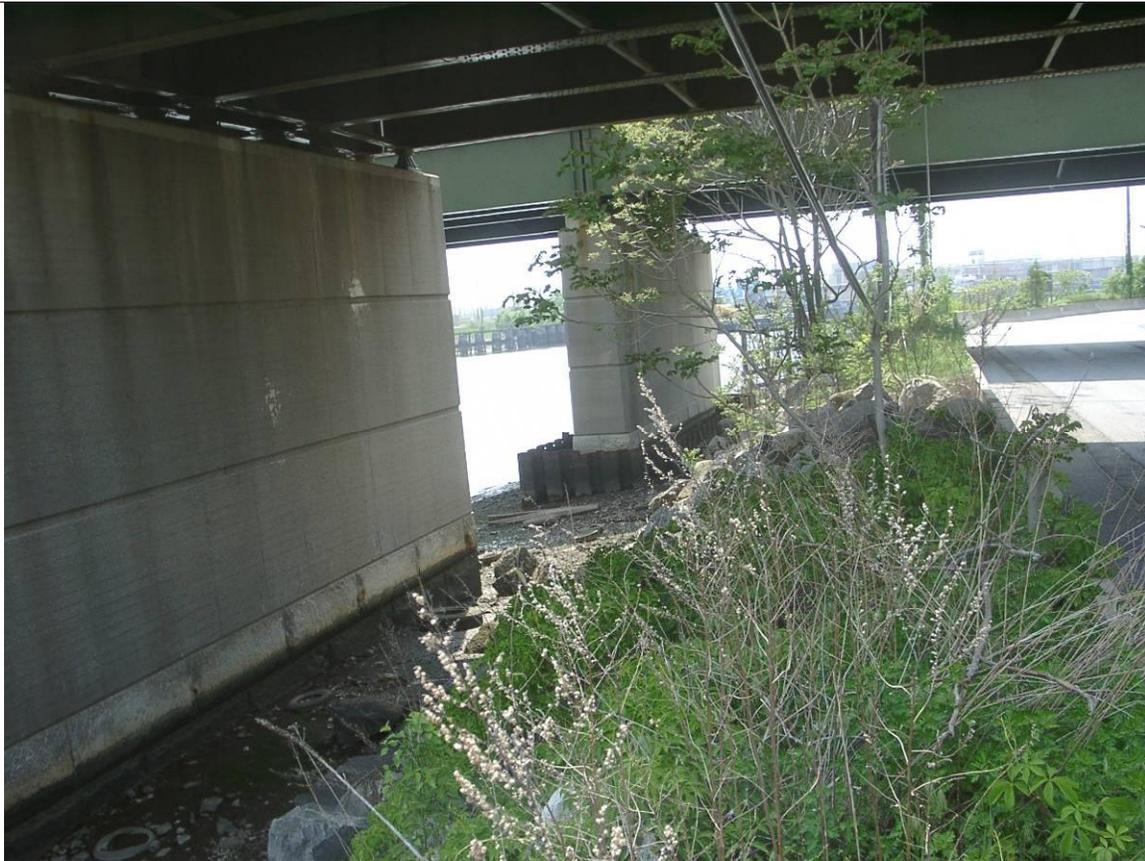
Photo No.: WSE07

Location: North shoreline looking west.

Description: Shore slopes down a short distance beyond the shore side barriers.

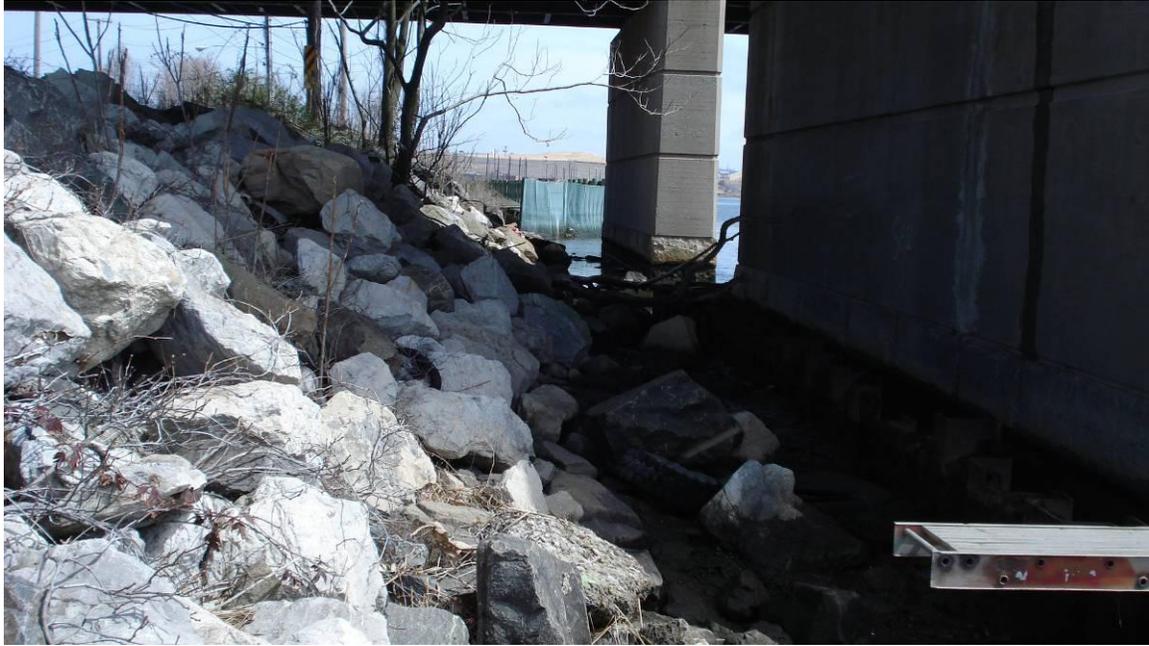
Photo No.: WSE08

Location: North shoreline looking east.

Description: Shore stabilized with large stone rip-rap.

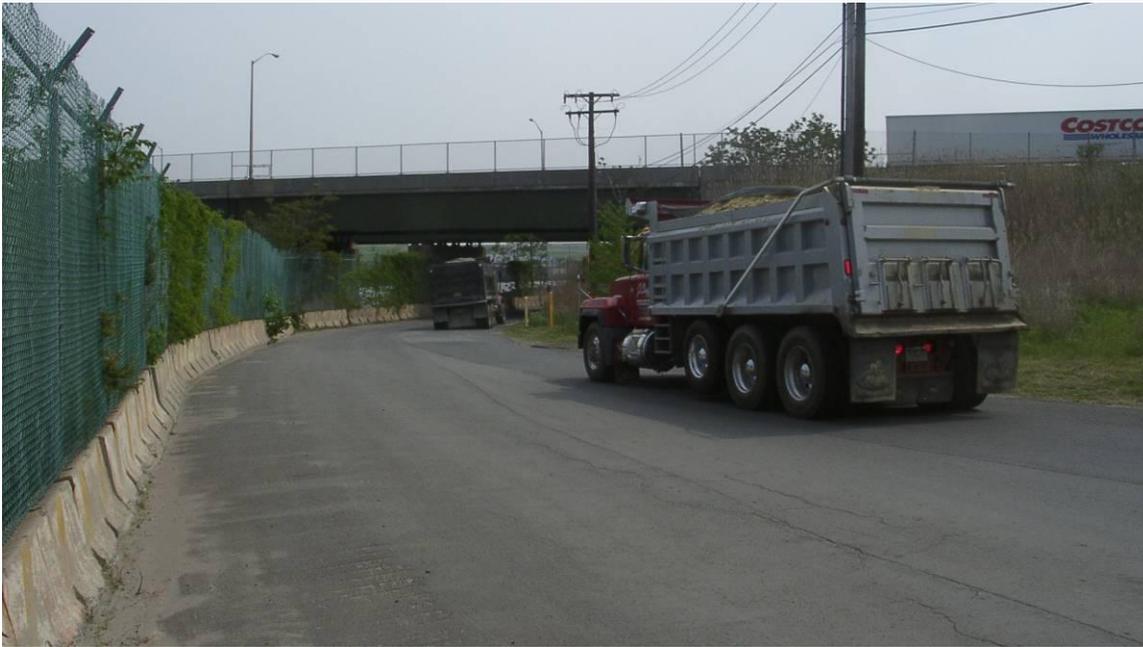
Photo No.: WSE09

Location: South shore underpass looking east from the west approach.

Description: General configuration. Barriers and fence in fair to poor condition.

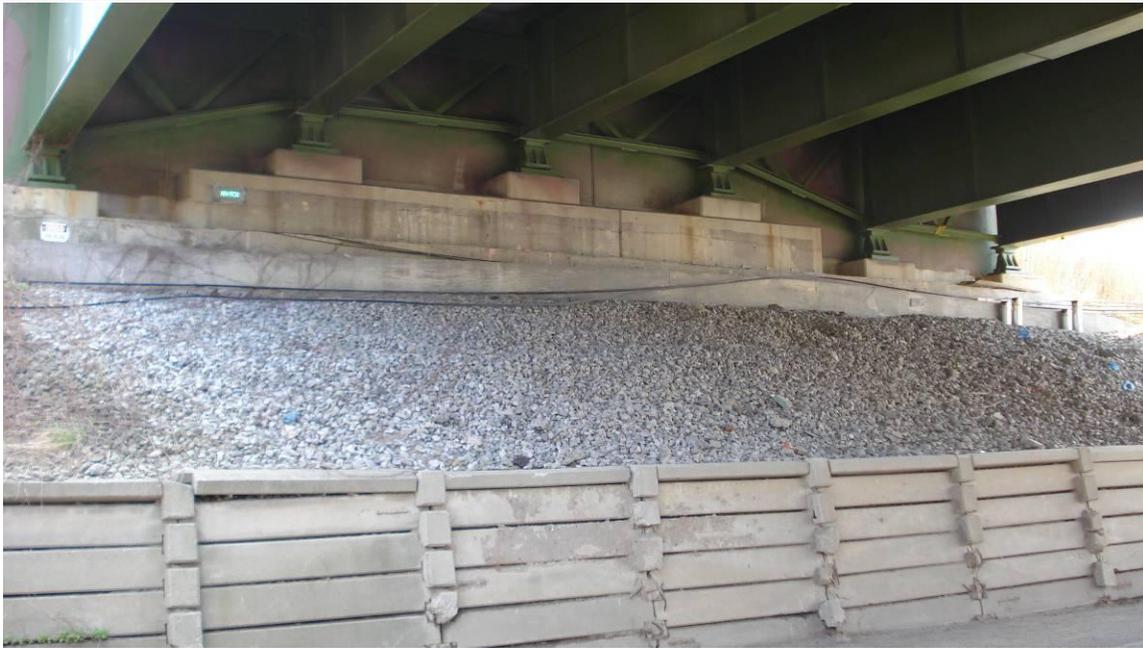
Photo No.: WSE13

Location: South shore west bridge abutment slope.

Description: General configuration. Slope stabilized with gravel and stone. Typical for both bridges.

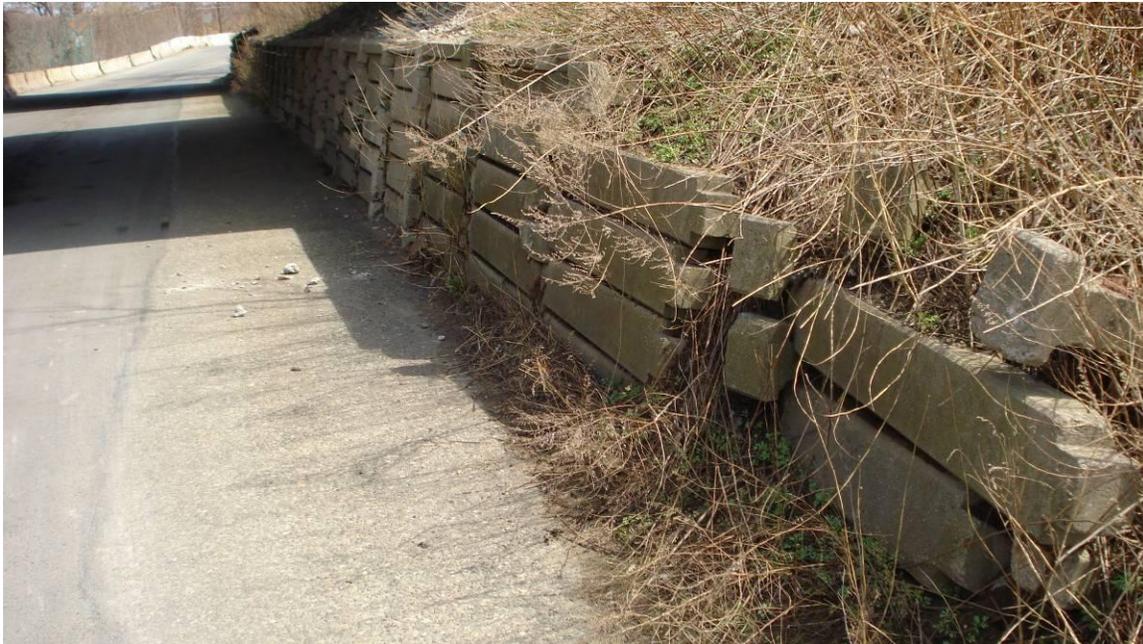
Photo No.: WSE14

Location: South shore underpass, west of west bridge, looking east.

Description: Beginning of concrete crib wall. Wall badly deteriorated.

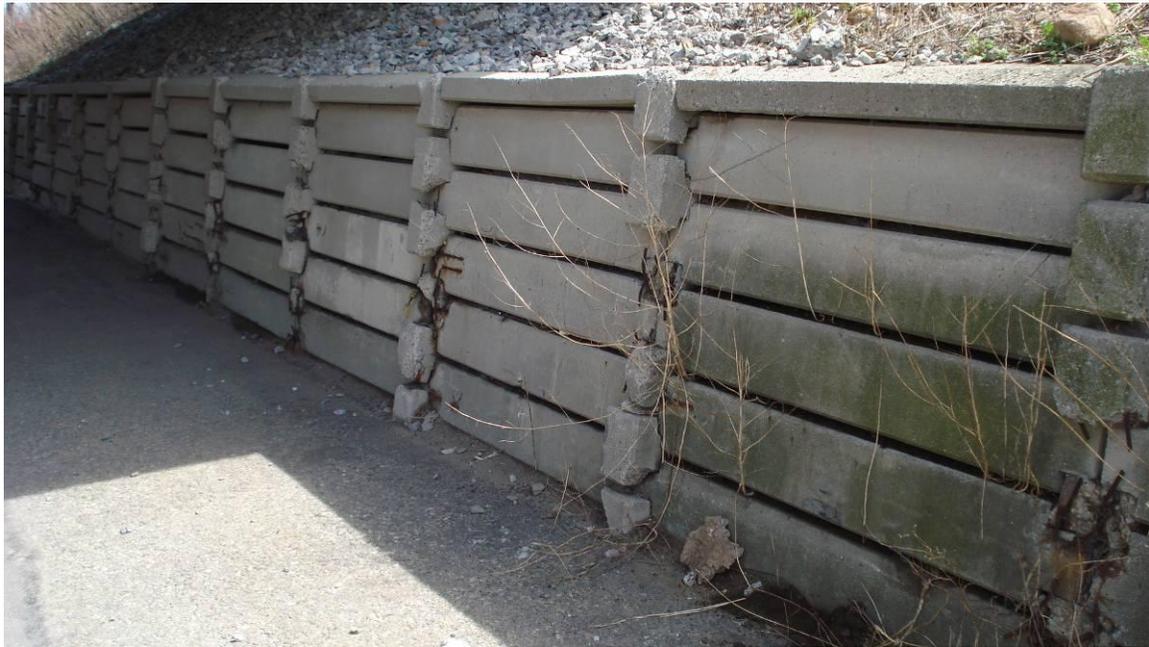
Photo No.: WSE15

Location: South shore underpass, just west of west bridge, looking east.

Description: Continuing east along crib wall. Wall stable at this section, but deteriorating.

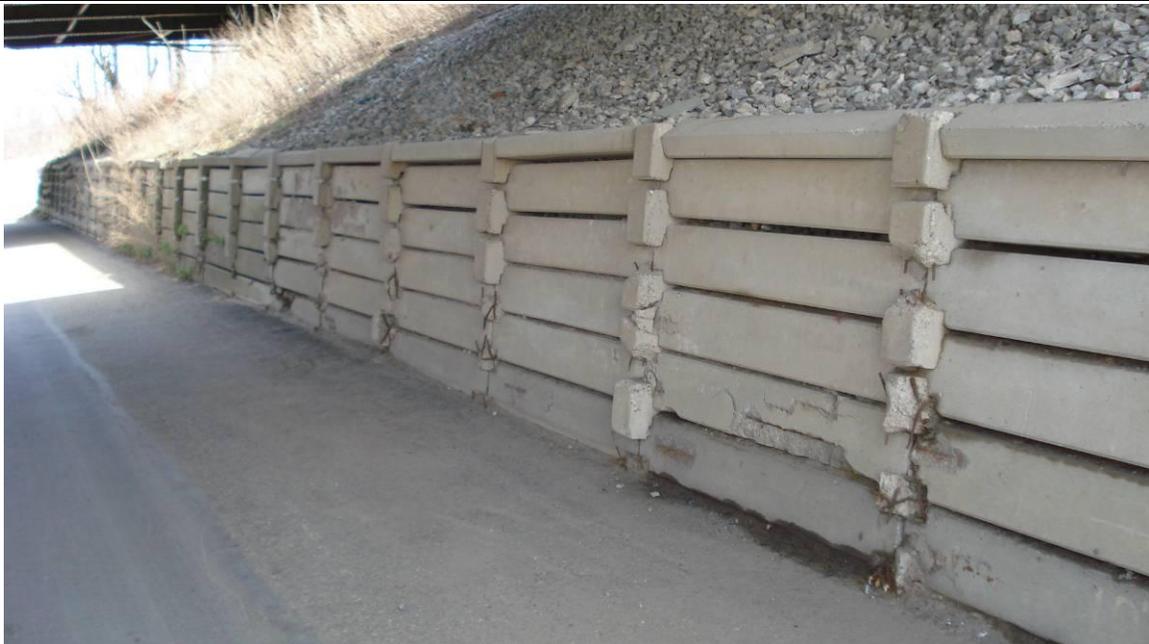
Photo No.: WSE16

Location: South shore underpass, below west bridge, looking east.

Description: Continuing east along crib wall. Wall stable at this section, but deteriorating.

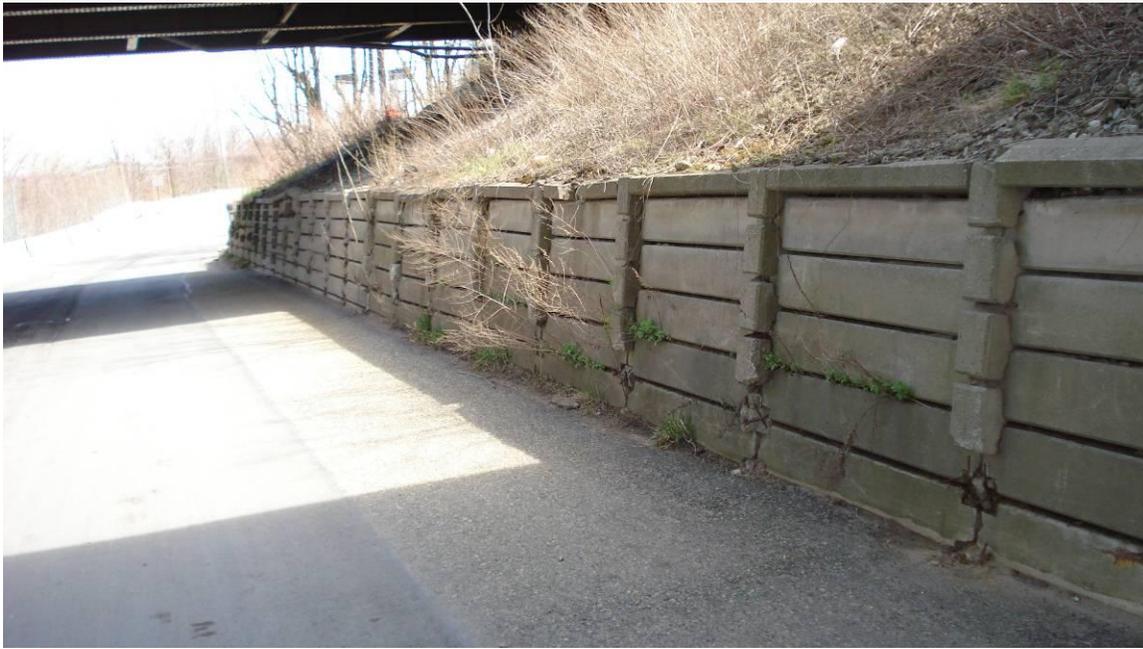
Photo No.: WSE17

Location: South shore underpass, between east and west bridges, looking east.

Description: Continuing east along crib wall. Wall stable at this section, but deteriorating.

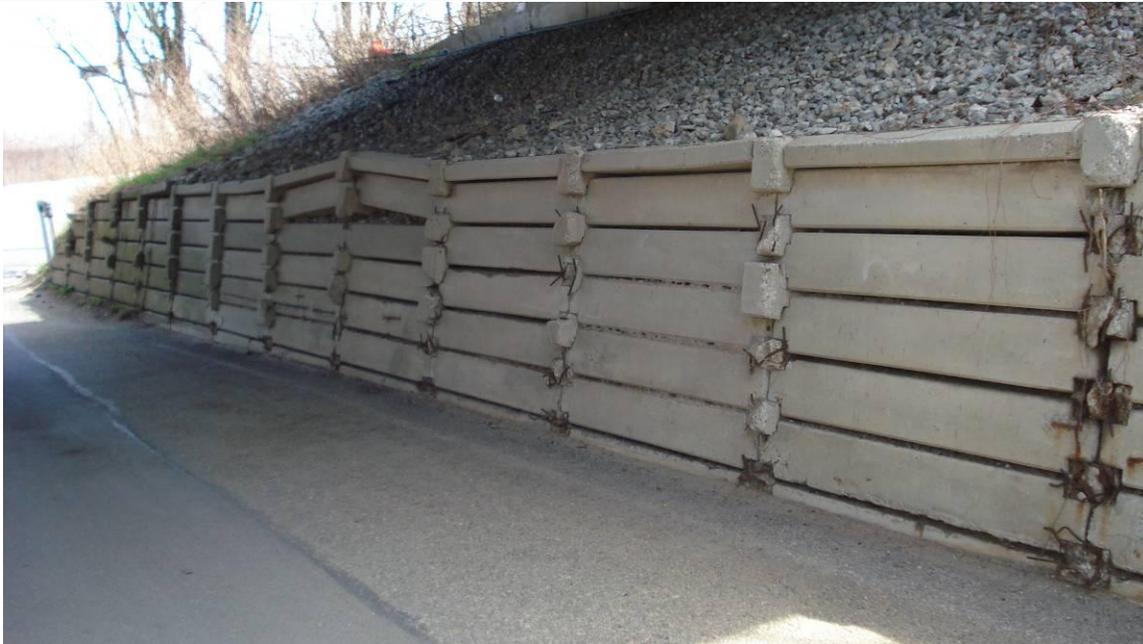
Photo No.: WSE18

Location: South shore underpass, below east bridge, looking east.

Description: Continuing east along crib wall. Wall becoming unstable at this section.

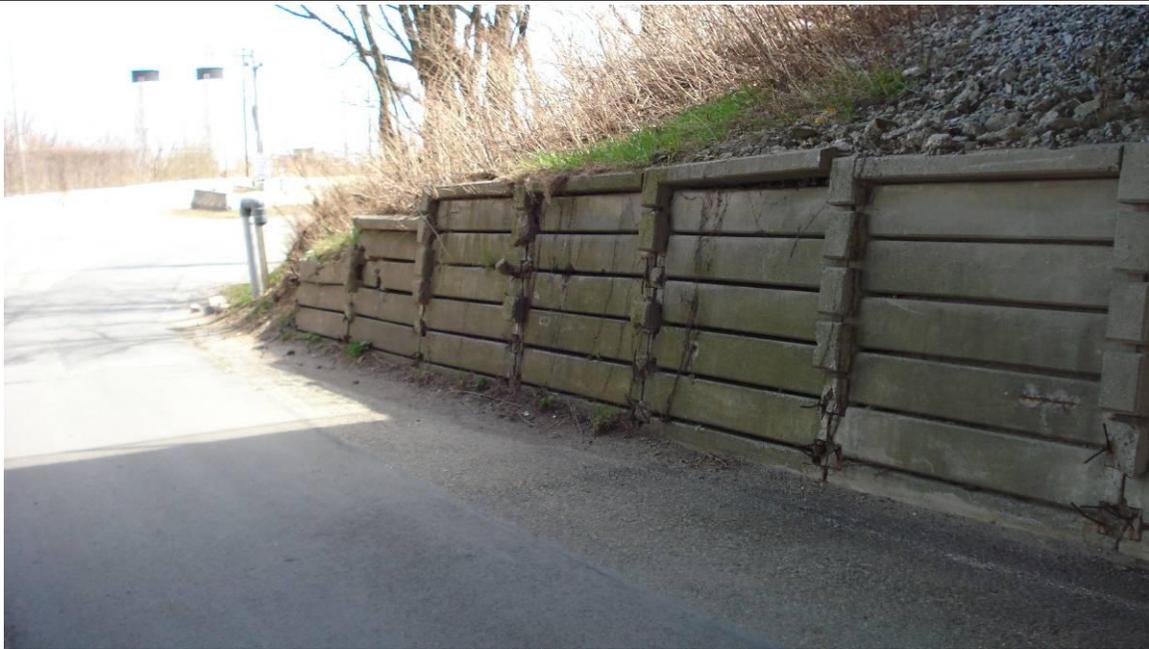
Photo No.: WSE19

Location: South shore underpass, east of east bridge, looking east.

Description: Continuing east along crib wall. Wall deteriorating badly.

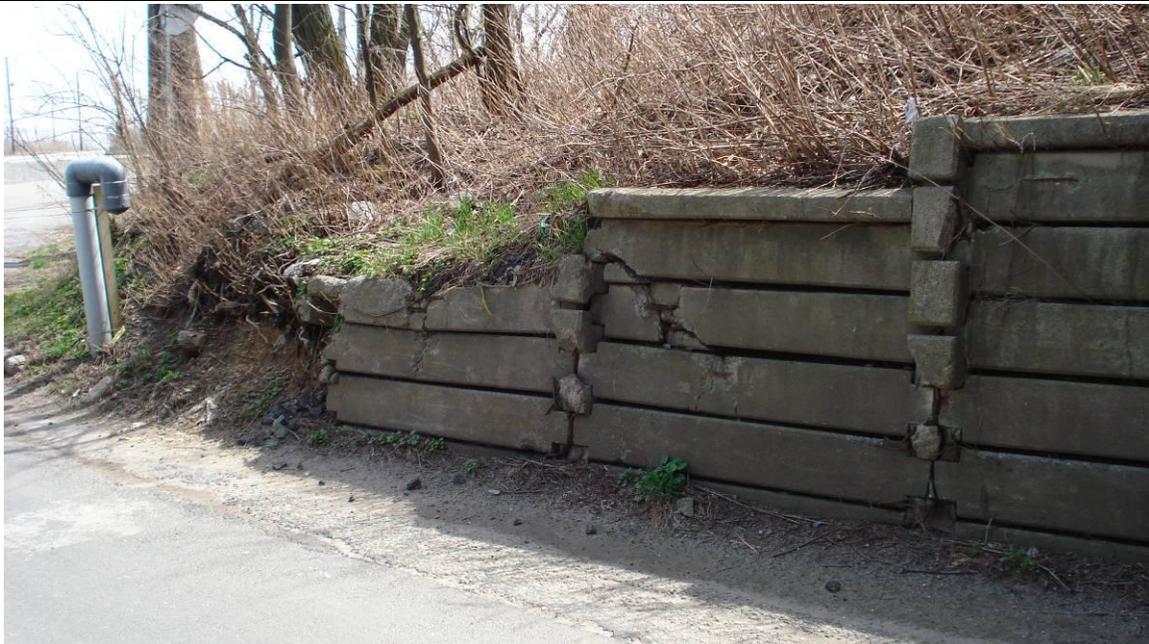
Photo No.: WSE20

Location: South shore underpass, east of east bridge, end of wall, looking east.

Description: Continuing east along crib wall. Wall badly deteriorated at this section.

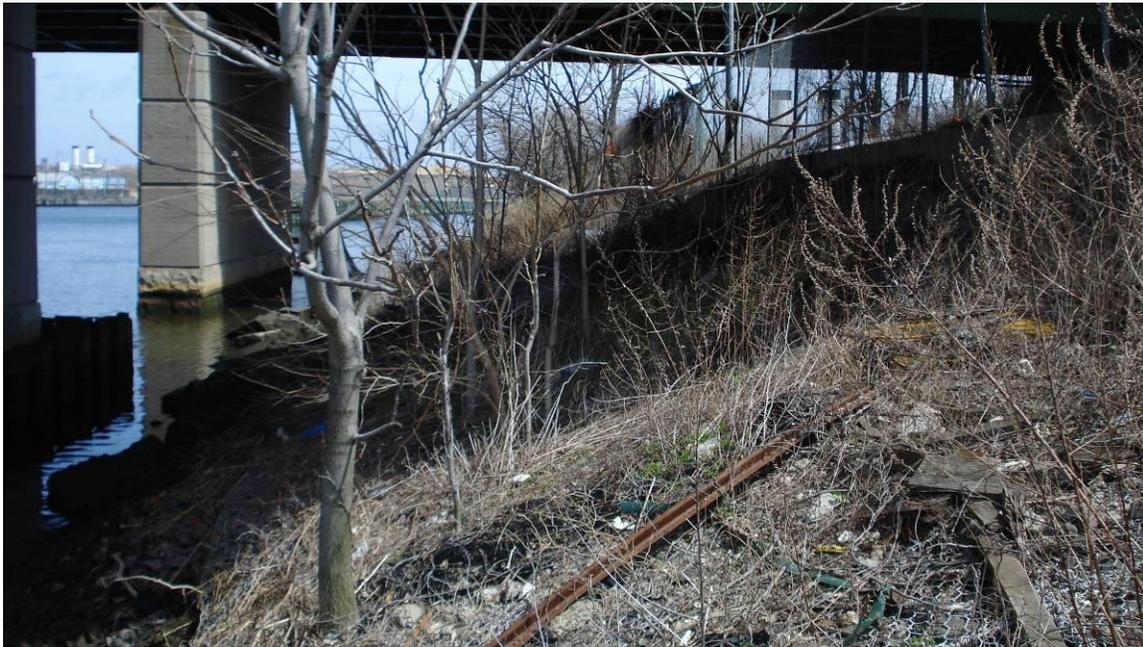
Photo No.: WSE21

Location: South shore just west of west bridge, looking east.

Description: Shoreline not stabilized. Slopes down rapidly to water.
